Mock Data Run 2015

Electron Muon Ranger (EMR)

Single Anode PMT replacement

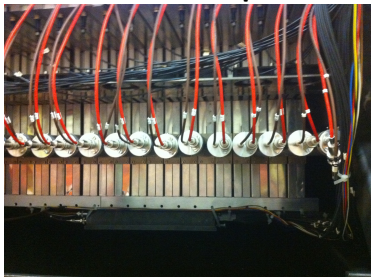
Old set up

Ageing **Philips XP2972** :

- Sensitivity: $\sim 65 \mu\text{A}/\text{lm}$
 - Gain: 3×10^6
 - Time spread: $\sim 800 \text{ ps}$
 - QE: 14.5 %
- 30 years old
- Degraded photocathode
- Reduction of secondary emissions
- Gain loss
- Spurious pulses

New **Hamamatsu R6427** :

- Sensitivity: $\sim 100 \mu\text{A}/\text{lm}$
 - Gain: 5×10^6
 - Time pread: $\sim 500 \text{ ps}$
 - QE: 24 %
- 56 PMTs (8 spares)
- Change done by UniGe technicians at RAL at the beginning of October 2014 (two days work)

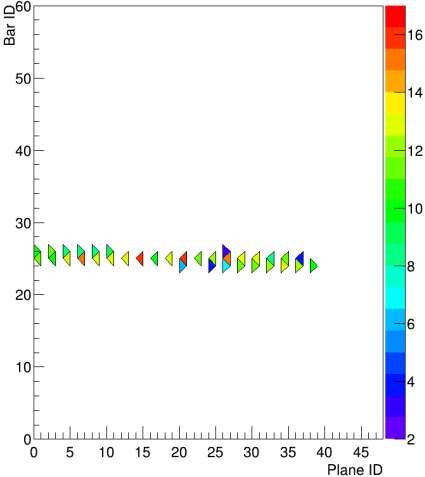
Time over Threshold [X planes]

After fixing the issues encountered after restarting, a first round a cosmic data was taken in January. The following configuration was used:

- All the boards, fans and crates were on at nominal voltage
- All the SAPMT set to 1500V
- All the MAPMT set to 700V, except 2 at 680V
→ 2 noisy FEBs
- Spill generated by the software, every 2.5ms, for 2ms
→ ~ 1 in 10 spill has a trigger
- Particle trigger generated by a pair of coincidences between two adjacent planes (14&&15) || (30&&31)
→ 4 trigger planes record no charge information
- 100k events recorded to check stability
