CEA PREVENTIVE ACTIONS FOR XFEL CRYOMODULE ASSEMBLY

Stéphane BERRY completed from Trublet| Thierry at XFEL meeting in 2015 April

COUPLER WARM PART
ASSEMBLY

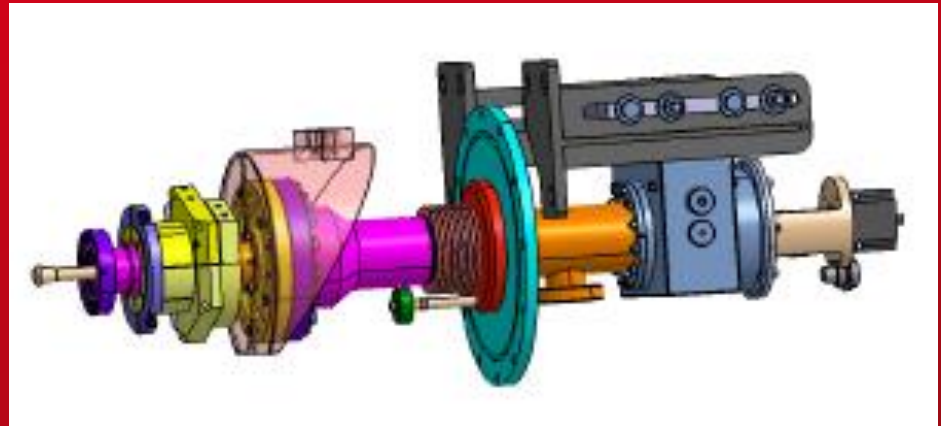
Coupler Warm Part

- Issues
 - Scratch on warm part inner conductor (on RF contact)
- Source
 - Disassembly warm from cold part
- Corrective actions
 - LAL: sand paper to remove thickness which risk to compromise the RF contact
