Update on Sector 34

R.Saban
LEMIC - October 28th 2008

Summary of the analysis

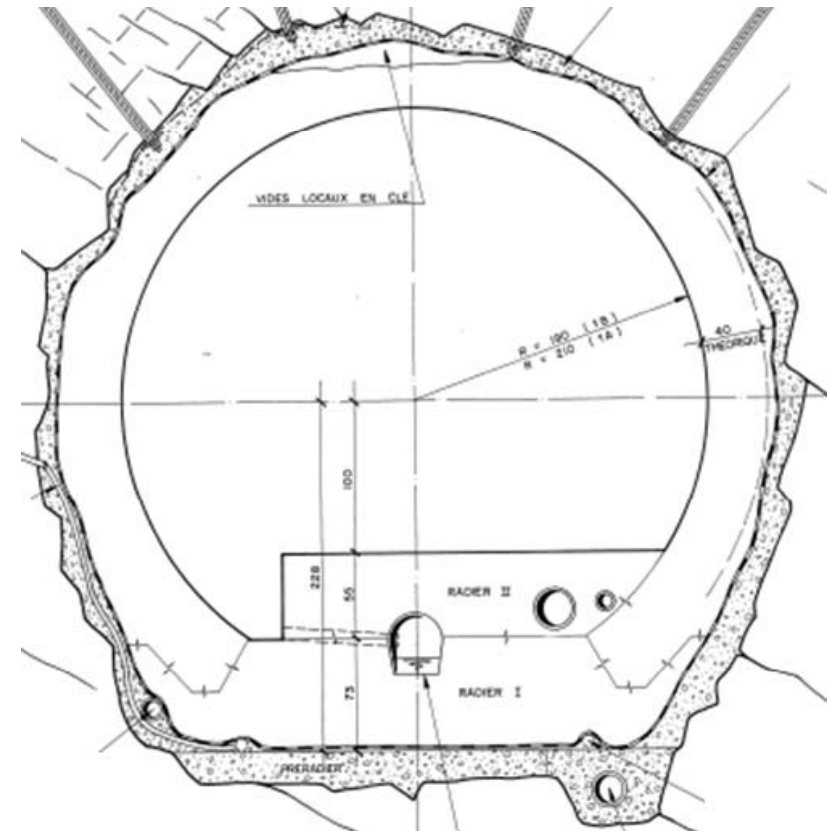
Constats

- ▶ Rupture du radier à l'emplacement du pied de jack arraché et détériorations diverses autour des socles de certains pieds de jack
- ▶ Quelques nouvelles fissures mineures décelées
- ▶ Pas des nouvelles fuites d'eau, mais une légère recrudescence des fuites déjà existantes
- ▶ Pas d'éclats de béton provenant de la voute
- ▶ Pas de modification perceptible dans l'écoulement d'eau
- ▶ Pas des zones sonnant le creux

Conclusions

- ▶ Pas des signes apparents de désordre structurel de l'ouvrage dans la zone de l'incident.
- ▶ Les ruptures en radier concernent seulement le radier secondaire (donc pas d'incidence sur la structure).

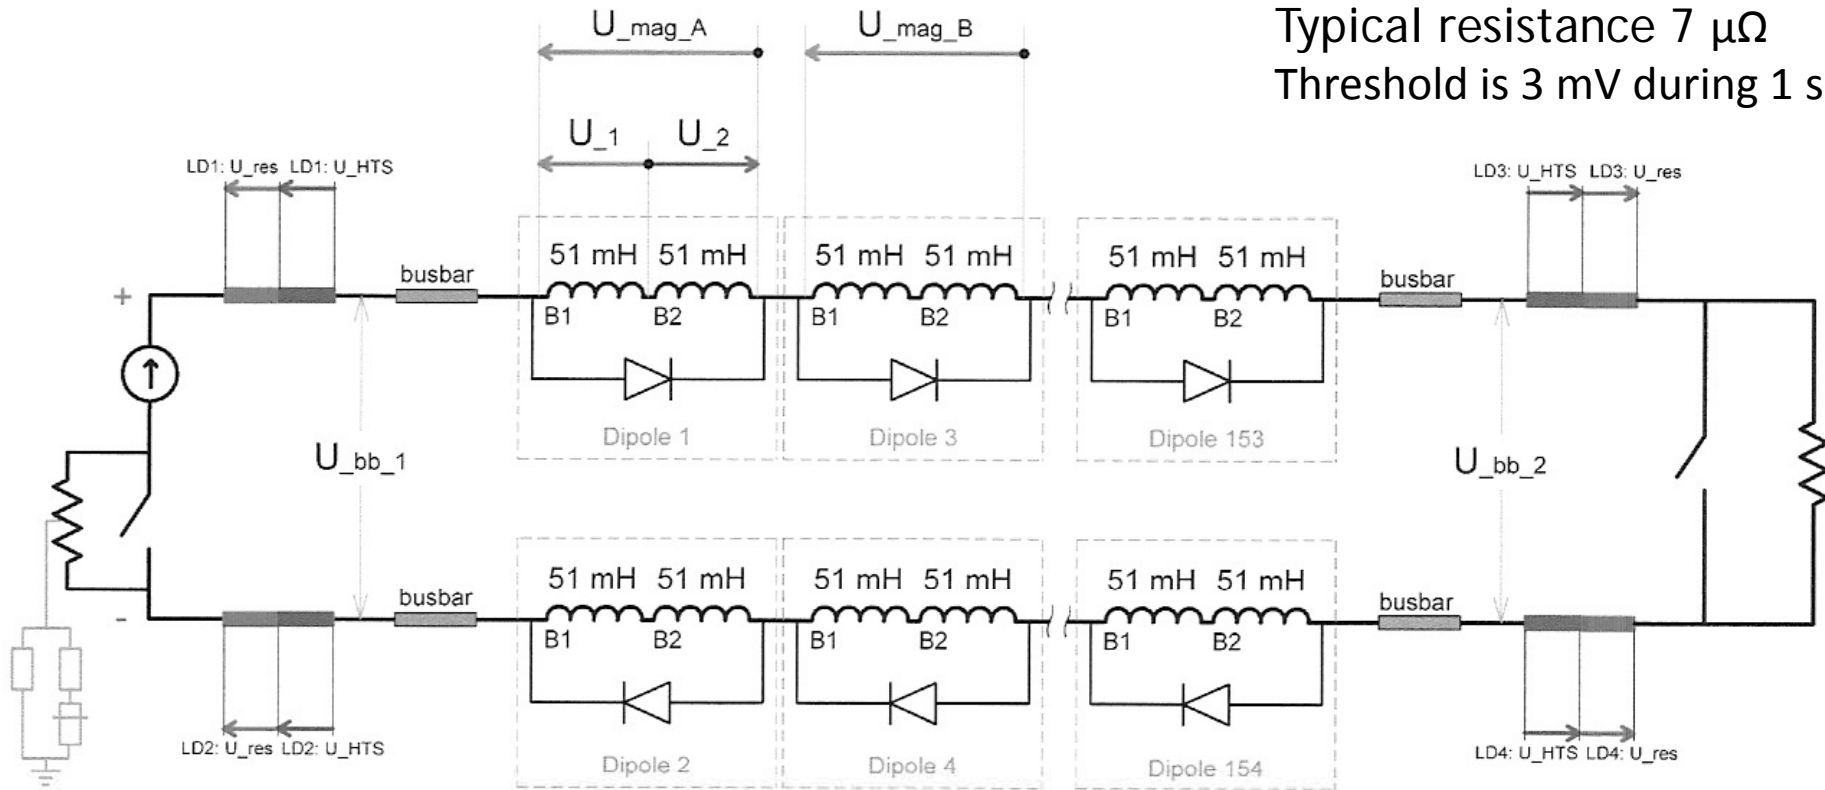
the circuit

The current leads
 Typical resistance $7 \mu\Omega$
 Threshold is 3 mV during 1 s
