# Qualification of the CMS Digital Optohybrid

# CMS Control Link Digital Optohybrid (DOH)

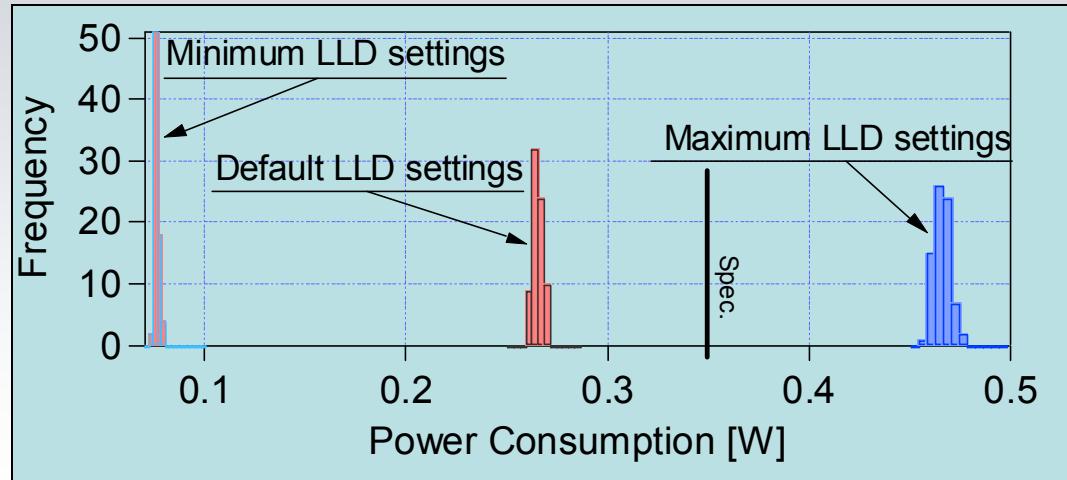
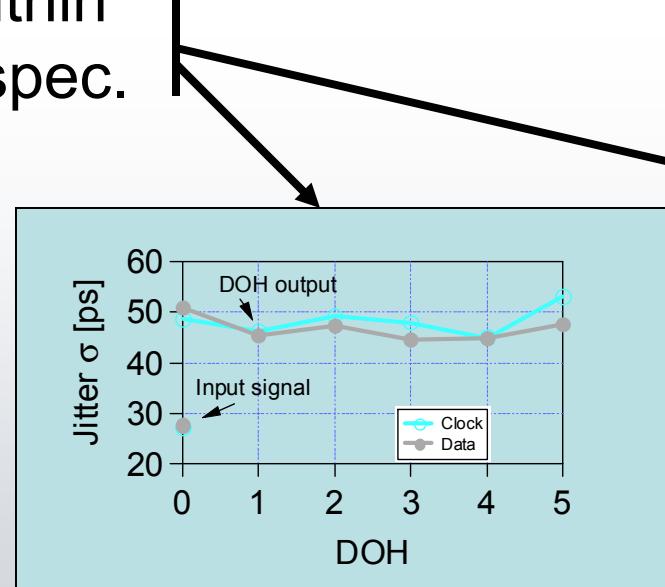
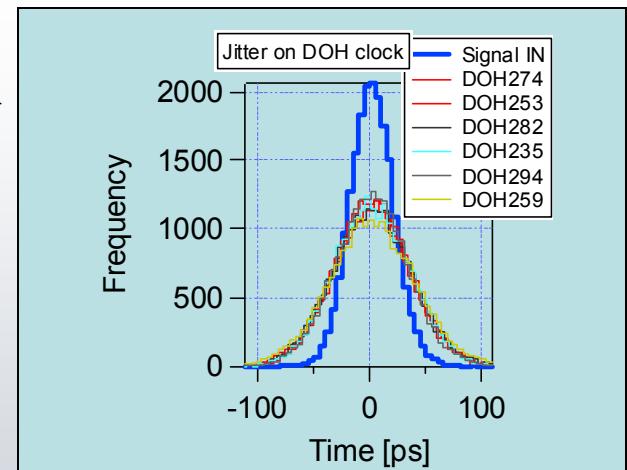
- Power consumption within 350mW spec.
- Bit Error Rate,  $<10^{-12}$
- Skew  $<1\text{ns}$
- Jitter well within 250ps rms spec.

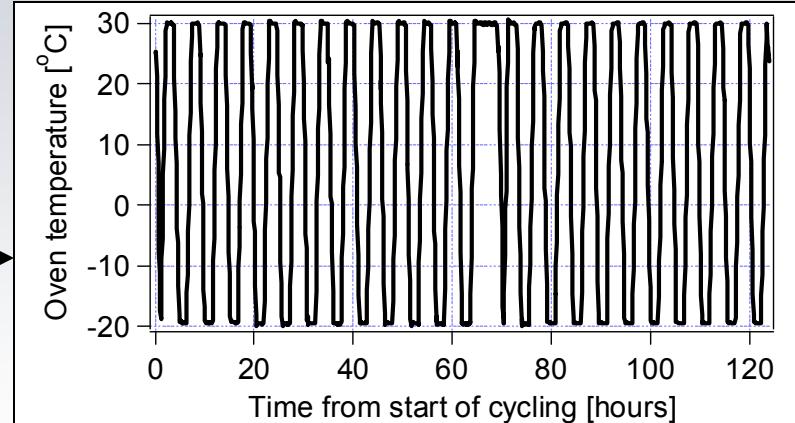
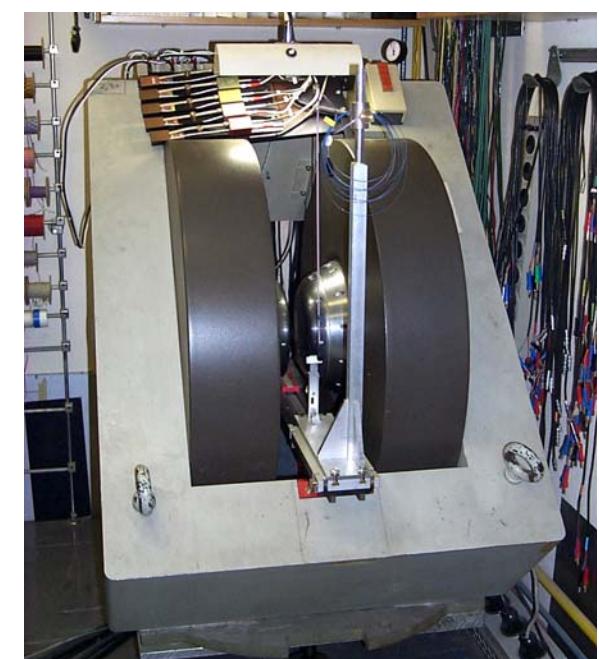
- Temperature cycling (CERN)
- B-field (CERN)
  - 2 DOHs, 3 orientations, 2.4 T
- Shock test (Kapsch)
  - 6 DOHs, 20G
- Vibration test (Kapsch)
  - 6 DOHs, 10Hz-500Hz
- All DOHs were functional after above tests

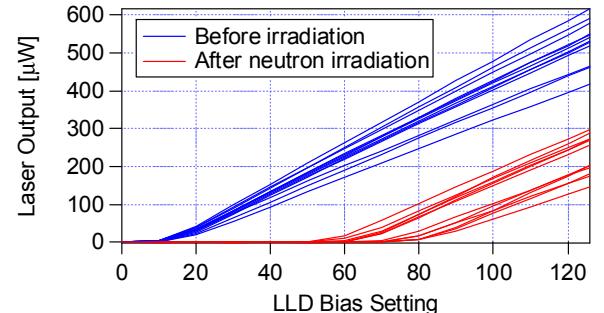
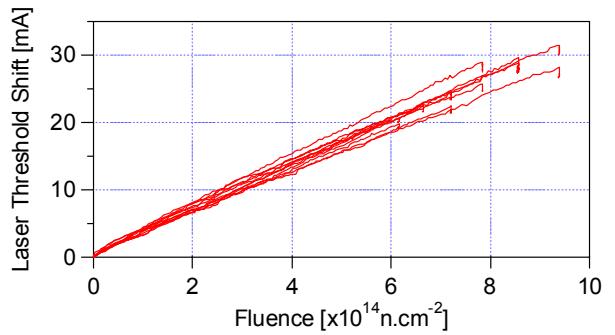
- Irradiation (6 DOHs)
  - 100kGy Co-60 gamma
  - Up to  $9.4 \times 10^{14} \text{n/cm}^2$  (UCL ~20MeV)
- Expected laser and photodiode damage
- Final system laser threshold shift should be less:
  - ~6mA (LLD bias shift =13)

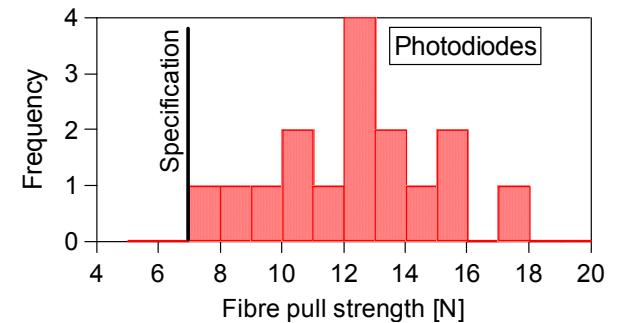
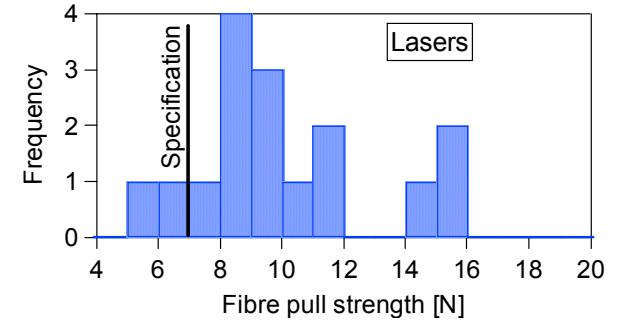
- Attach 700g to fibre
- 3/40 fibres failed (all lasers)

- Pull fibre until it fails
- 2/36 fibres below spec  
(all lasers 5.5N & 6.7N)

- Fibre strength reasonably good
- Revise DOH pull strength specification
