LHC RF system reliability

LHC run 2: all RF trips

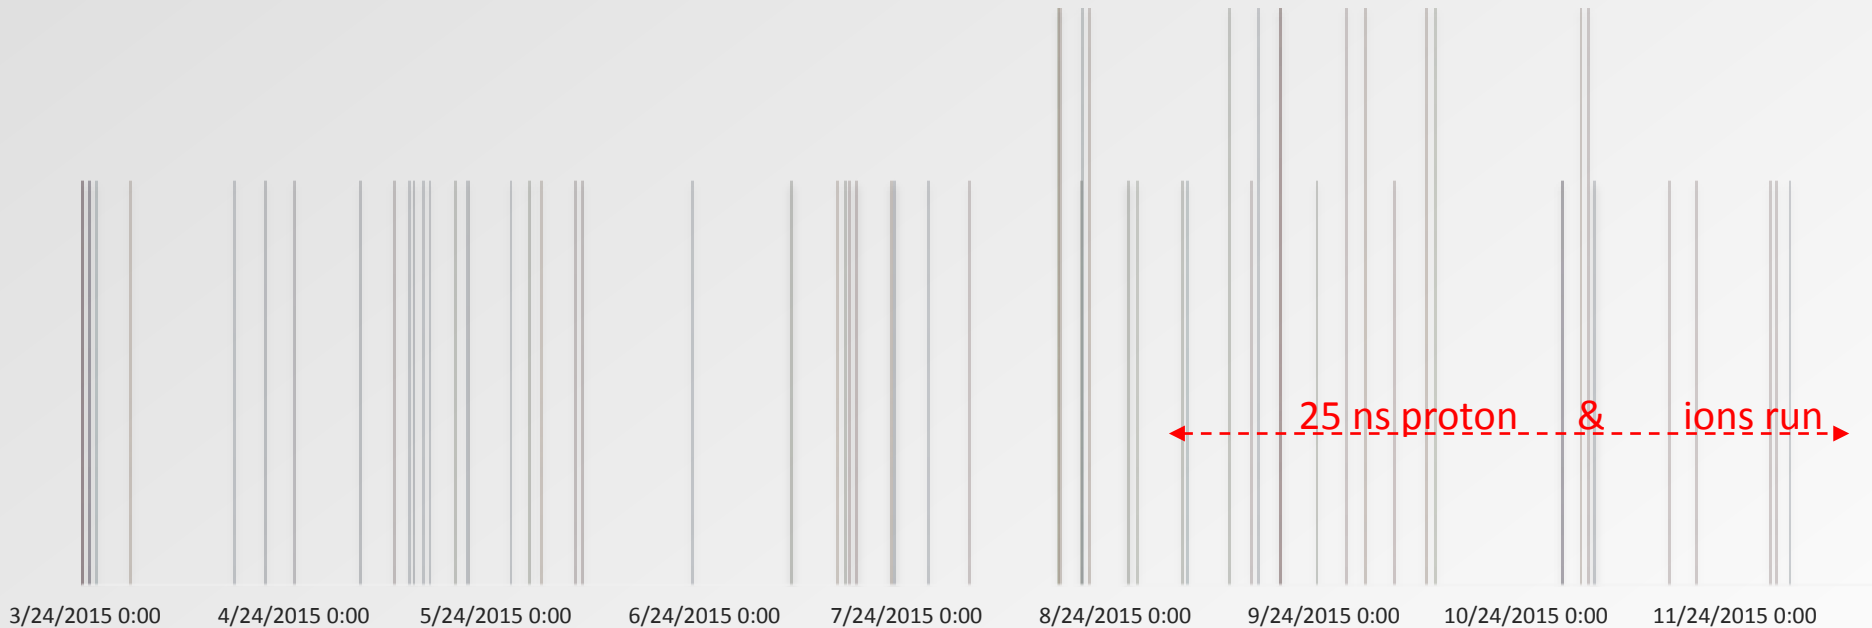
- 57 trips recorded
- 13 beam dumps (higher bars) – 7 during 25 ns run
- 15 categories

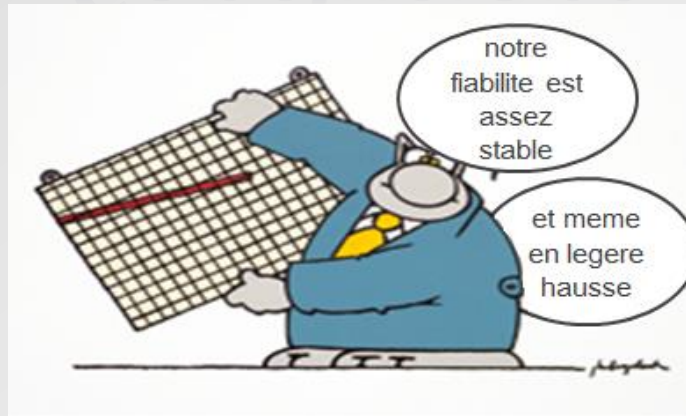
Conclusions

- ❖ Work done during LS1 and along run 2 proved to be effective -> No spurious trips since TS2
- ❖ More frequent (minor) hardware failures!
 - ❖ Only very few LLRF spares!
 - ❖ Replacement campaign during YETS (e.g. 5V P.S.)
- ❖ With increasing beam intensity the system is more sensitive:
 - ❖ The RF system is approaching its limits - > time needed for RF conditioning & LLRF setup
 - ❖ Arc detectors trips do not seem –all- real! -> new configuration and new diagnostic system installed during YETS
