NuMI Horns Experience

NBI2006
September 6, 2006
NuMI Horns Experience
Jim Hylan / FNAL
Page 1

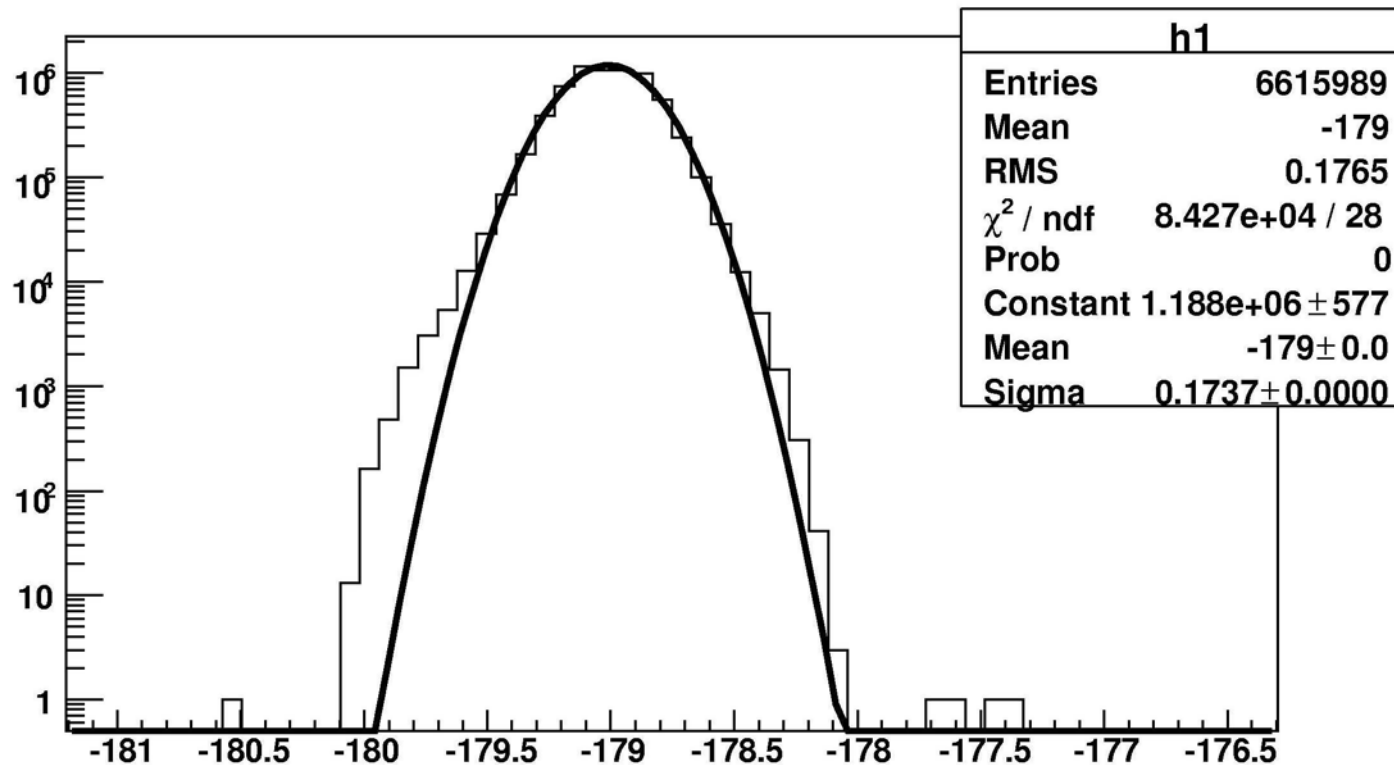
Horn Peak Current (uncorrected) during LE-10 running May, 2005 - Feb, 2006

Current stability is excellent, pulse-to-pulse RMS < 0.1 % (spec. 0.4%)

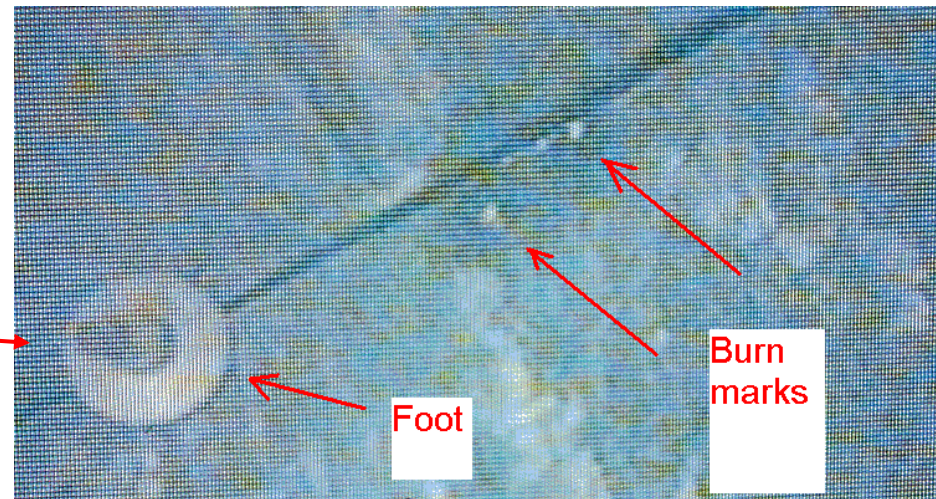
Horn 2 before beam
1.5 inch clearance foot to floor

Owl shift Thurs. Sept. 29, 2005 intermittent horn trips.
 Owl shift Sat. Oct. 1, hard ground fault of 1 ohm.
-removing stripline fingers Horn 2 + stripline block
-when Horn 2 moved to work cell ground fault cleared
-foot left behind in chase, nut had vibrated off
-scorch marks seen under foot

Moved old foot, installed new foot
