HIE-ISOLDE

Commissioning report

Walter Venturini Delsolaro
on behalf of the HIE ISOLDE Commissioning team

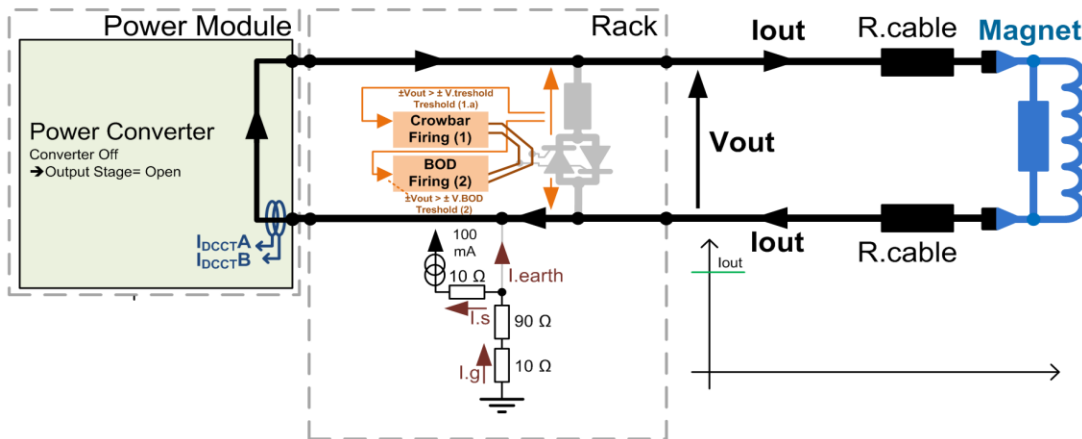
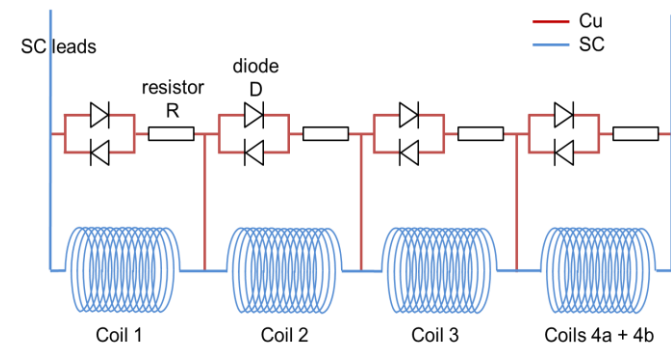
Solenoid test results

- Nominal current set conservatively for operation: (115.5 A \rightarrow 100 A, need 90 A)
- Insulation at cold tested up to 500 V (checked to be sufficient in case of quench)
- Vapour cooled current leads set at 0.5 g/s
- Fast power abort from nominal triggered quench (as expected): good reaction of the cryogenics system
- **No spontaneous quenches, continuous operation at $\sim 60\%$ of I_{NOM}**
- **Small issue:** power converter trips (in current mode) when changing polarity...traced back to repolarization of the parallel diodes
- **Need to verify for future solenoids if this events are not signs of a defect in the protection scheme**

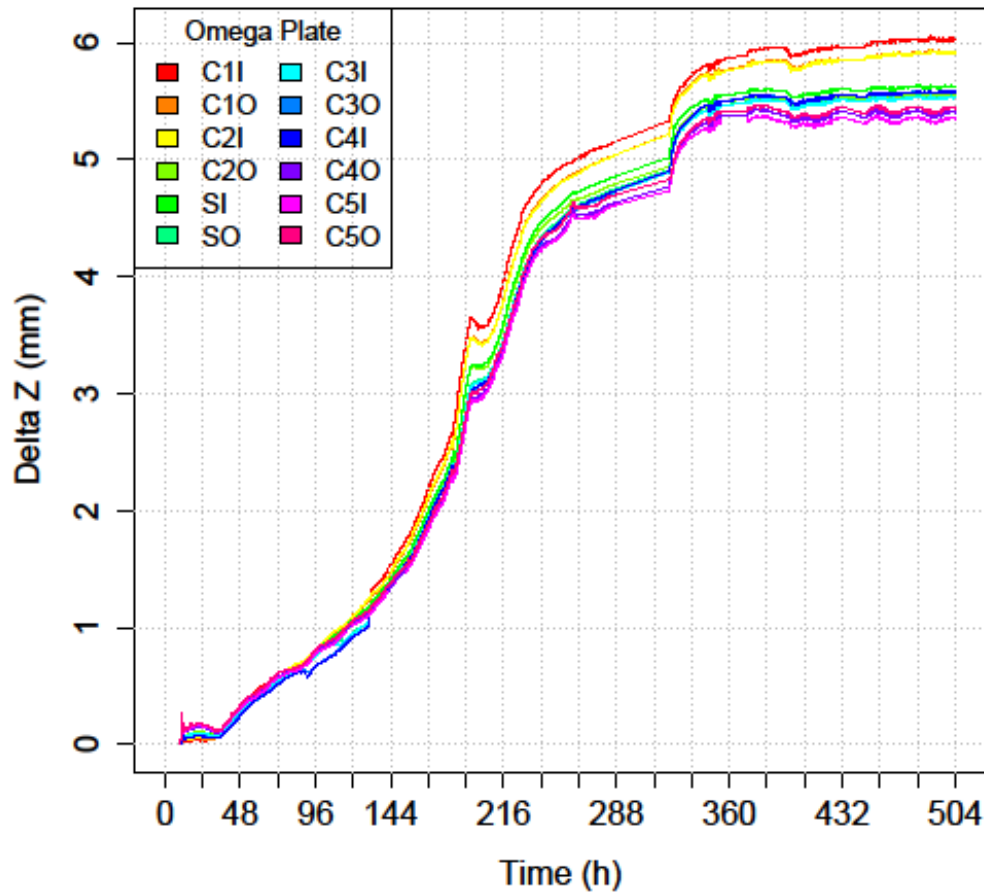
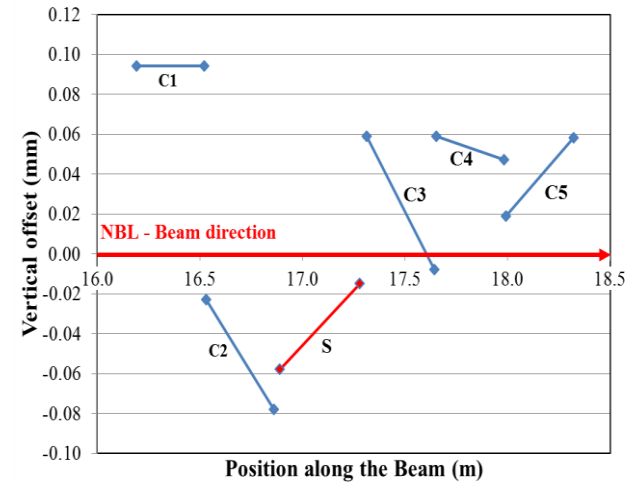
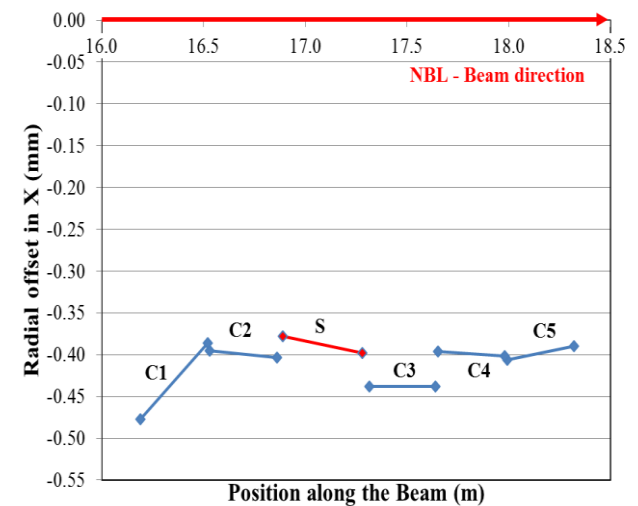
Survey and alignment

Delta Z (mm) over time during first cool down (0-->504H)
