Operational Experience with the MICE Spectrometer Solenoid System

Sandor Feher

Fermilab

8/30/2017

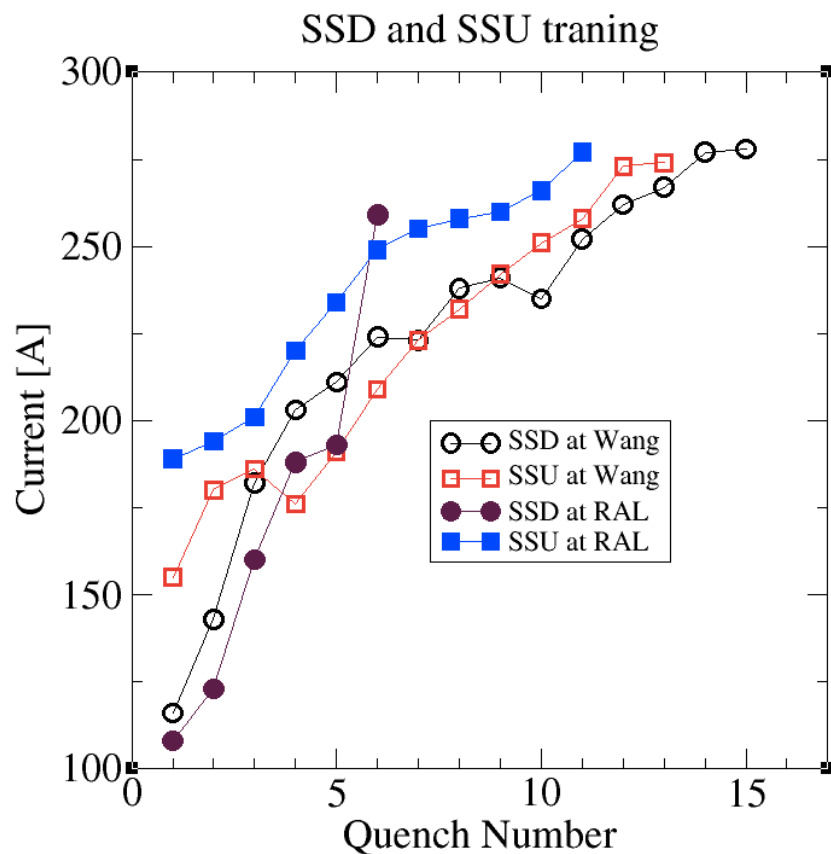
Commissioning SSU and SSD

SSU and SSD cold HiPot: Limited to ~ 250 V

- 1600 V internal peak voltage during quench

SSU initial bus-work incorrect – 1 month of delay

Both magnet does not remember its training
SSU training at RAL similar than at Wang NMR

SSD: lost V-tap - decided not to run M2 for the current ramp of the 6th quench
