LHC Status Report

96th LHCC meeting, CERN 19th November 2008

Interim Summary Report on the analysis of the 19th September 2008 incident at the LHC

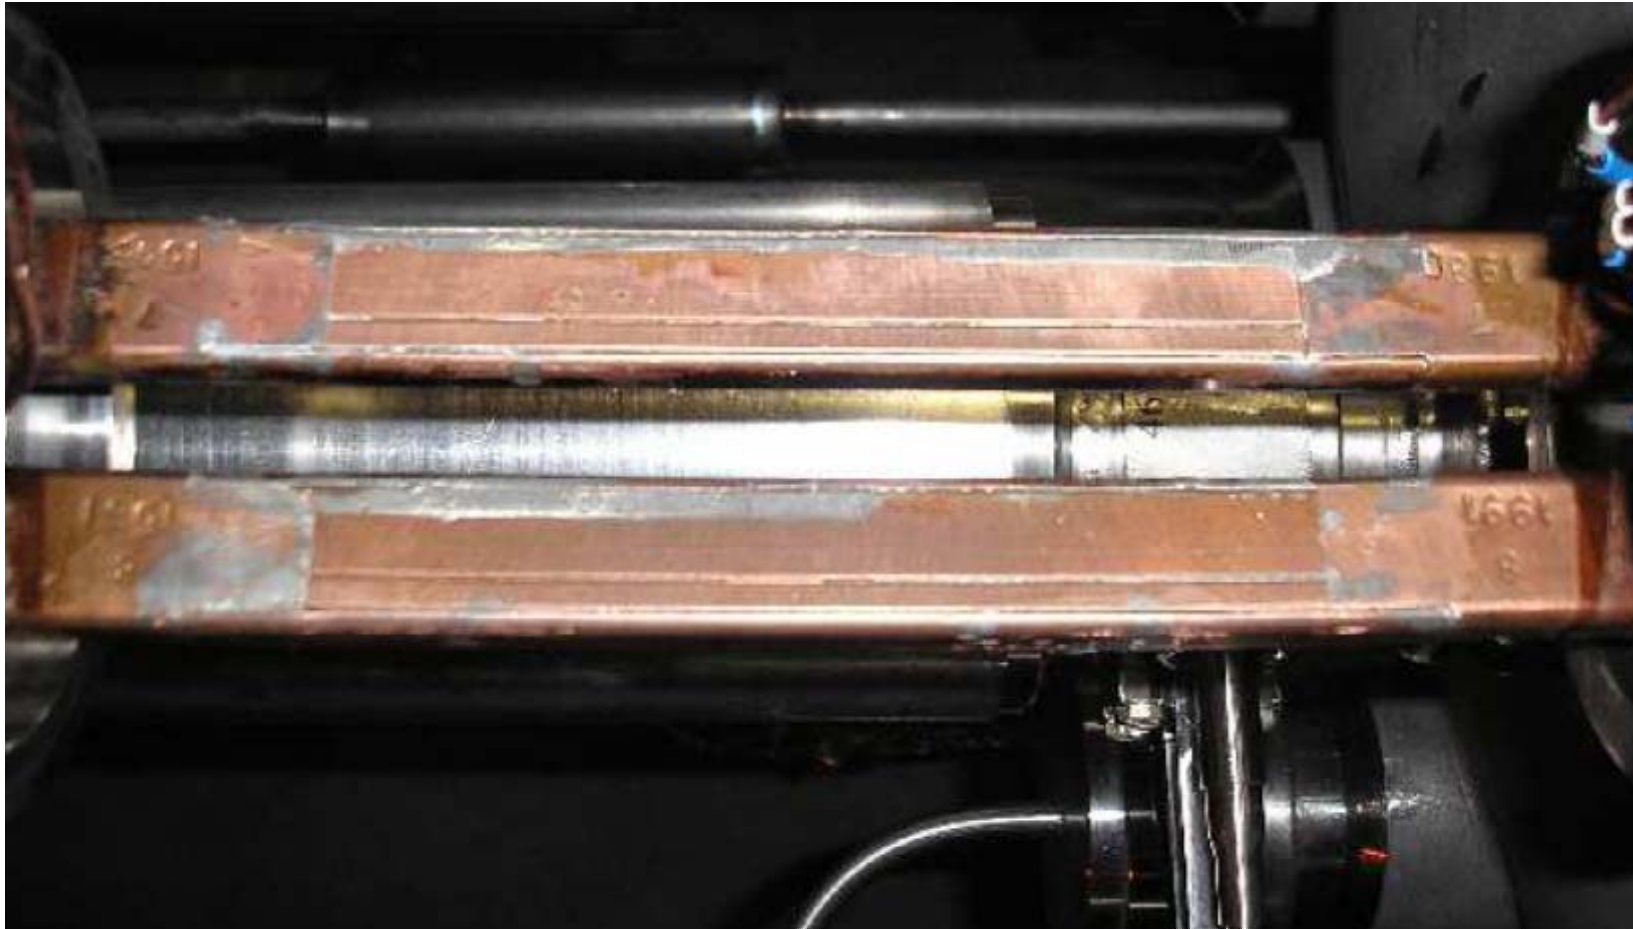
Busbar splice

On 19 September 2008 morning, the current was being ramped up to 9.3 kA in the main dipole circuit at the nominal rate of 10 A/s, when at a value of 8.7 kA, a resistive zone developed in the electrical bus in the region between dipole C24 and quadrupole Q24. The first evidence was the appearance of a voltage of 300 mV detected in the circuit above the noise level: the time was 11:18:36 CEST. No resistive voltage appeared on the dipoles of the circuit, individually equipped with quench detectors with a detection sensitivity of 100 mV each, so that the quench of any magnet can be excluded as initial event. After 0.39 s, the resistive voltage had grown to 1 V and the power converter, unable to maintain the current ramp, tripped off at 0.46 s (slow discharge mode). The current started to decrease in the circuit and at 0.86 s, the energy discharge switch opened, inserting dump resistors in the circuit to produce a fast power abort. In this sequence of events, the quench detection, power converter and energy discharge systems behaved as expected.

Within the first second, an electrical arc developed and punctured the helium enclosure, leading to release of helium into the insulation vacuum of the cryostat.

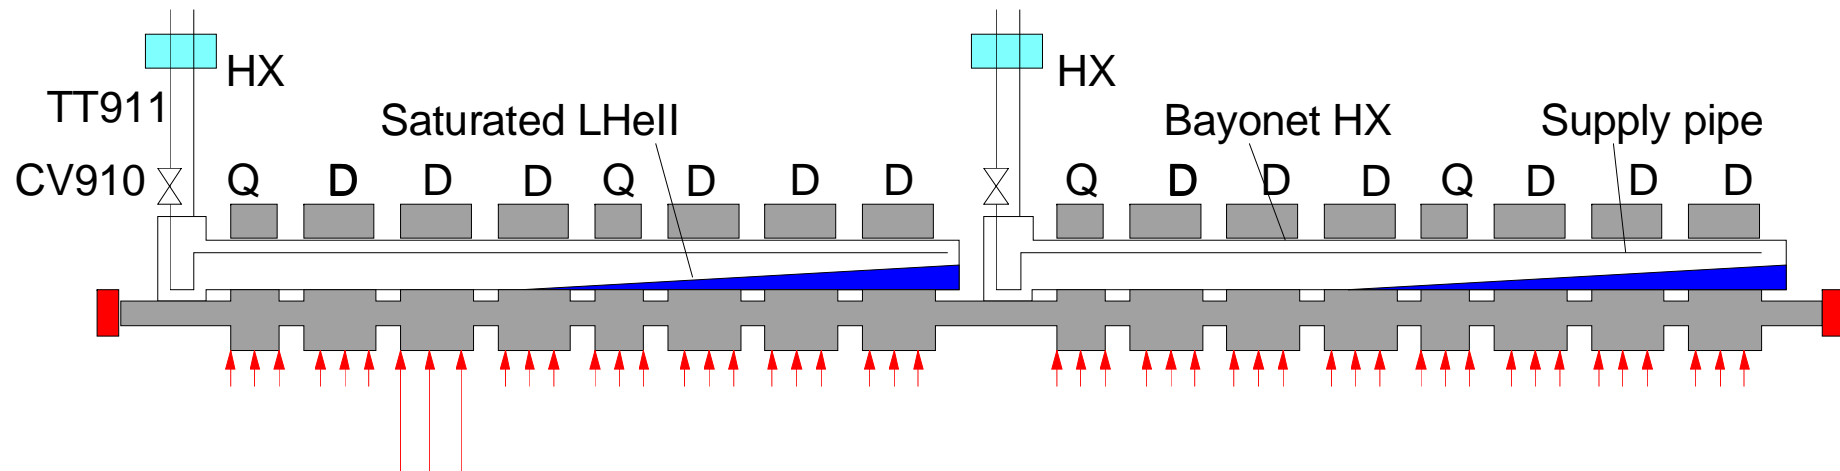
Sub-sector magnet cooling scheme

- Blocking of the JT valve at a value to extract the static heat inleaks before the powering
- Then, the temperature drift is due to electrical resistive heating dissipated during the powering

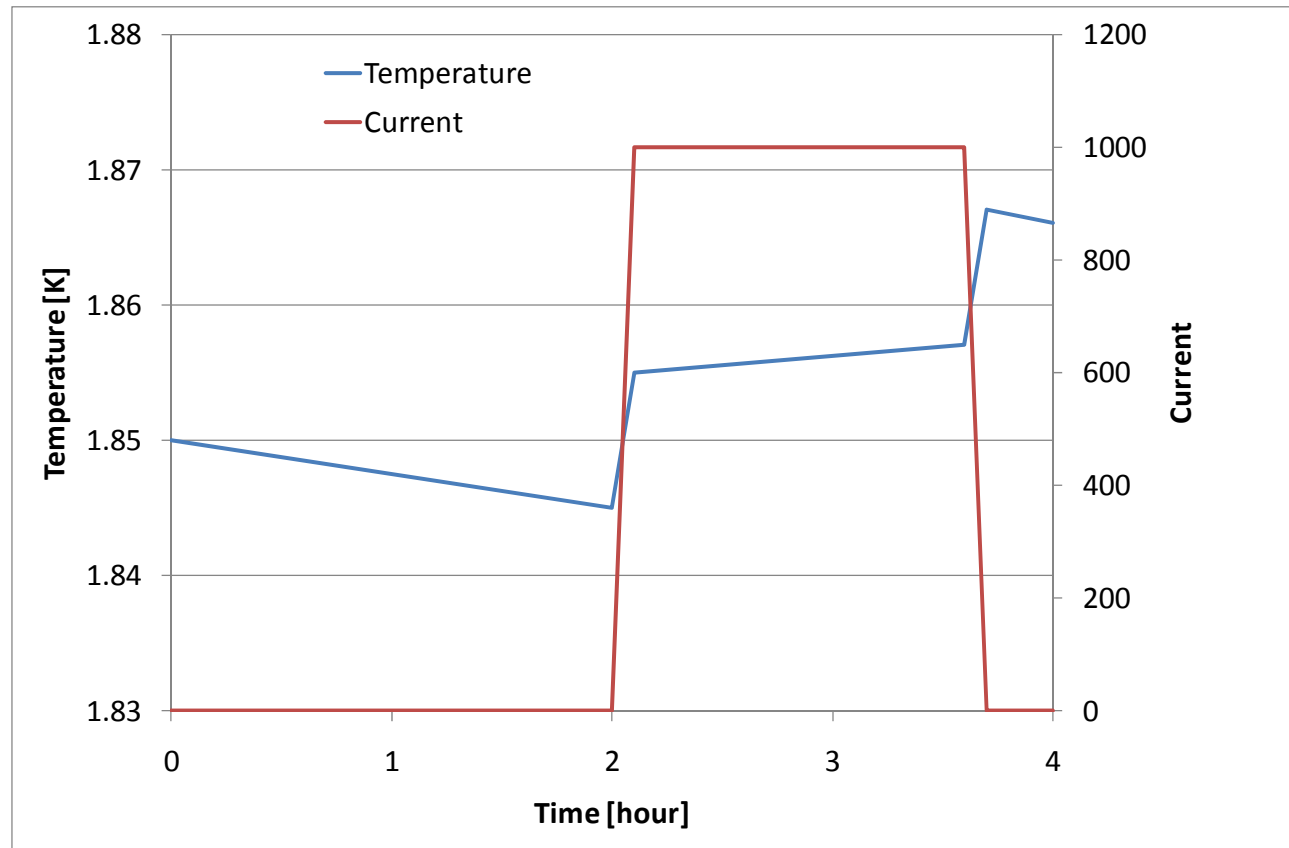
Methodology

1. Assessment of the baseline slope (remaining CV opening mismatch w/r to static HL)
2. Assessment of the temperature increase during powering plateau
3. Assessment of the internal energy variation (J/kg)
4. Assessment of the deposited energy assuming a mass of 26 l/m of LHell
