Electrical Performance of LHC Magnet Circuits

F. Rodriguez Mateos, TE/MPE-EE
Chamonix 2016
Session 3: LHC Hardware Performance

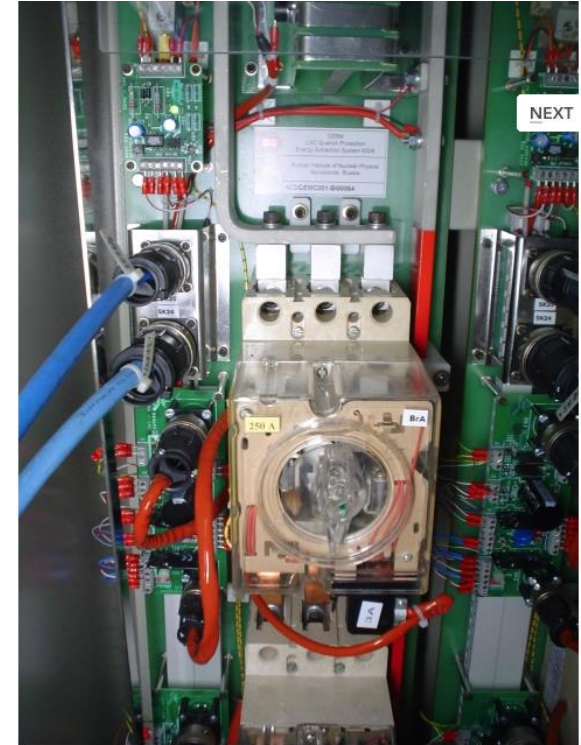
- 11 interventions in total
- 8 in the tunnel:
 - 5 breakers replaced (2 x main ax, 1 micro-switch, 1 holding coil, 1 producing closing failures requiring re-adjustment)
 - 2 LV TRACO power supplies (in total 3 cases during the 2015 calendar year)
 - 1 case of loose wire (post LS1) on a new small transformer
- 3 faults that could be reset remotely

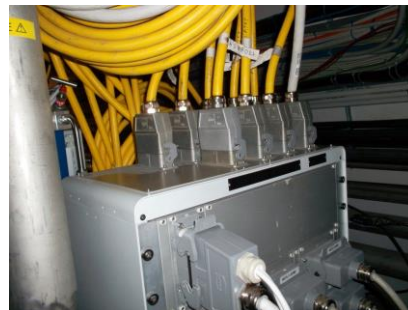
- Top part of the current leads must be maintained at room temperature to avoid heavy condensation or ice formation. Cartridge heaters are incorporated in the top of each current lead.
- When one of the CL heating systems stops working, it does not trigger dumping of the beams. The system will need to be repaired in the tunnel after the first upcoming beam dump.

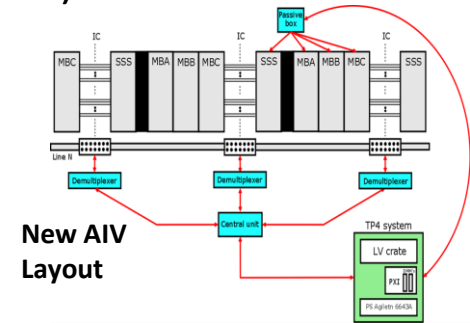
3 kV crate with the new DAQ prototype

- New hardware and software with improved features - ongoing
 - New DAQ Interface and other upgrades of the High-Voltage Insulation Testers, with delivery of 10 complete systems
 - New hardware for the Arc Interconnection Verifications (nAIV) units
 - New software tools for ELQA
