MAXIMUM CREDIBLE INCIDENTS

J. Strait, Fermilab, Batavia, IL 60510, U.S.A.

Abstract

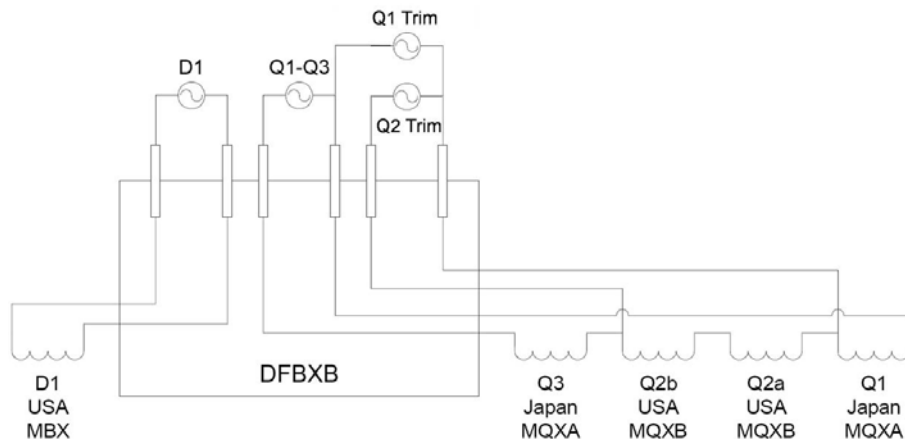
The stored energy in the triplet (7.3 MJ) is comparable to that in one main dipole (6.9 MJ). The powering scheme is complex, involving three power converters, as shown in Fig. 5. There are diodes across each power converter, which divide the triplet into three circuits once a quench occurs, and each magnet has to absorb only its own stored energy (2.3 MJ for each of the Q1 and the Q3, and 2.7 MJ for the Q2 pair).

Figure 5: Inner triplet powering scheme.

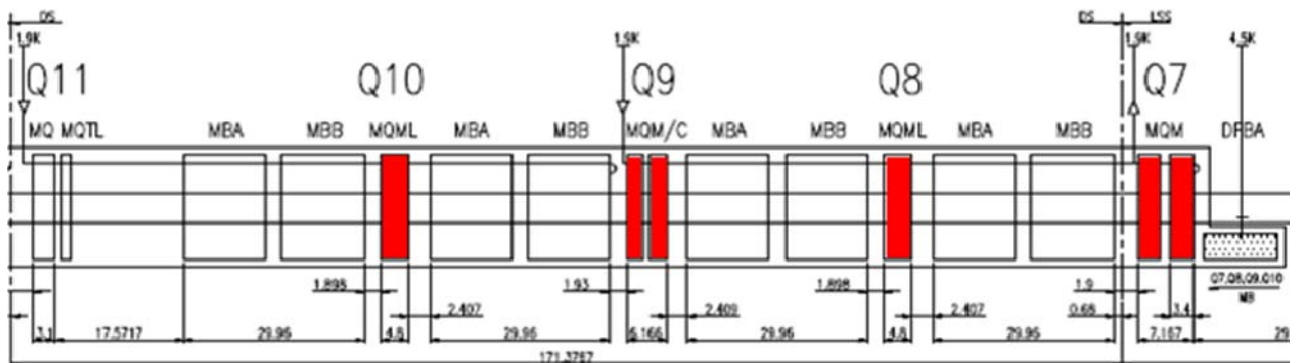
Figure 11: A dispersion suppressor sector, showing the locations of the individually powered quadrupoles.

In half the individually powered MQM quadrupoles in the DS (Fig.11), the bus to magnet splice is made in a “praying hands” configuration, as shown in Fig. 12. In this geometry, the electromagnetic forces tend to pry the splice apart, if it is not adequately clamped. Even if the splice itself is clamped, if the adjacent conductors are allowed to flex, wires can break due to mechanical cycling, which could eventually result in an abrupt bus rupture. Experience with HERA, where a splice of this sort failed, and with the Tevatron, where buses of a different geometry failed due to mechanical cycling with magnet excitation, show that this is a real risk.
