# Magnets repairs for 3-4 sector

P. Fessia, M. Modena and L. Rossi  
Technology Dept.– MSC group

### Sector 3-4 Event Findings and Observations Summary

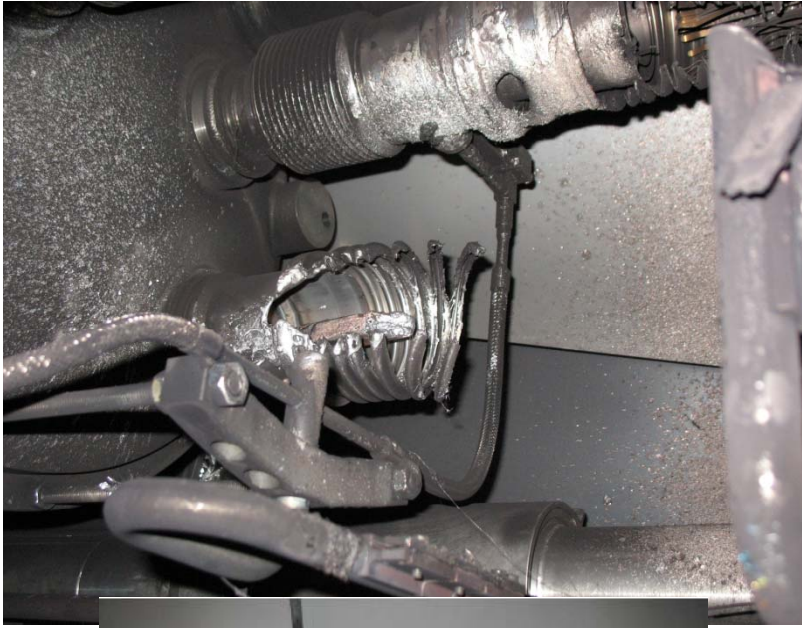
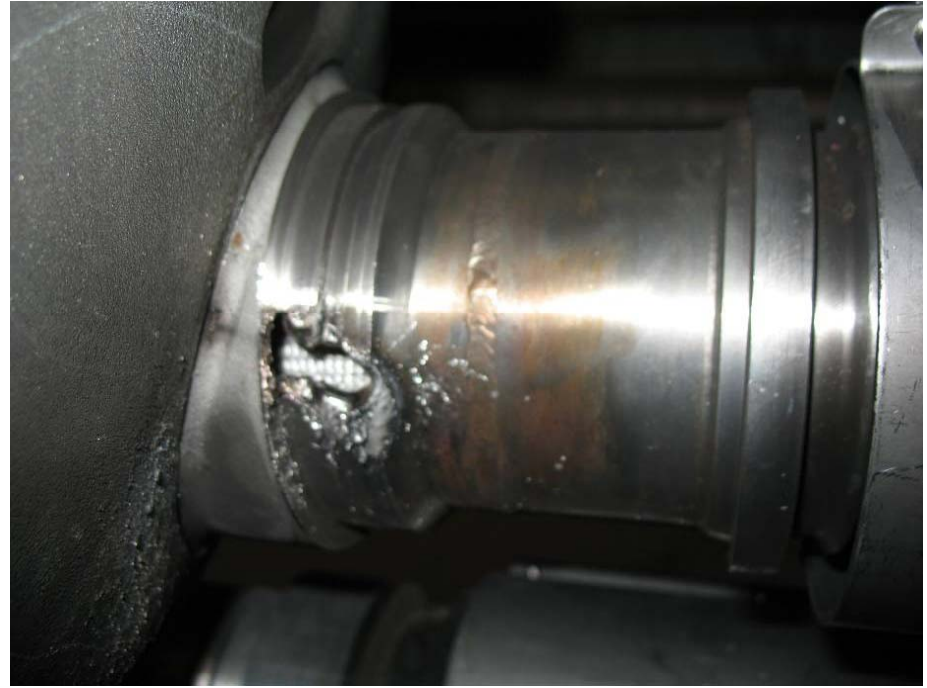
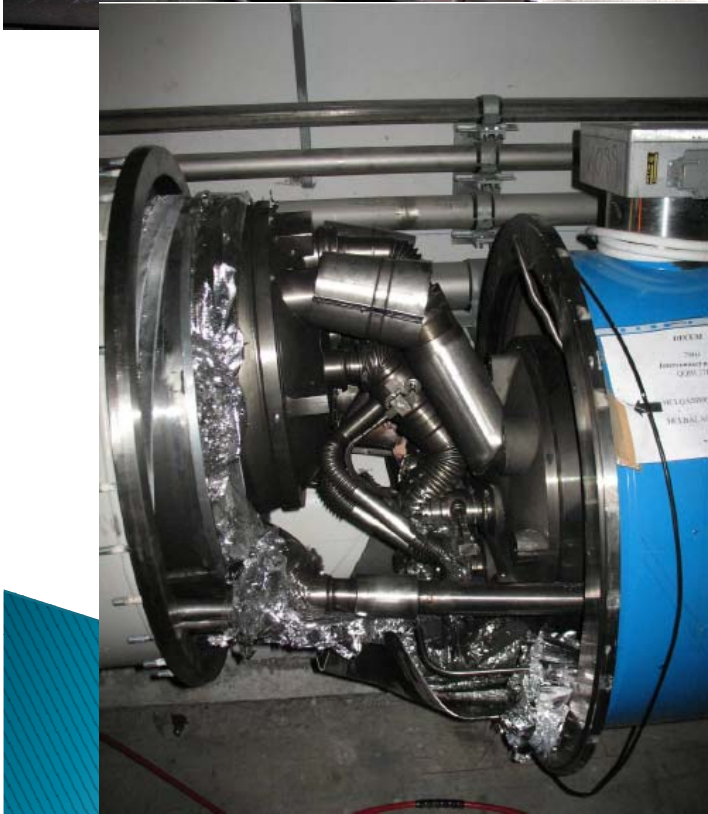
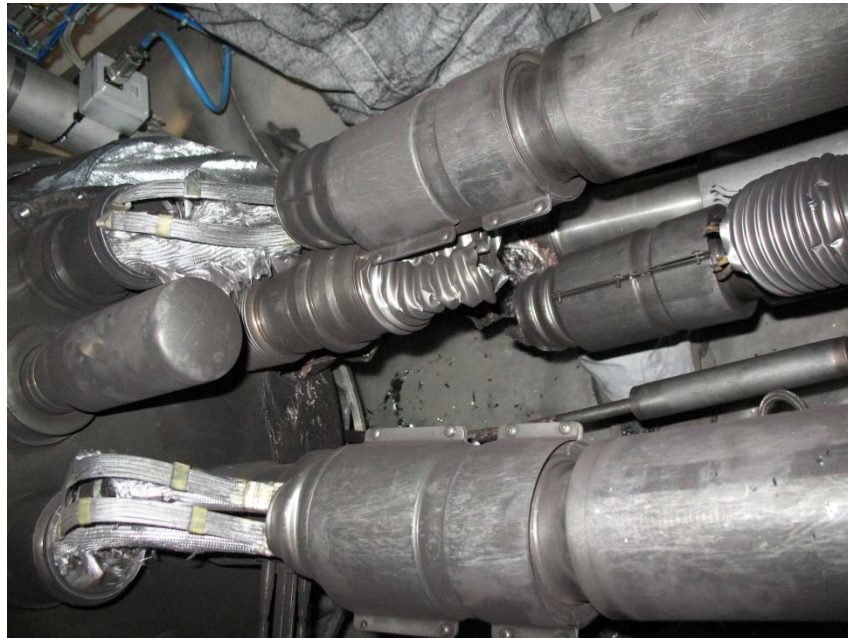
## Inspection of Q32.R3 (M 1-2 lines)

Serious contamination by soot. TS-MME analysis show a mix of copper and SS (not austenitic). Magnetic and elec. conducting; around-globular shapes; micrometric dimension for some amount.

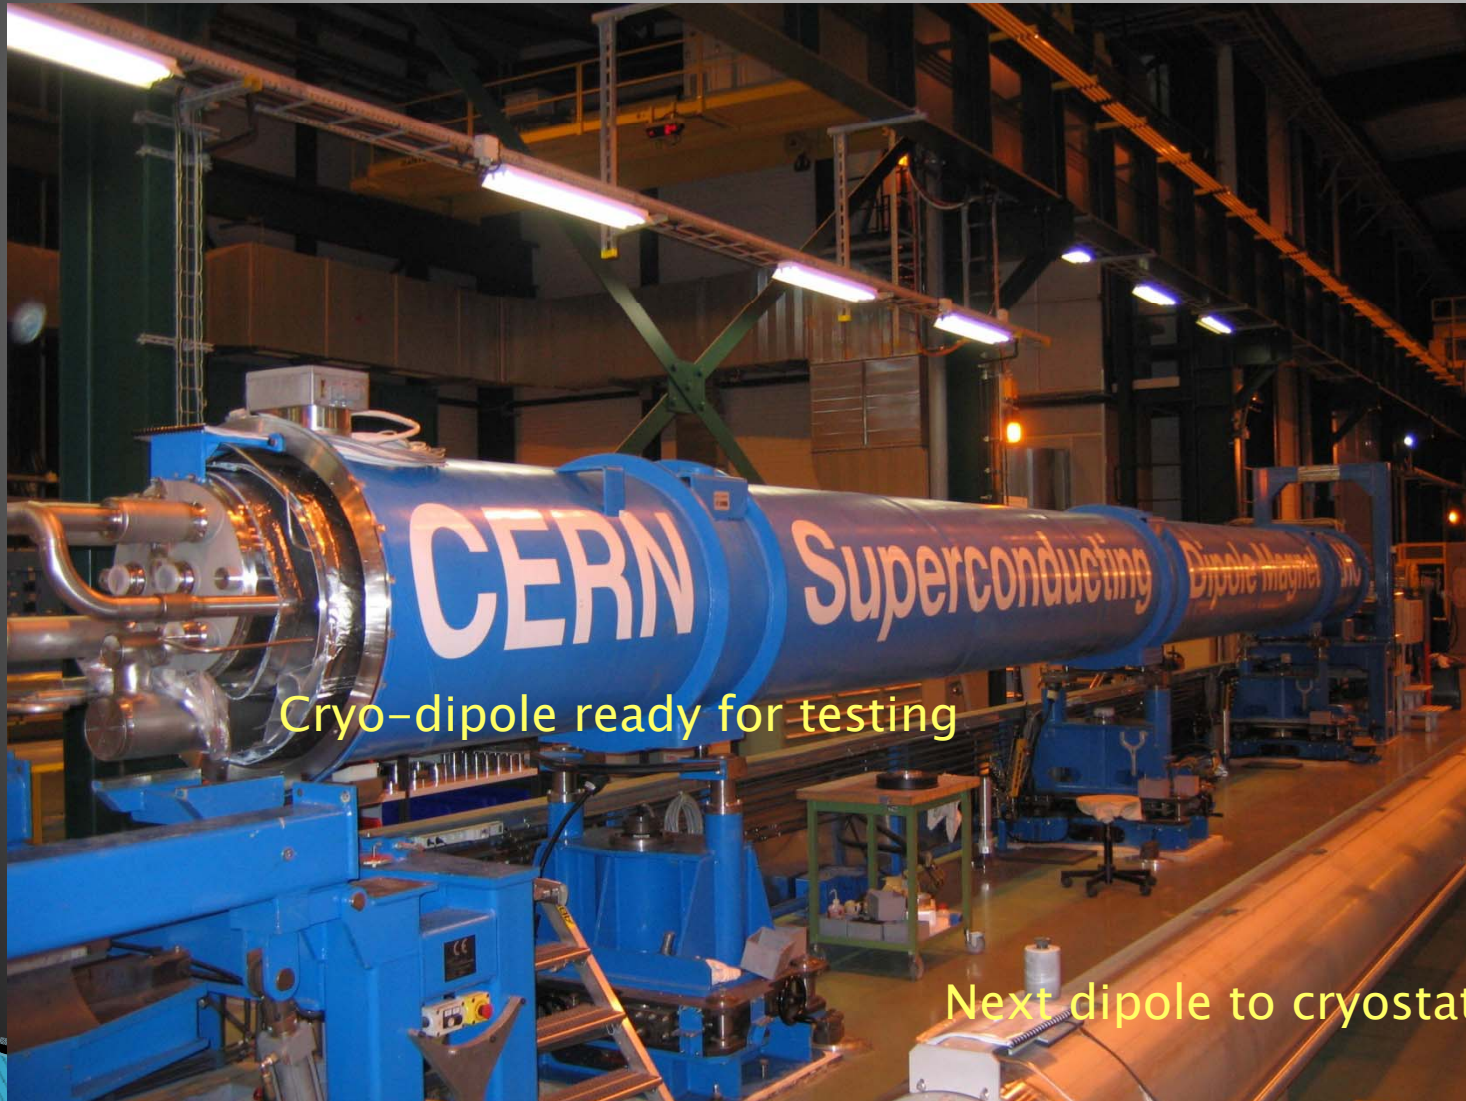
# New cryo-dipole assembly

Cryo-dipole ready for testing

Next dipole to cryostat
