HTS tape insulation

Nikolaj Zangenberg, Danish Technological Institute
Dec 1st, 2015

Study of defective coil from Danfysik HTS magnet

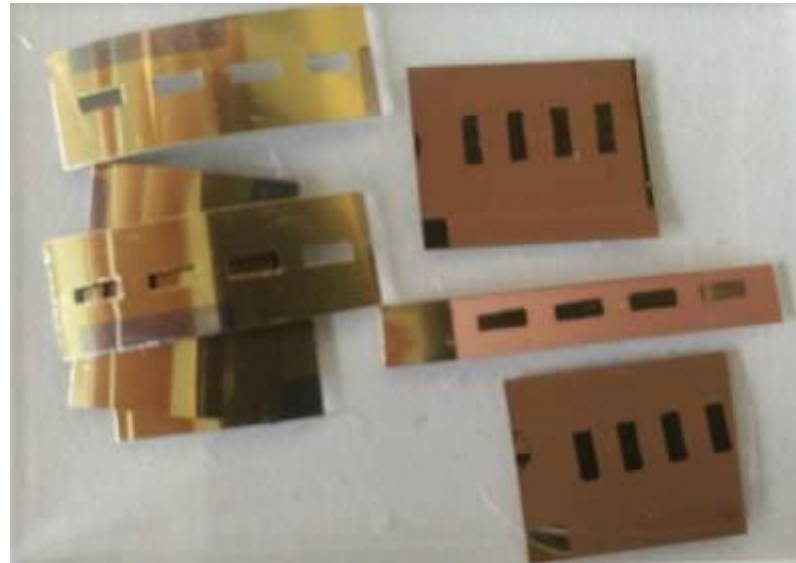
Breakthrough voltage

Gold masking used to prevent edge effect.

On 4 mm tape
(SuperOx, Danfysik) or
12 mm tape (Sol-Gel)

Insulation	Insulation thickness	600 V	1000 V
Polyimide (SuperOx)	25 μm	OK	OK
Epoxy (Danfysik)	20 μm	OK	OK
Sol-Gel (DTI)	6 μm	OK	Fail

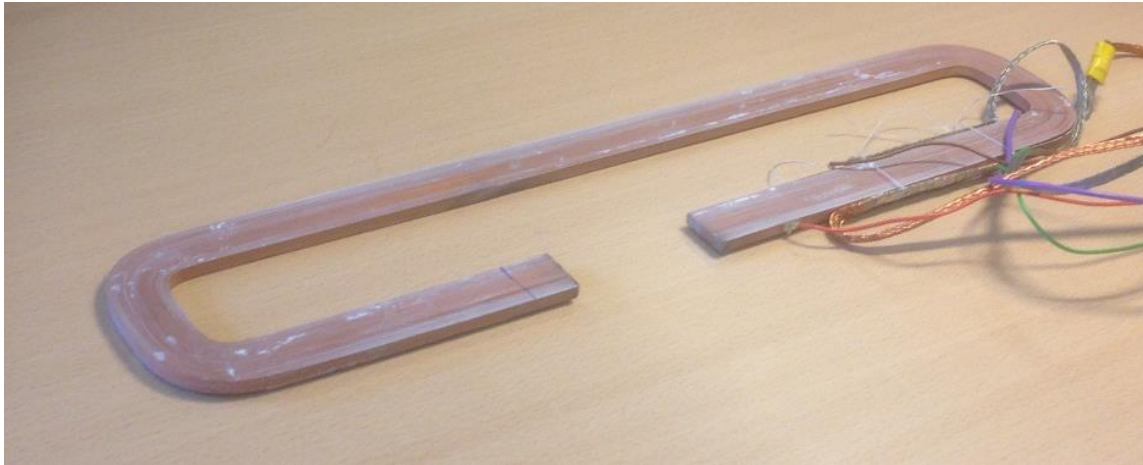
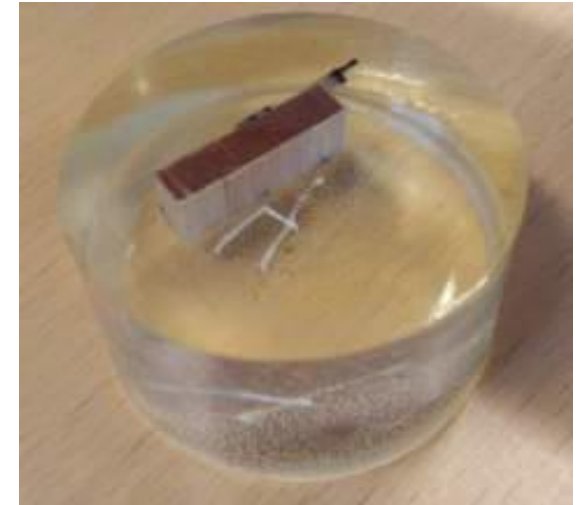
Mapping of defects in coil

- A) defect (partial delamination)
- B) complete delamination

Complete delaminations occur with some correlation between 1-2 and 3-4 (to a smaller extent). Serious conductor damage.

Damage may have been caused by outwards pressure on YBCO layer without mechanical backing from Hastelloy.

No correlation between partial delaminations in coil sections 1-2 and 3-4. Defect origin from section preparation cannot be excluded.

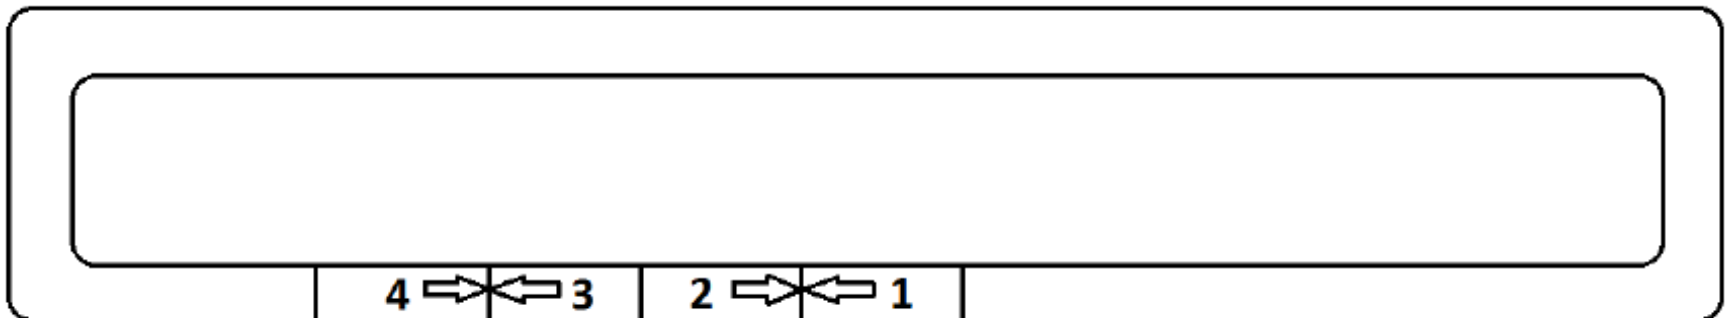
Metallographic sections (cut, grind, fine polish)
Light Optical Microscopy and SEM/EDX

Tape/coil delamination
