Operation of Diamond Light Source SRF Cavities

Pengda Gu On behalf of the Diamond RF Group*

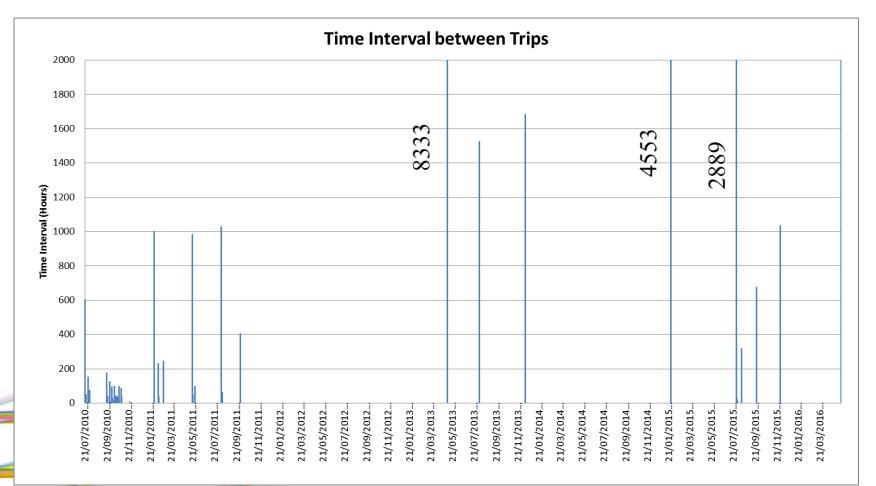
Cavity 3 Performance since Installation

Once good operation is established performance can be maintained. Cavity 1 hasn't had any trips after re-installed in August 2015.

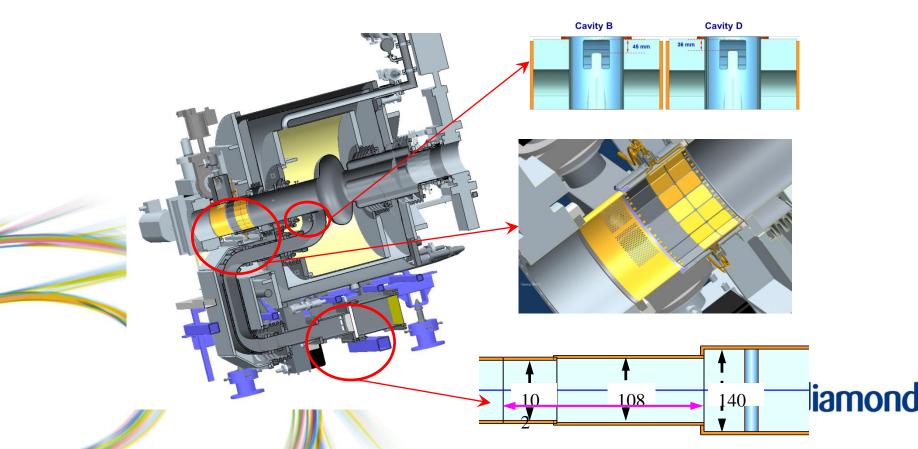
Cavity 4 Modifications

- 1. HOM loads at RBT side
- 2. Shanghai Coupler tongue
- 3. CLS Pump out box (Qe \sim 1.5x10⁵)
- 4. TSPs with isolation valve on RBT side
- 5. Position sensors on two sides
- 6. New LN2 flow controller

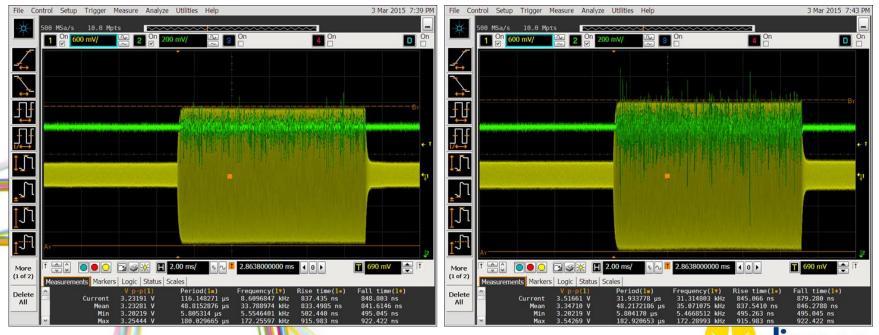
Radiation during pulse conditioning at different peak cavity voltagemond

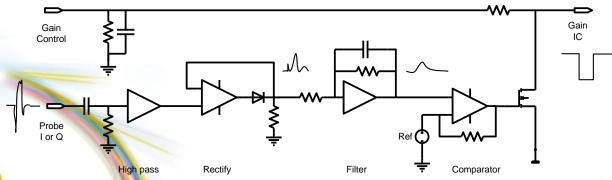
Simplified schematic of probe blip detection circuit

- fast rise-time spikes causing loss of RF signal on cavity HF pickup (and spare probes). Up to 4 blips/day/probe.
- LLRF interprets this as reduction in cavity volts and pushes up the forward power to compensate, causing a beam trip in some circumstances.

- Addition of filtering in the LLRF to reduce the bandwidth from 1MHz to 50 kHz. This has been successful at preventing trips at low loop gains. No probe blip trips since January 2014.
- Trial of a additional circuitry to detect the blip and reduce the loop gain during the period of the blip (~2 to 6us typically).

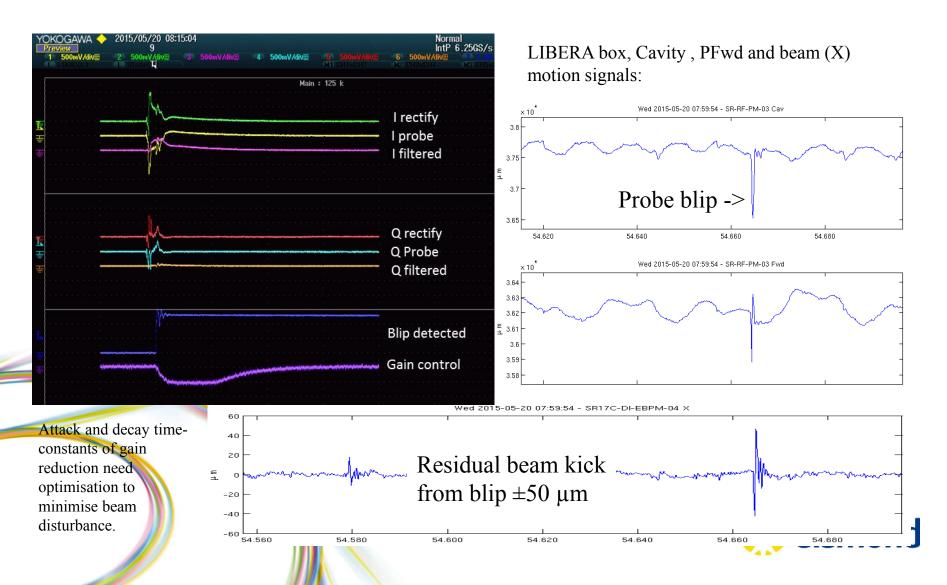
Storage ring tests @ 300mA with LLRF#3 modified to include blip circuit:
