# Availability of PETRA III from the rf point of view

PETRA III Availability Review

DESY, May 26<sup>th</sup>-27<sup>th</sup> 2016

CWRF 2016, Genoble June 24th

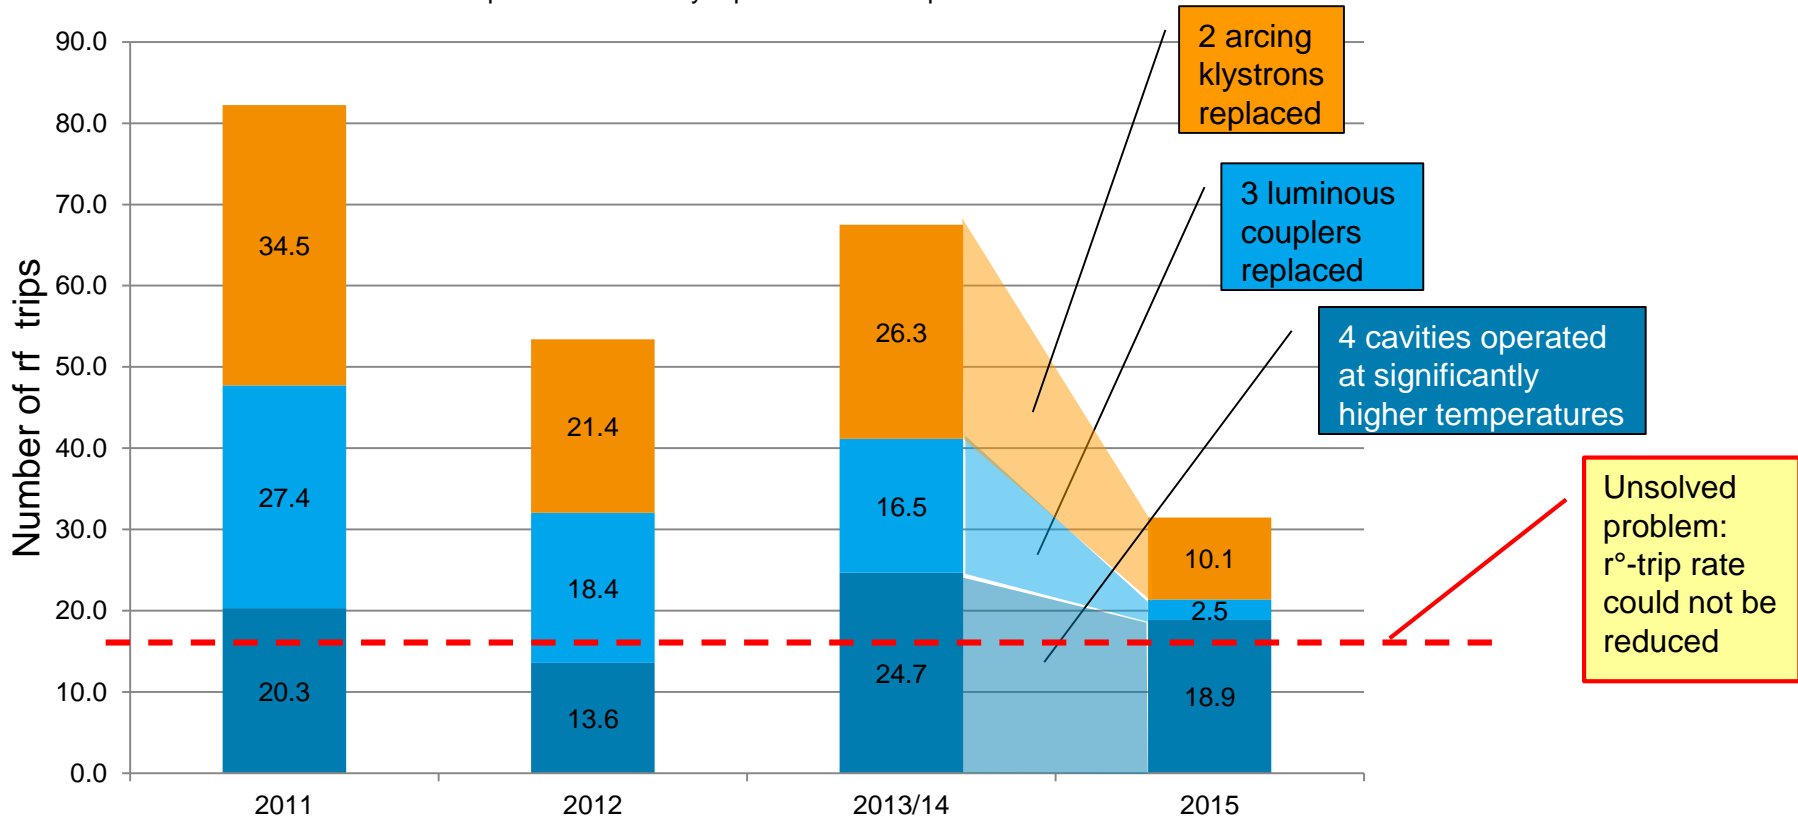
## Development of reliability

PE III 2015: 116 trips in 159 user days  
(corresponds to 145 trips in 200 user days)

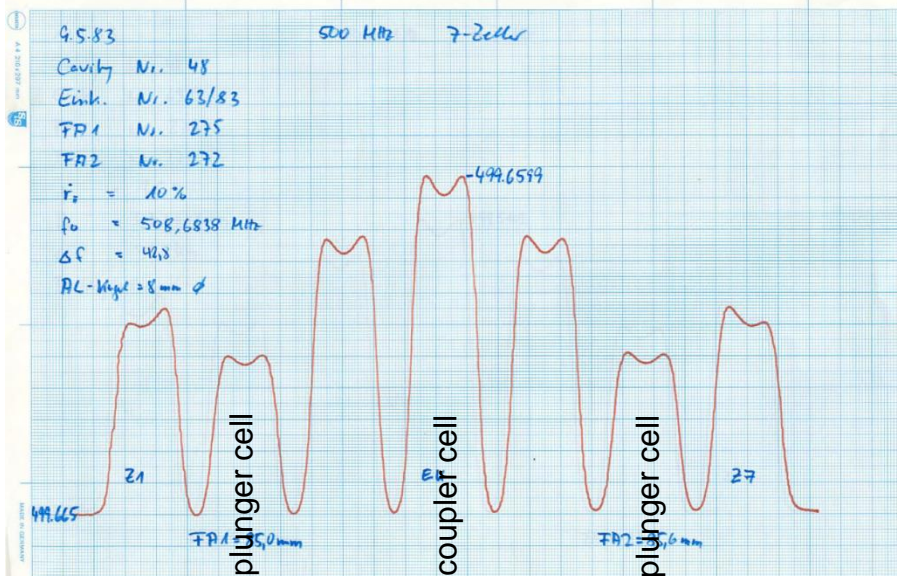
### Field pattern of reliable cavities

The cavities with highest  $\dot{r}$ -event rate are characterized to have a homogeneous field distribution!

We do not know the mechanism yet.  
But the problem seems to be related to the plungers somehow

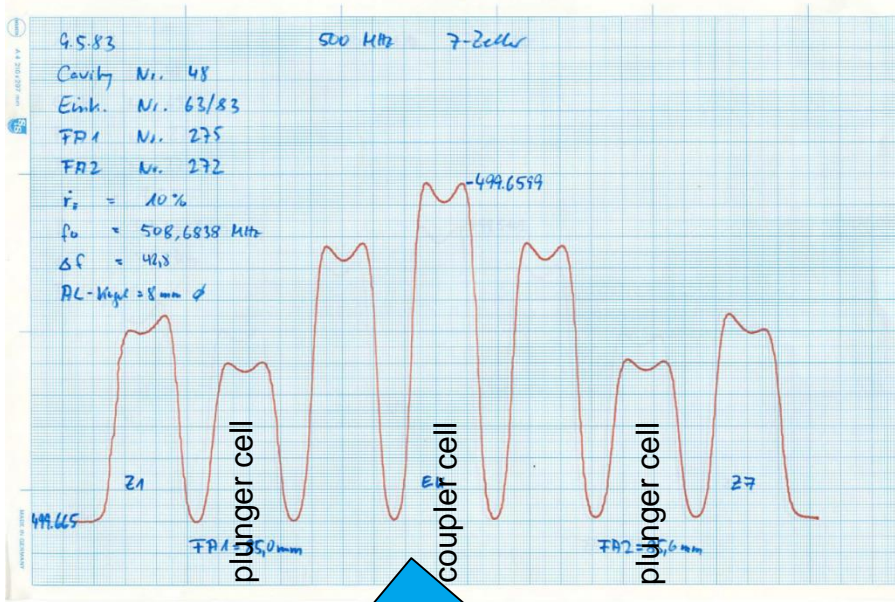
### Field pattern of reliable cavities

Field pattern can be turned from **unreliable** to **reliable** by increasing the cavity temperature

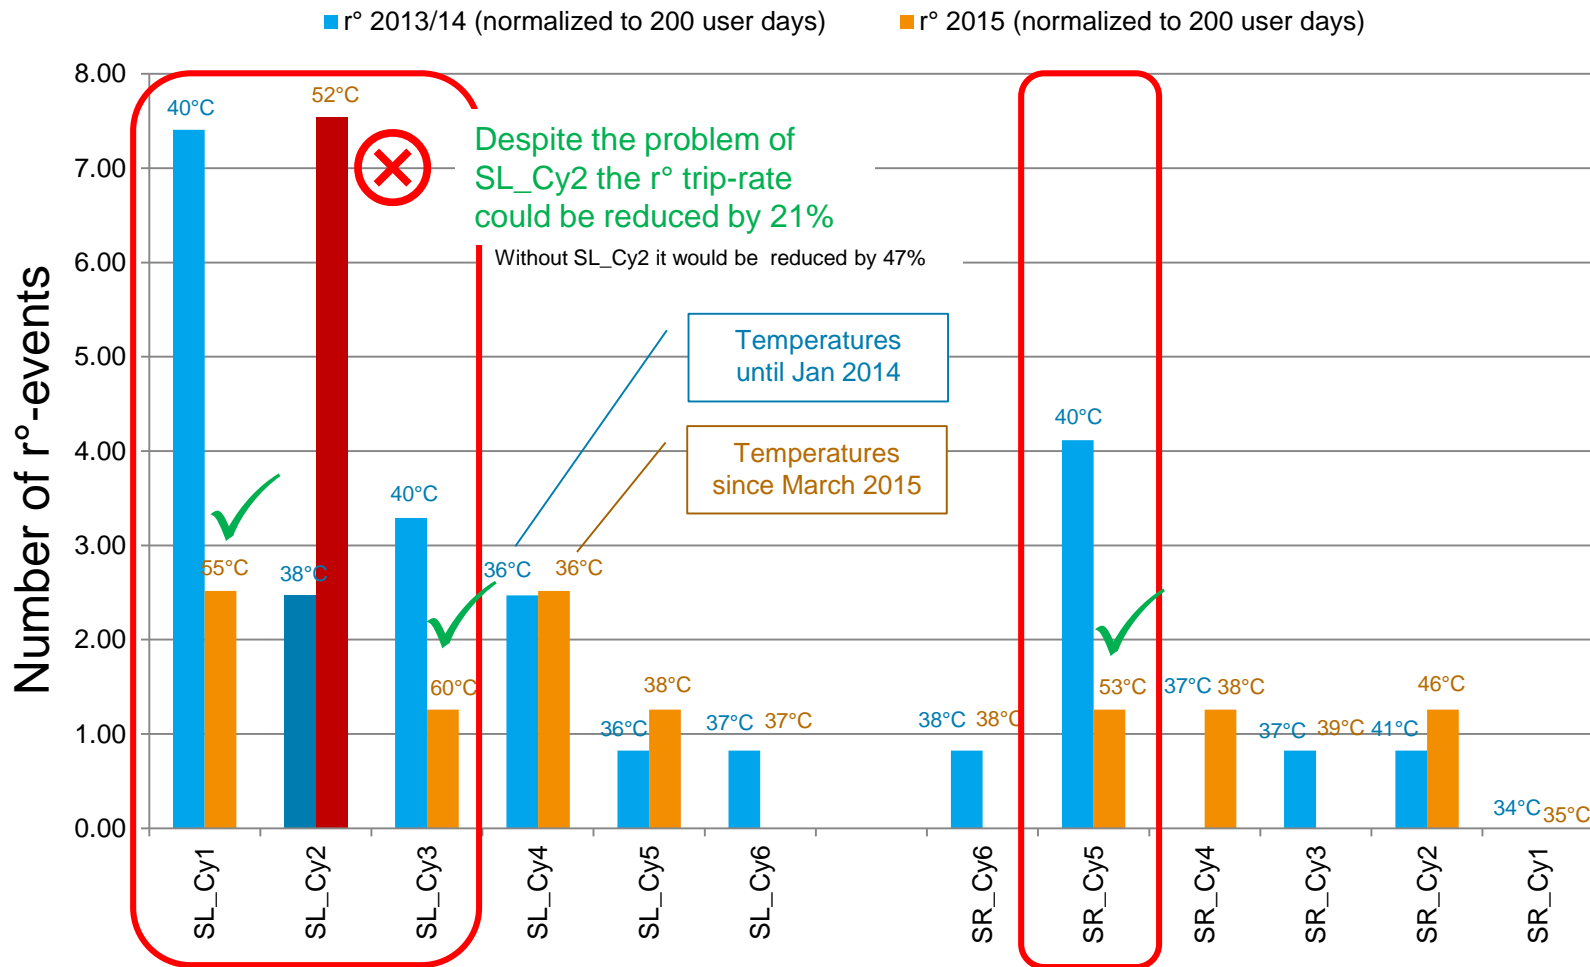
## Effect of increased cavity temperatures

- > The downtime of the rf systems could be reduced over the last few years more and more and was <1% in 2015
- > Operating 4 cavities at significantly higher temperatures reduced the  $r^\circ$  trip-rate by 21%
- > Despite this, the rf trip-rate is still dominated by the  $\dot{r}$ -problem. Solving the  $\dot{r}$ -problem would increase the  $MTBF_{RF}$  from 6,4 d to 15,9 d (and the  $MTBF_{PETRA}$  from 1,4 d to 1,6 d)
- > We believe to have the vacuum problem of SL\_Cy2 under control
- > We hope that we do not really need to replace the cavity
- > We do not give up hope, to find the cause for the  $\dot{r}$ -events someday

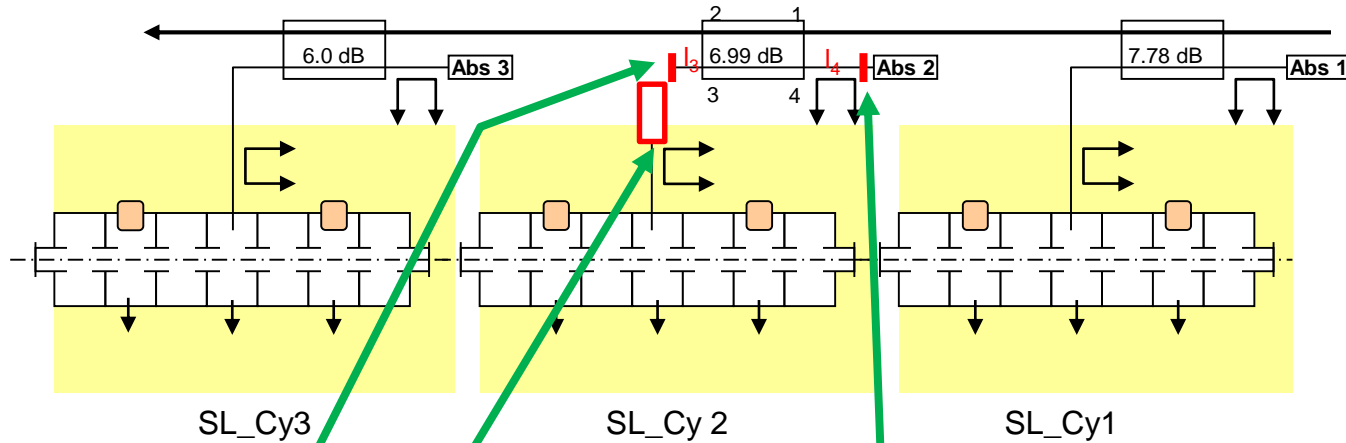
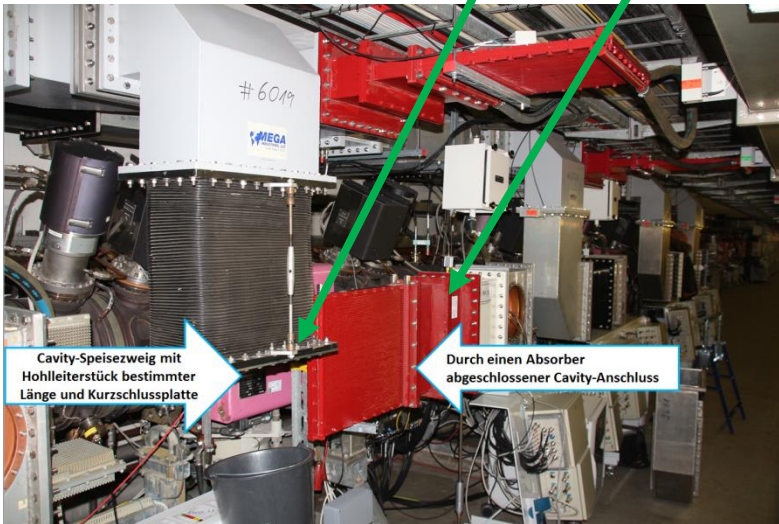
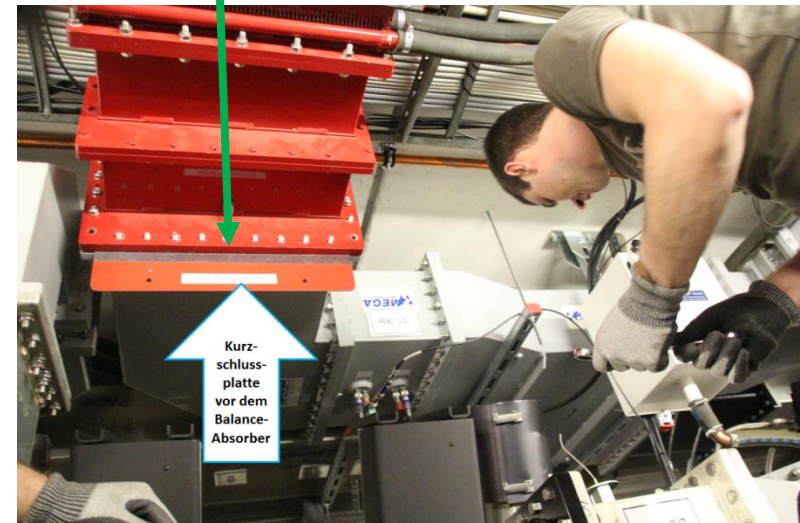
## Disconnecting SL\_Cy2 from RF system

A vacuum problem occurs 18 days before start of user operation

- Instead of the expected  $\dot{r}$ -events, we got plunger temperature and vacuum events.
- The vacuum behavior looked like a leakage. But no leakage could be found!
- A similar event has occurred at this Cavity already in 2012!
- In order to avoid venting the vacuum system the cavity was disconnected from rf system.

- > With some chance one plunger could be the culprit.
- > We plan to replace both plungers of this cavity during the service week in August.
- > Afterwards the cavity is reconnected to the RF system again.
- > Should turn out that not a plunger, but the cavity itself has a vacuum problem, it could be replaced at the next suitable service-break.

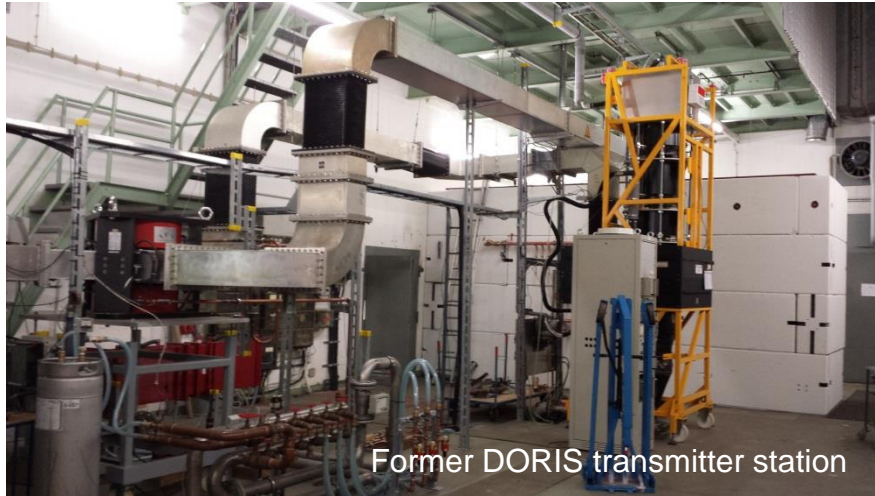
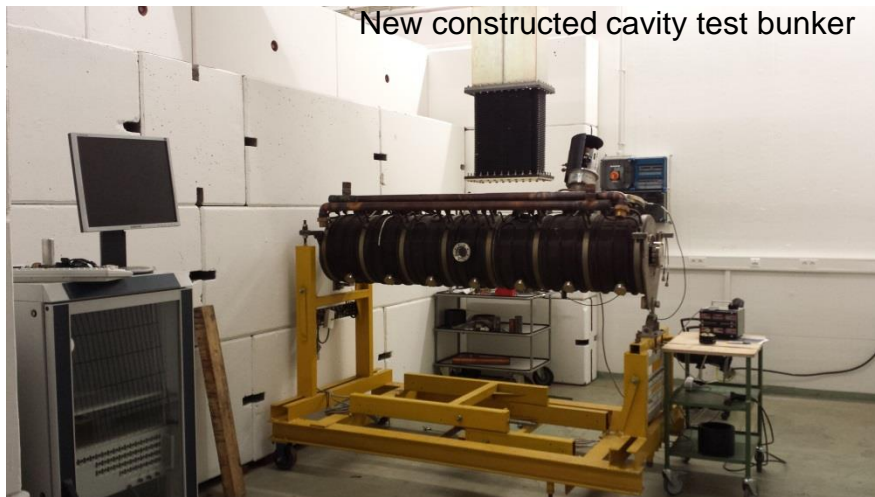
## Cavity Test Stand

- Completion delayed due to higher priority of XFEL (plumbing & personal interlock)
- The chosen spare cavity was refurbished by electro polishing but must be complained
- Earliest completion date: July 2016 (depends on personal interlock)
