# Instrumentation Performance in the SPS in 2015 & Requirements for the Future

Serge Massot

On behalf of SPS Operation

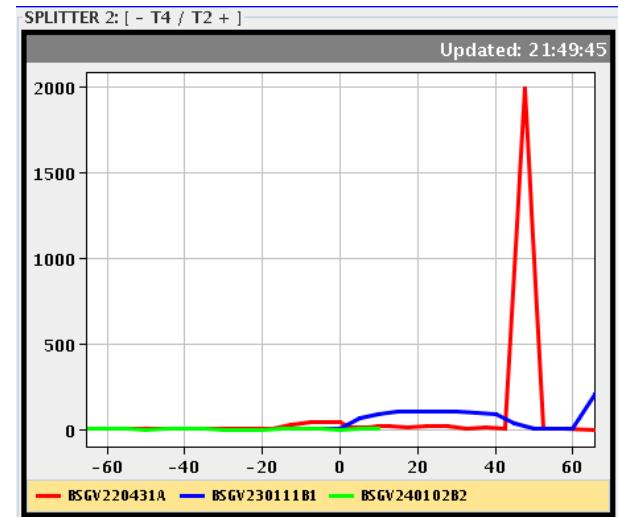
- BBS.21638 : Stuck in OUT position. The coupling was loose
  - Good reaction by BI, now fixed

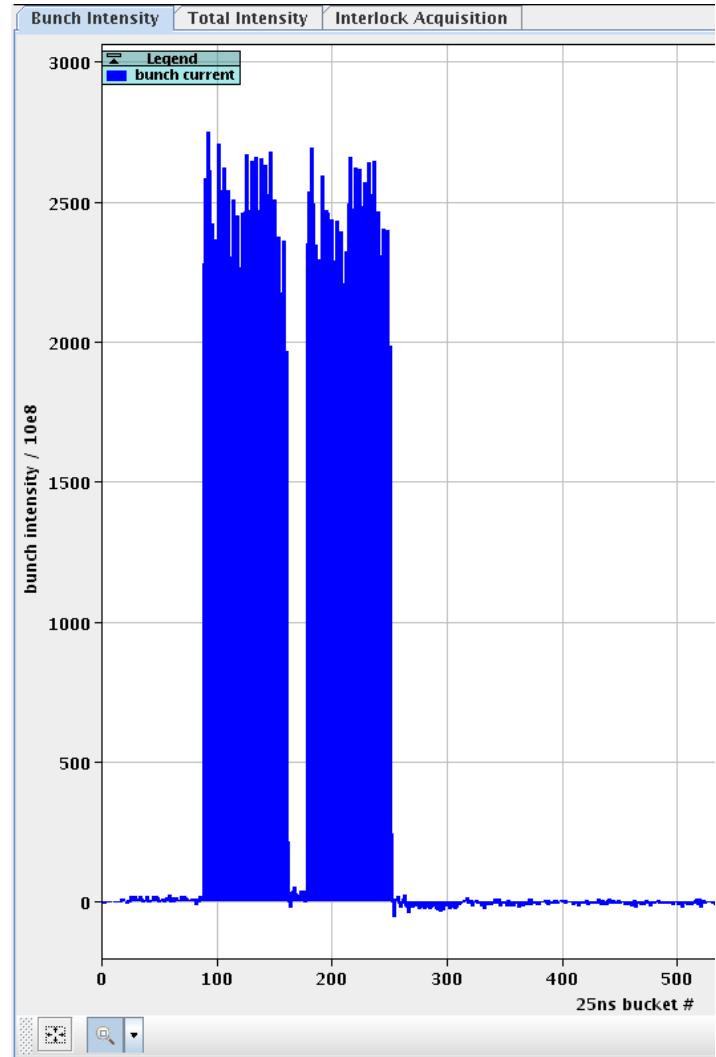
- BCTFR.31450 and BCTFR.51895
  - Intensity histogram doesn't correspond to reality
  - Difficulty to adjust the phase
  - Not possible to measure with fixed frequency acceleration (Ions)
