The ISOLDE Robot Incidents

Richard Catherall EN-STI-RBS

13th August Incident

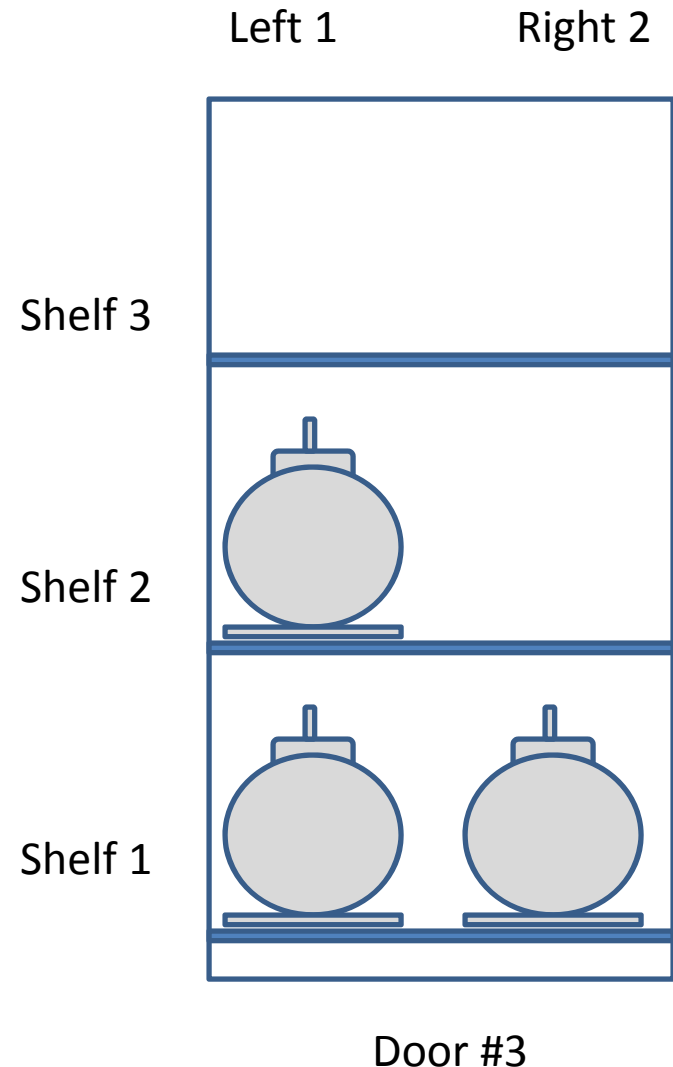
- Pre-programmed pick and place cycle
Pre-defined locations
E.g. Take target from Front End to door position 322
Incident occurred because 321 coordinates were saved as position 322.
Human error? Overwritten values...Save as!!
Program manipulation error, software?
Action:
- Do not use this shelf position this year.
 - Test other shelf positions without target before use.
 - Re-program robot correctly during next shutdown.
