Linac 2 leak on 28th August

G.Vandoni, on behalf of

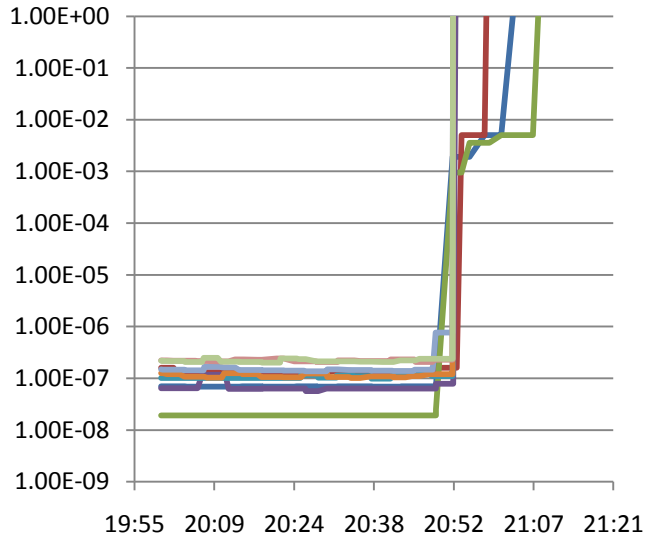
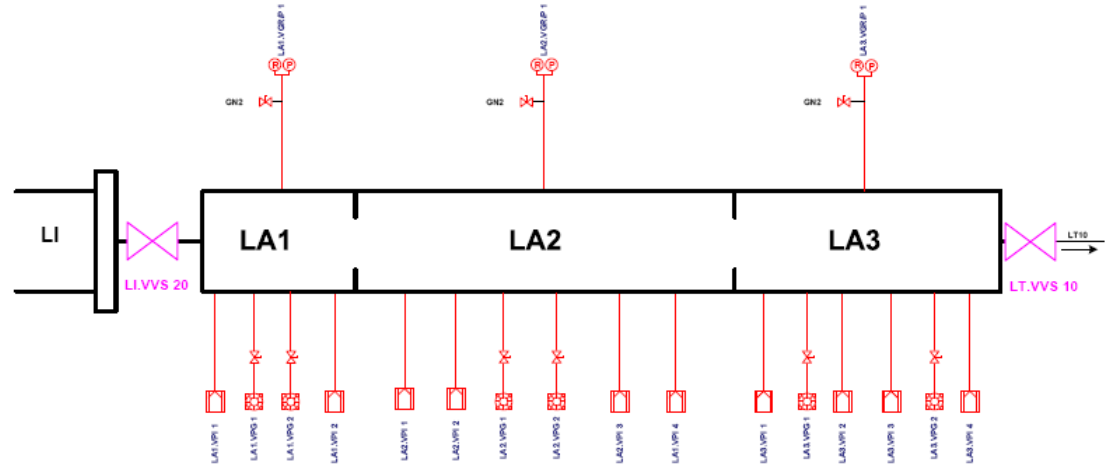
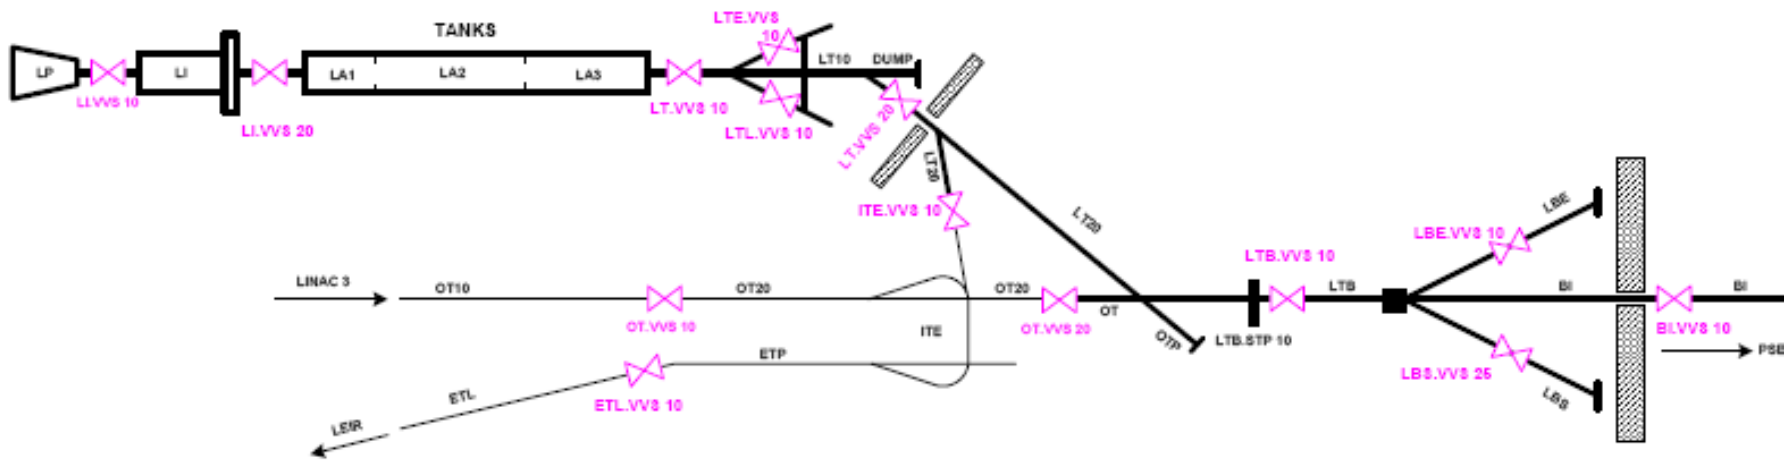
Leak!

- Pumping speed: 1000l/s. Ultimate pressure: 10^{-3} mbar => leak of 1 mbar l/s **BIG**
- Friday night: small leak found on Q5 of tank 2
- Saturday: leak on Q5 is evaluated quantitatively and results to be too small, so leak detection continues to analyze the girder
- Sunday: girder entirely analyzed, several smaller leaks
- Monday: RF feeder loops on tank2 are opened, the leak is found there.
