# **Failure of PI.SMH42 on 2 October 2009**

FOM – 6.10.2009

J. Borburgh

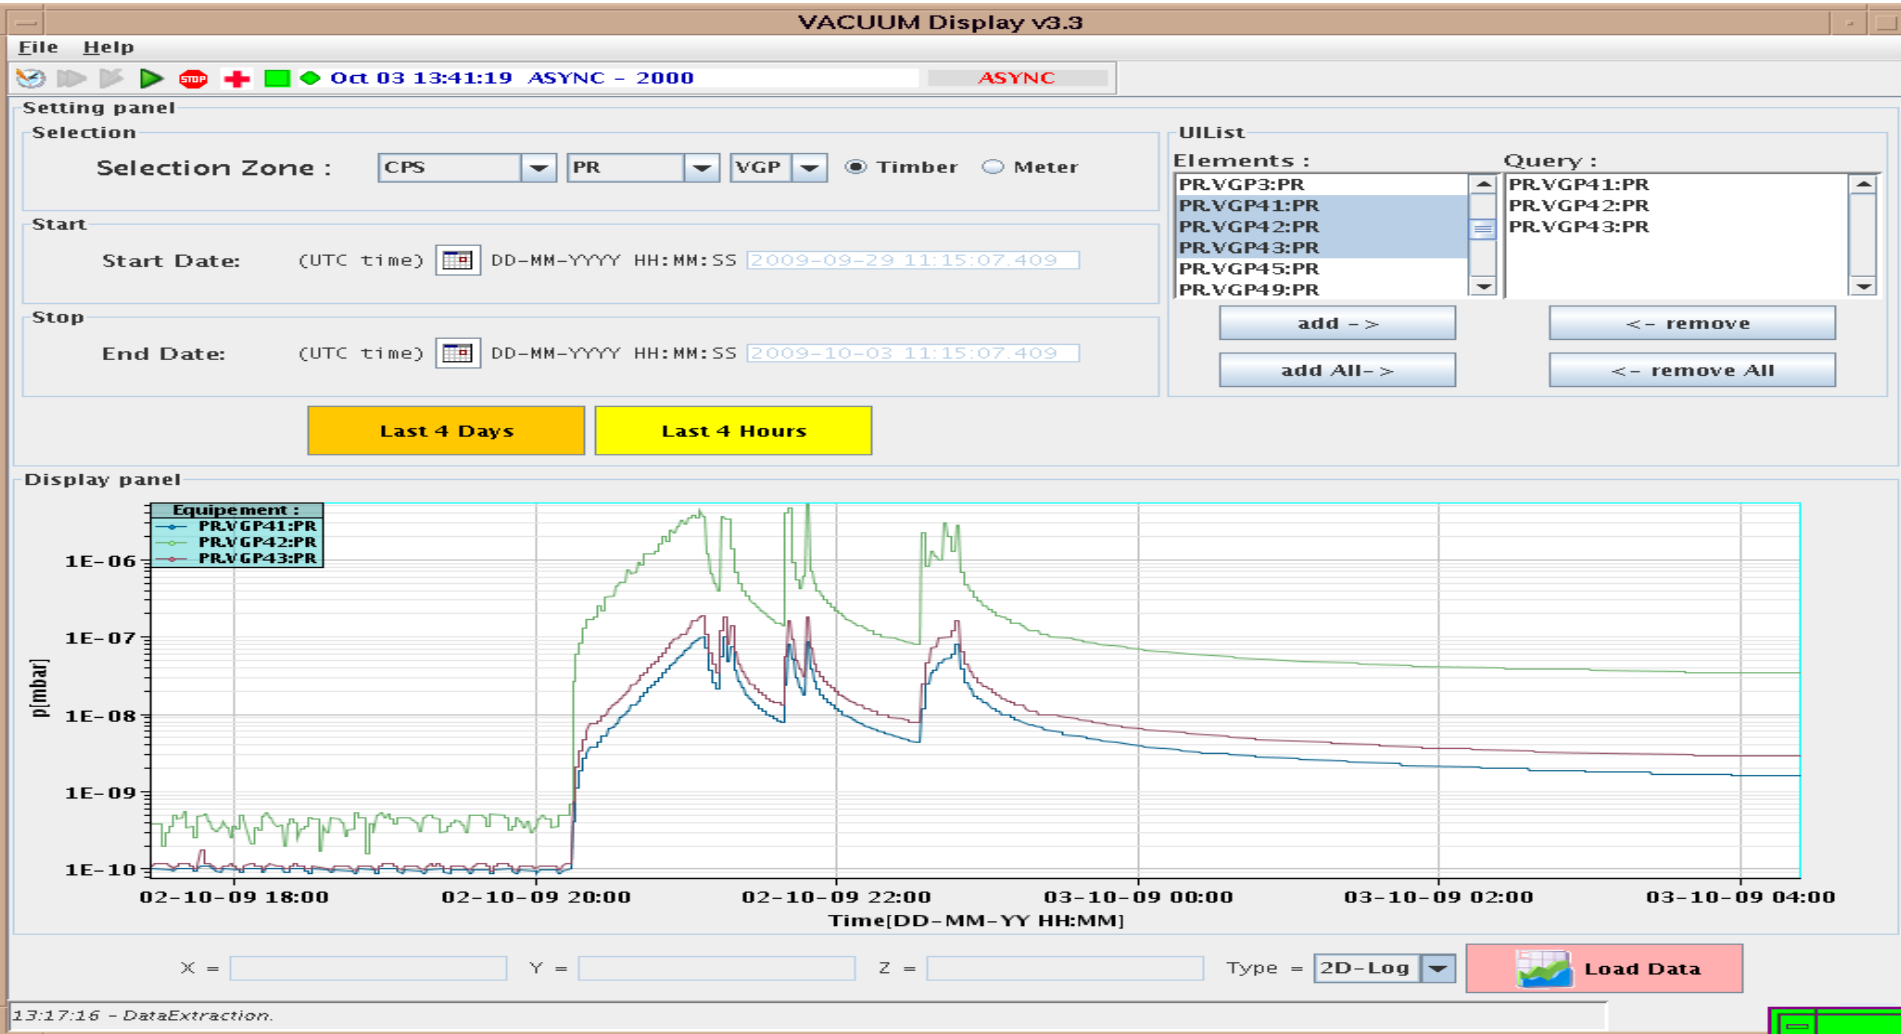
As of Friday, 2.10.2009, ~23:05, repeated vacuum interlocks on PI.SMH42 (6E-6 mbar range).

First check by SE specialist → stop, switch off, radiation cool-down overnight.

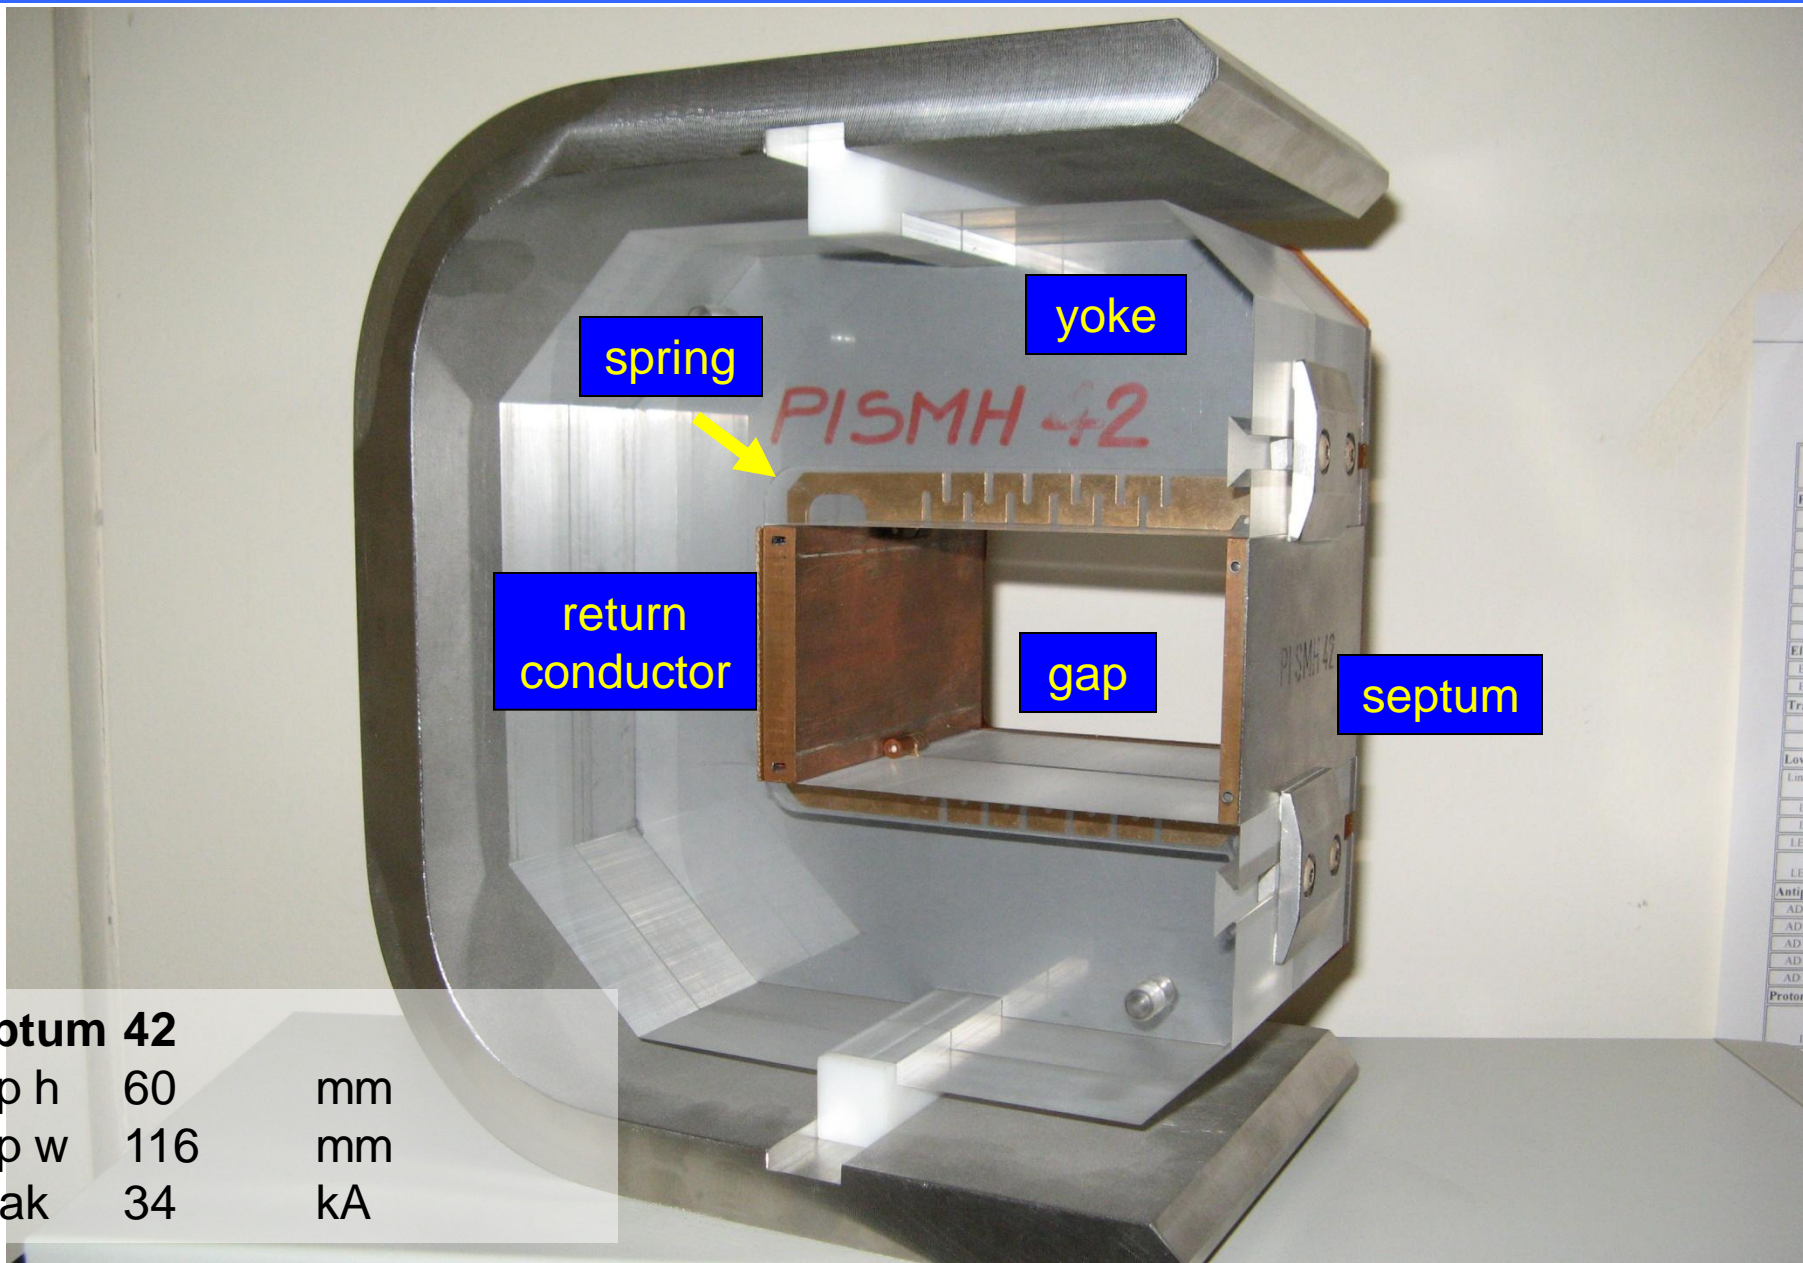
## Septum 42

Water circuit emptied, and He injected → leak found

Gap h	60	mm
Gap w	116	mm
I <sub>peak</sub>	34	kA

Decision to replace septum on Monday – delicate operation + area still hot
