Operational Experience and Longevity Studies in the CDF II Silicon Detector

Sergo Jindariani

Fermilab

2010 Vienna Conference on Instrumentation
Vienna, Austria, Feb. 15 - 21, 2010

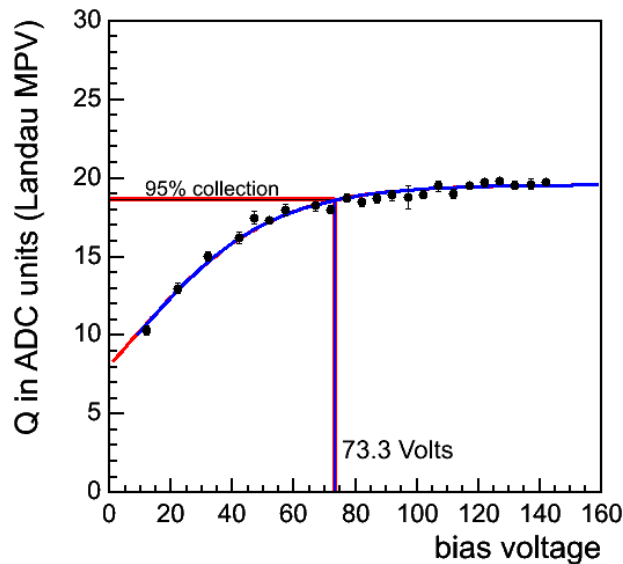
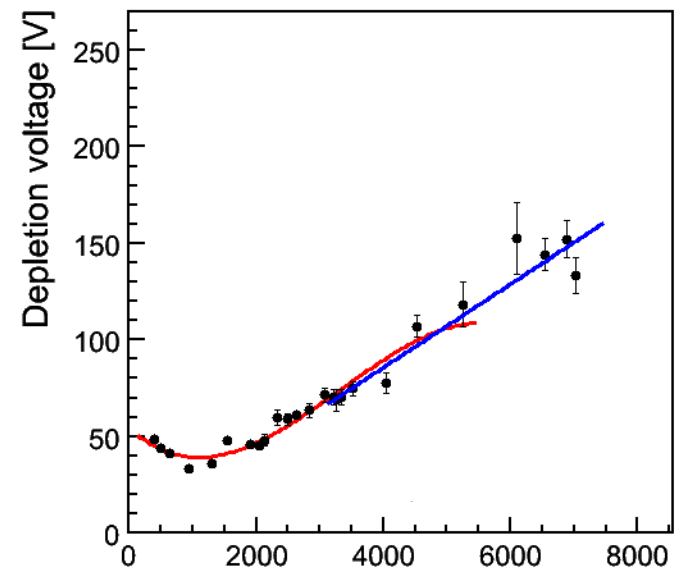
Depletion Voltage Study -- Signal Vs. Bias

- Depletion Voltage as a function of integrated luminosity

➡ 3rd order polynomial fit around the inversion point

➡ Linear fit to extrapolate to the future

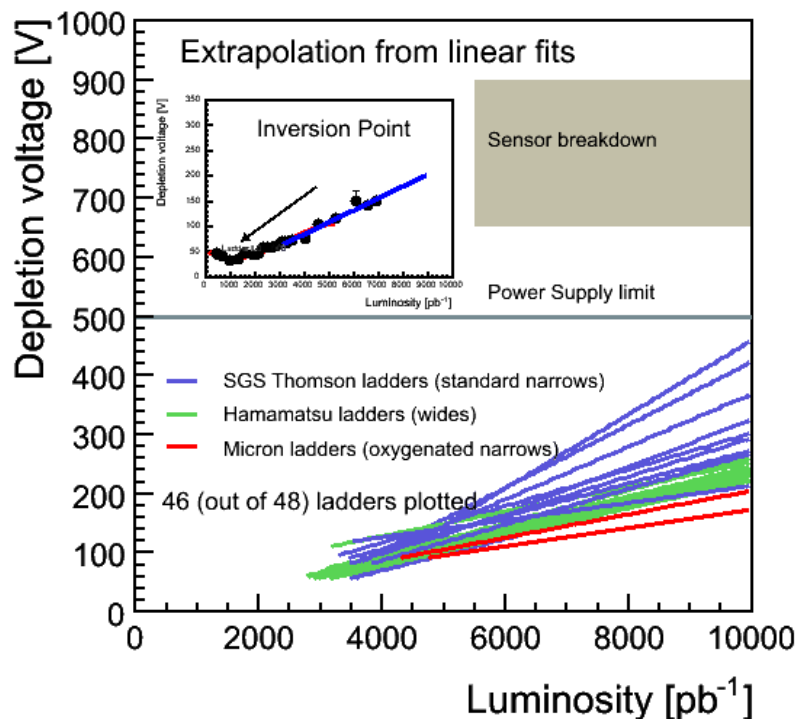
➤ Prediction for L0

- ➡ Depends on type of sensor
- ➡ Oxygenated ladders invert much later

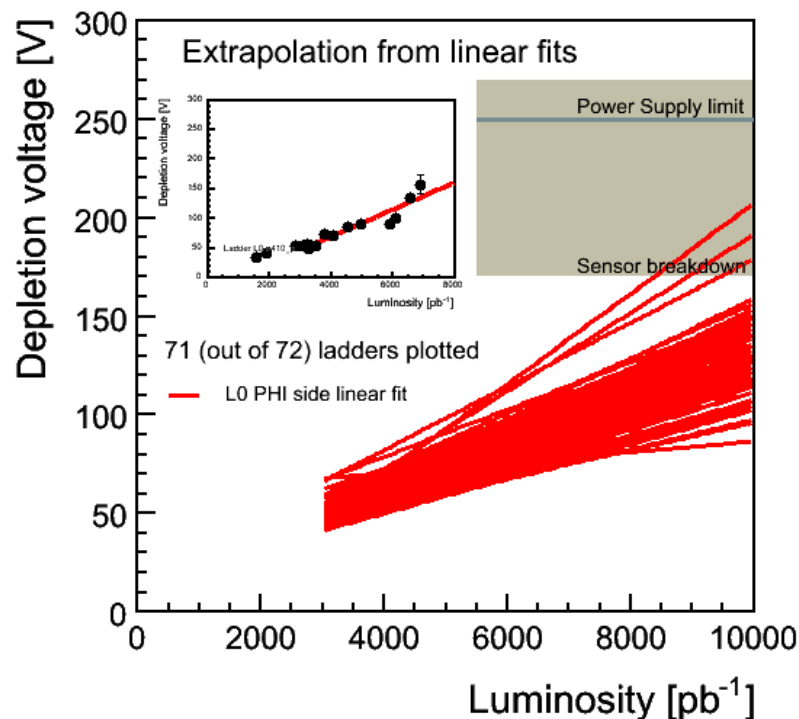
➤ Prediction for SVX-L0

- ➡ Bulk of ladders will survive
- ➡ First symptom: micro-discharges

We will be able to fully deplete most of the sensors beyond 10 fb^{-1}

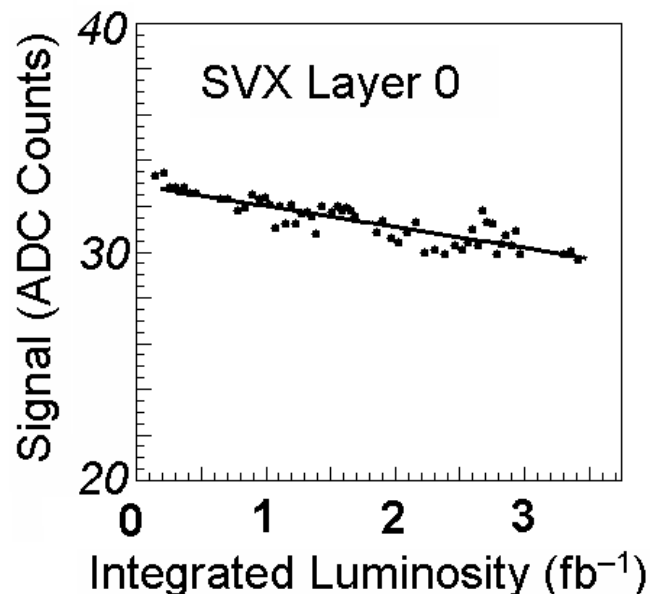
➤ Signal

- Use $J/\psi \rightarrow \mu^+\mu^-$ tracks
- Get total charge of cluster
- Decrease linearly with Lumi.

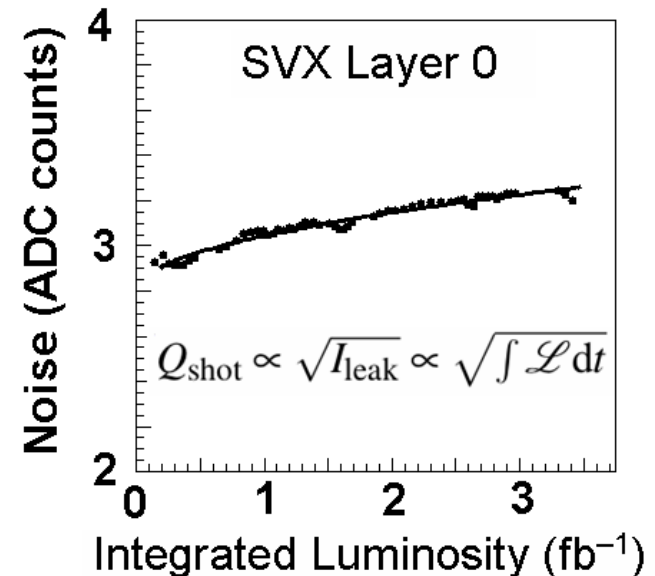
➤ Mean Strip Noise

- Average over strips in charge cluster
- Obtained from calibrations taken every two week.
- Square root increase with Lumi.

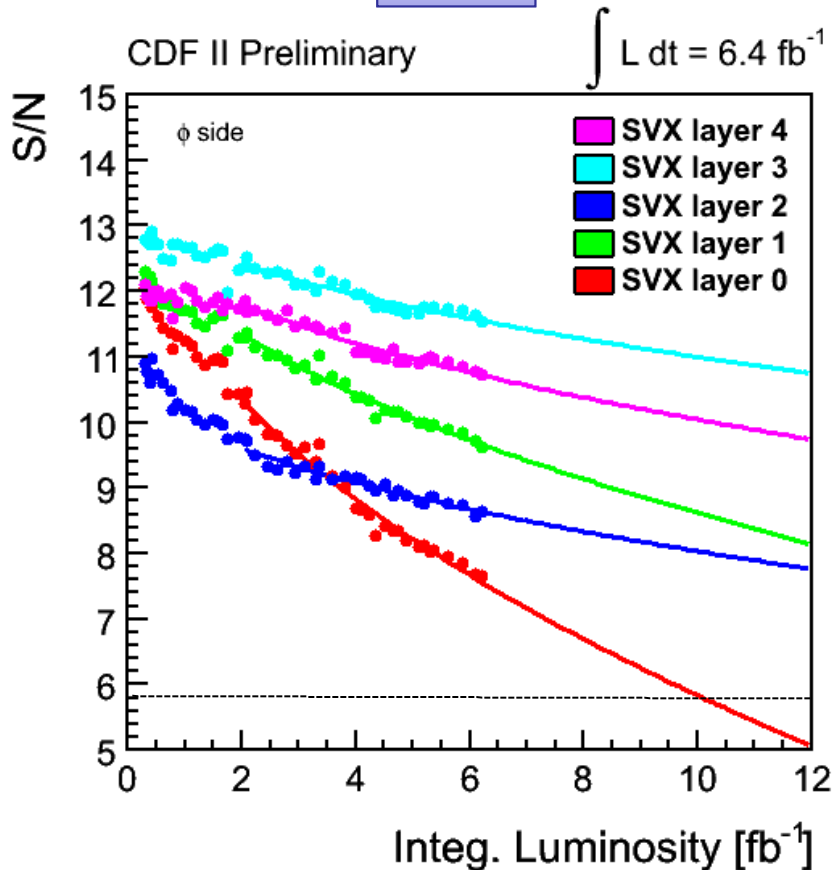
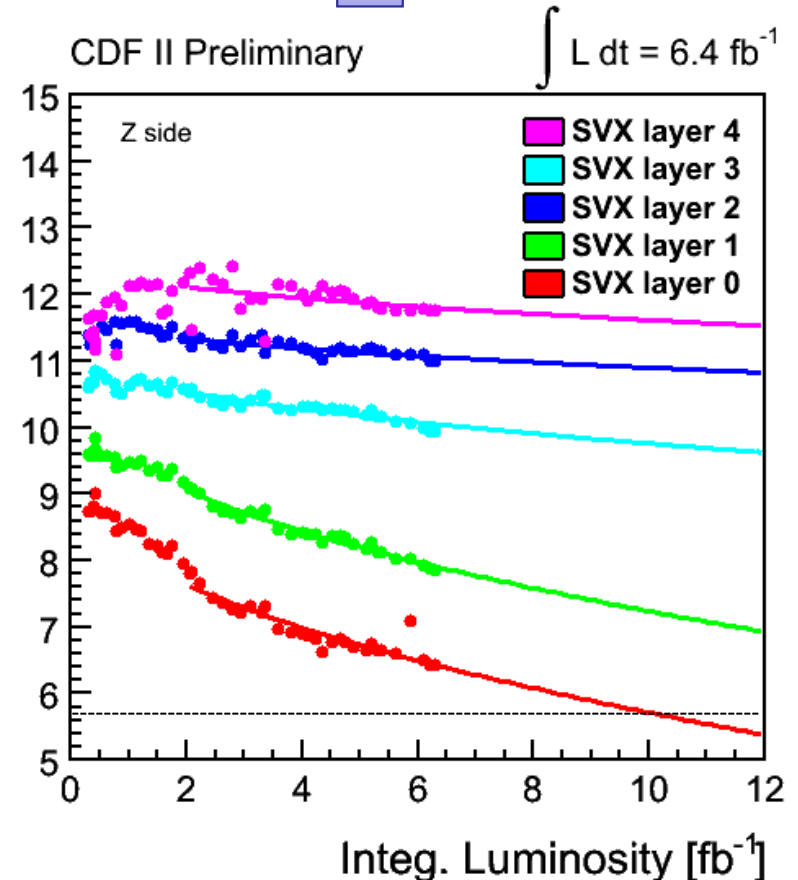
SVXII Signal / Noise Projection

Tracking performance of SVX-L0 will be adequate beyond 10 fb^{-1}

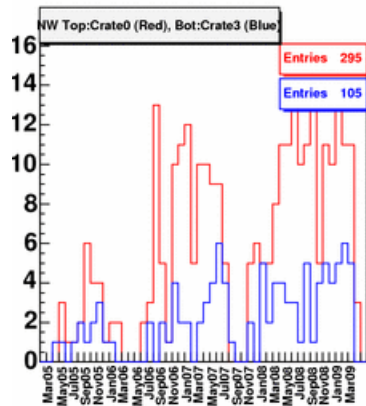
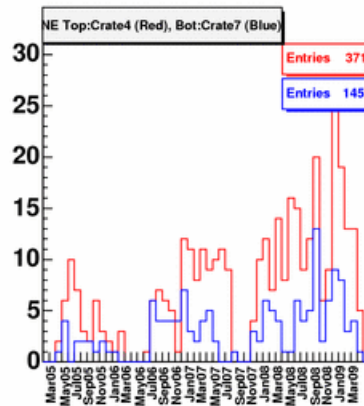
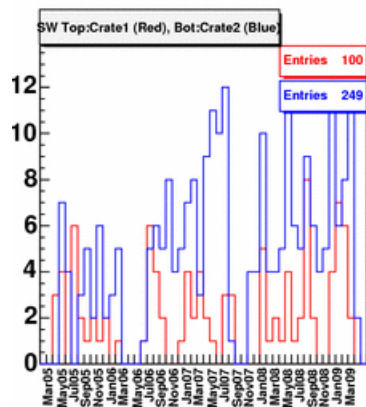
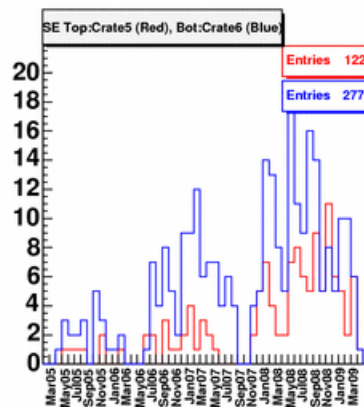
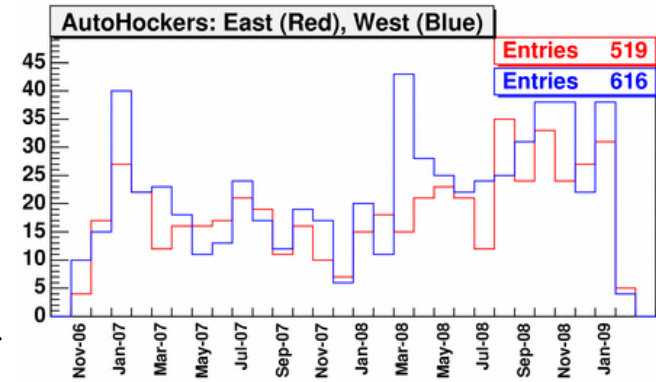
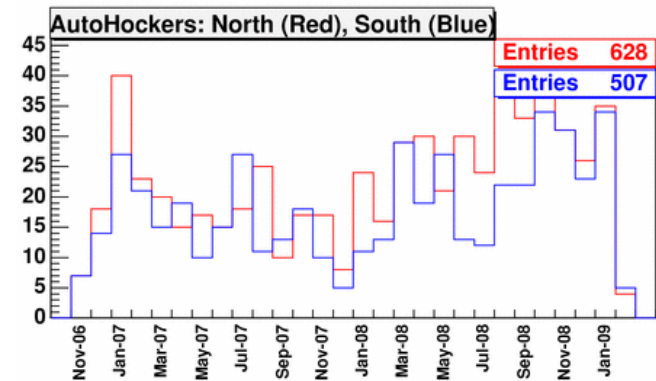
SEUs in CDF Collision Hall Electronics

➤ CAEN PS crate auto-reset rates in their collision hall locations.

➔ Slight rise over time.

➤ FIB crate SEUs on the rise
Mitigation studies ongoing.

➔ N-E corner is worst hit
