MKD ERRATIC TYPE 3

MPP meeting, 8-April-2016

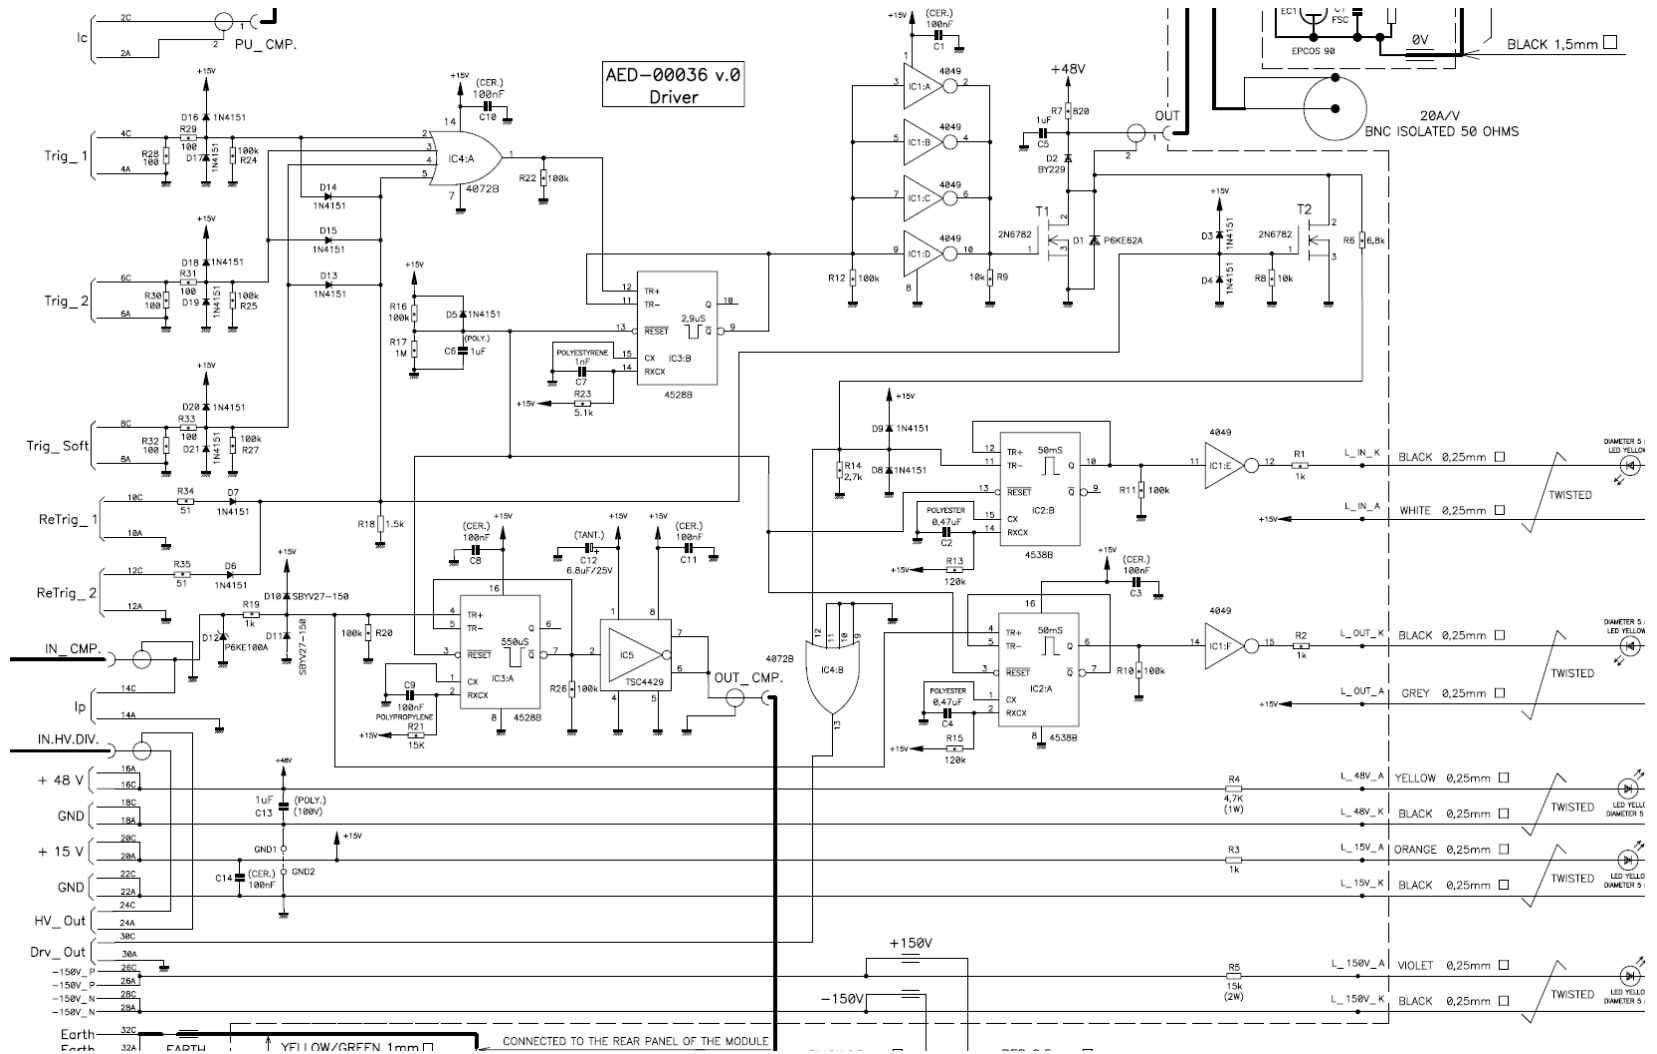
PTM retrigger schematic

- The reason for the erratic type 3 observed on 26th Feb. 2016 is a slowly rising signal on the retrigger line; its origin is not yet identified
 - A similar signal as observed can be injected into the retrigger line and by careful (devil) adjustment (\sim mV) one can generate an even worse case of erratic with reduced current in the magnet – this case will be shown by Roderik

- But the source of the signal cannot presently be explained
 - The expected failure rate can consequently also not be estimated
- Effect on the beam
 - Particle density induced by type 3 on the TCDQ and in the circulating beam aperture (4 - 8.6 sig) is not worse than type 2 erratic; even for one or two MKD prefiring

- Add retrigger signal surveillance system – under preparation
 - Need to re-define specification of retriggering – are the 800 ns still appropriate?
