Study of vacuum RF Breakdown in strong magnetic field

The University of Chicago/Fermilab

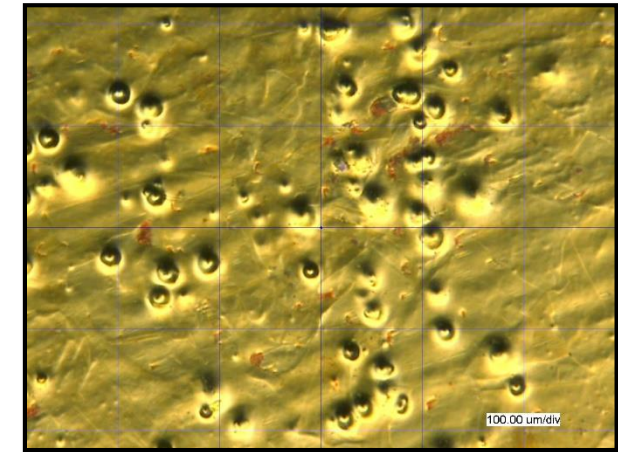
Type 1

- Cavity ran up to $\sim 50\text{MV/m}$
- **130** breakdown events detected
- Documented ~ 400 damage features
- Damage is relatively “non-violent” and flat
- No correlation between damage on opposing endplates observed - asymmetry

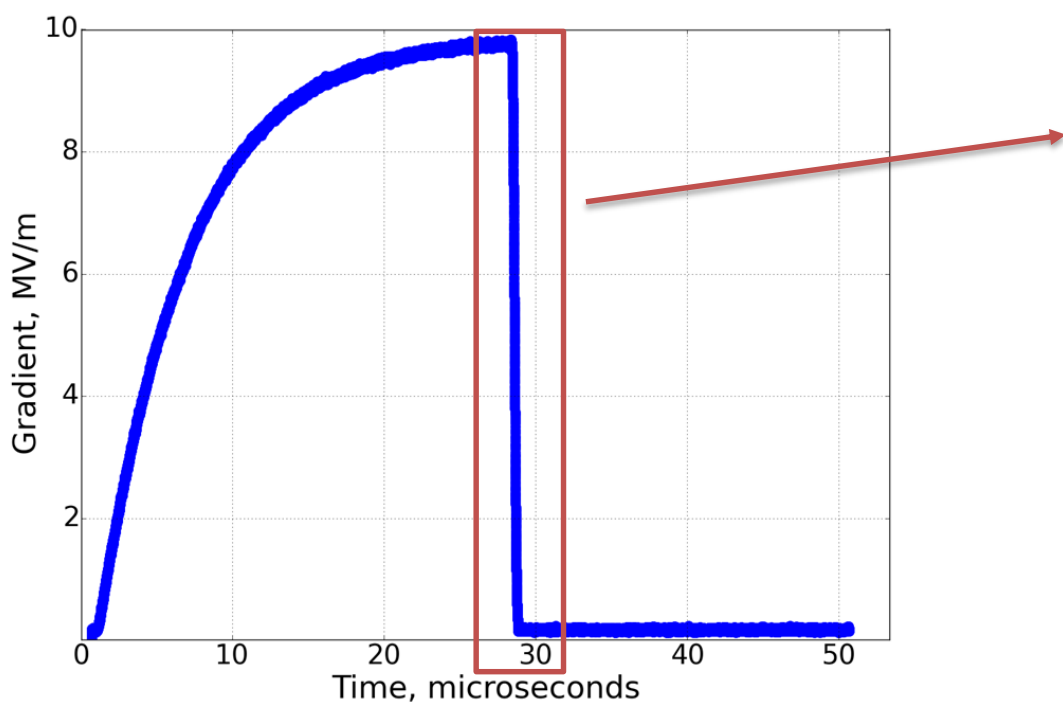
Envelope of pickup signal during breakdown event

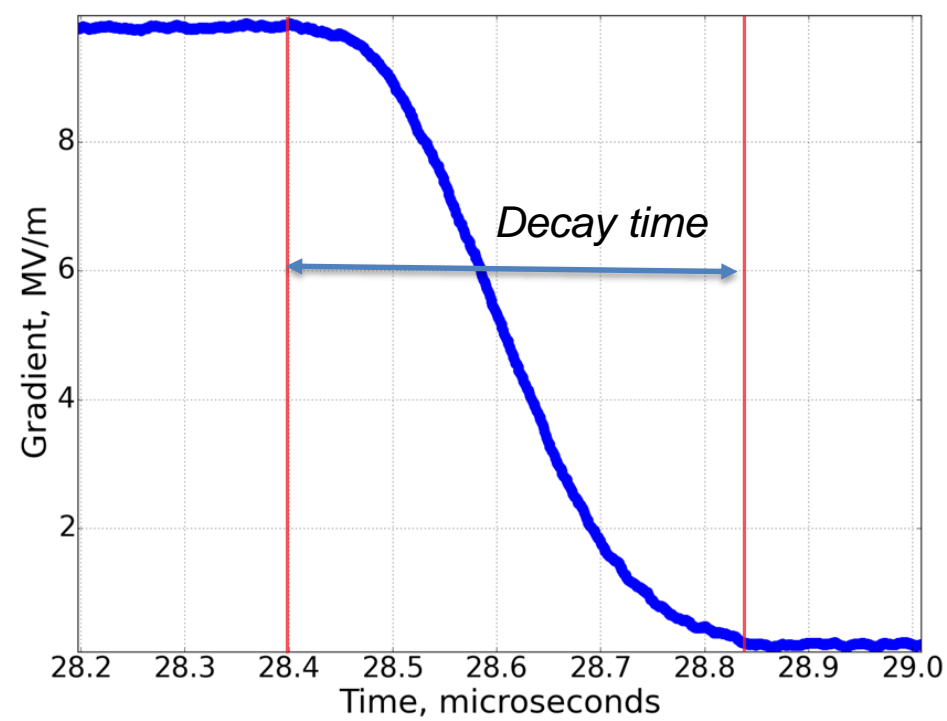
Decay time – exponential fit

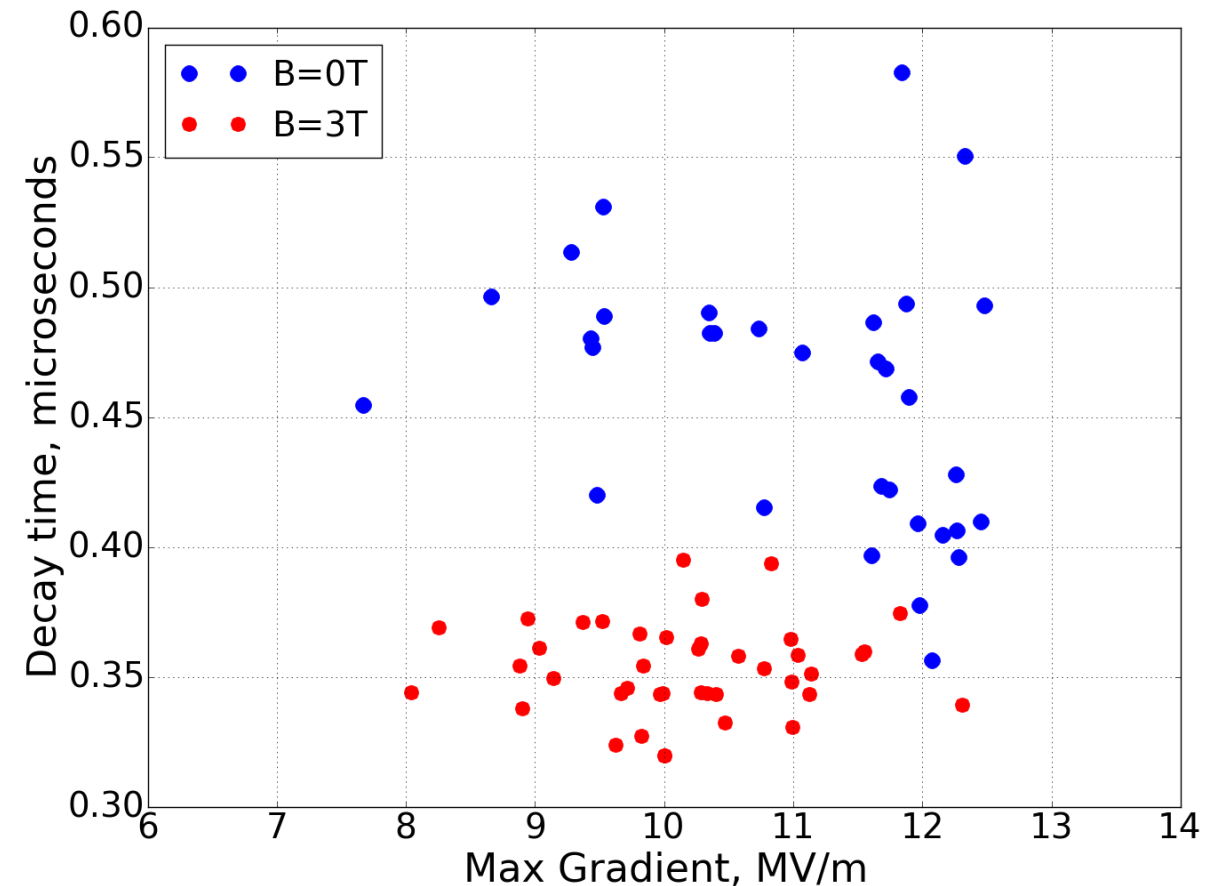
- Decay time in $B=3T$ is 30% smaller on average \rightarrow Implies that energy deposition mechanism is more efficient in strong magnetic field
- That is what we have expected to see
 1. Based on “violent” type of damage we observed in $B=3T$
 2. Due to focusing of dark current beamlets: higher arc currents and hence lower impedance

Decay times for sparks in zero and 3T external magnetic field

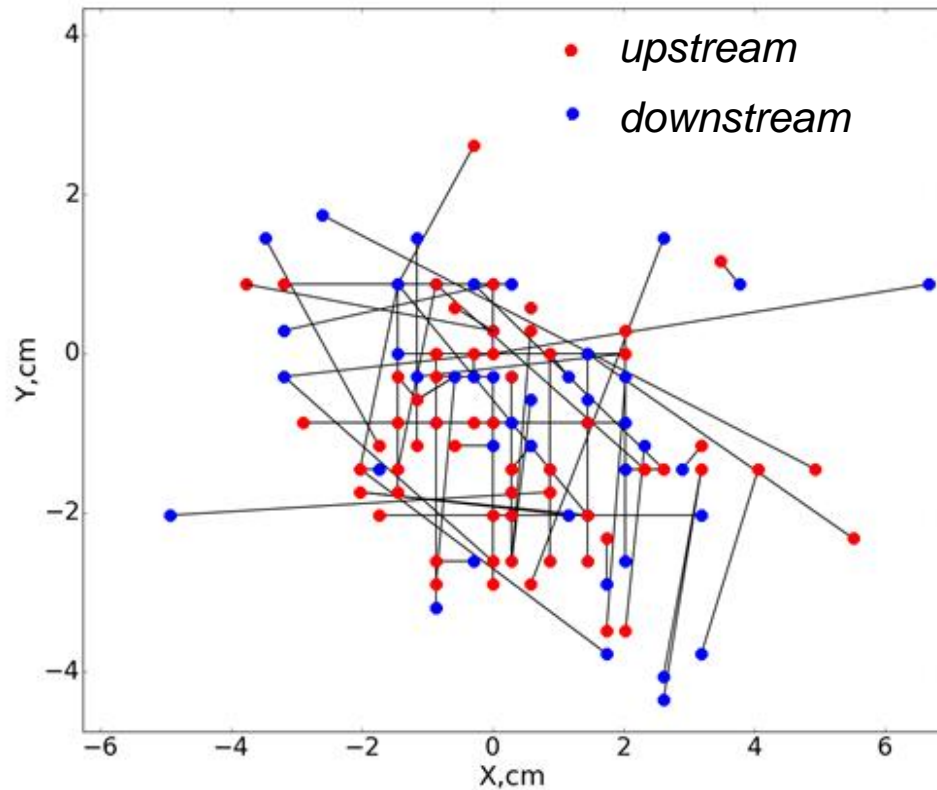
Acoustic predictions map: corresponding locations connected

- All predictions are within 7cm from the center of the endplate ($R=14\text{cm}$) – good agreement with damage distribution
- Error bar of measurement $\sim 2\text{cm}$
