Quench heater failure in dipole magnets

M. Bajko

M. Bajko for the LHC Risk Review
6th of March 2009

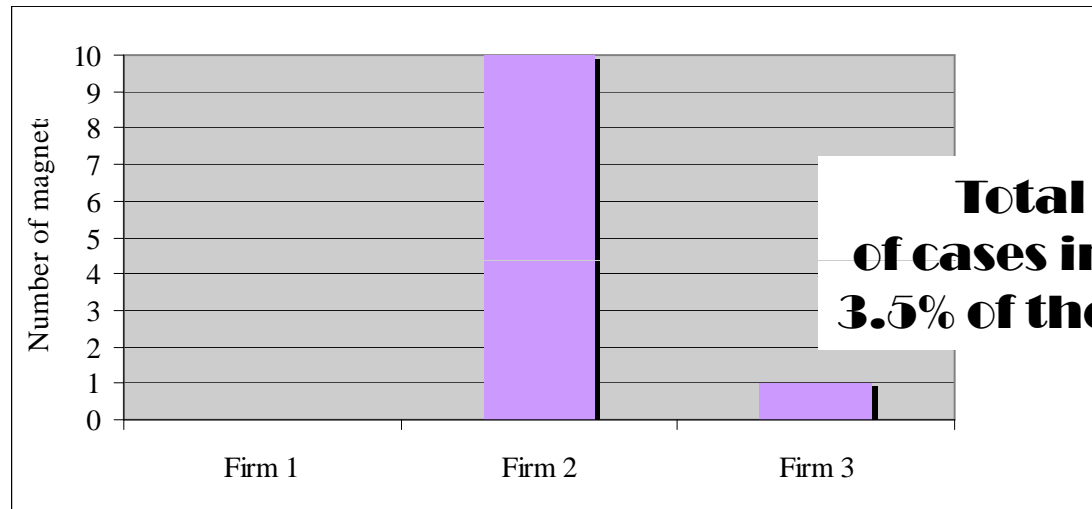
Reworked magnets before delivery to CERN due to quench heater failure

Total number of cases in Firm 2: 16, 3.5% of the production!

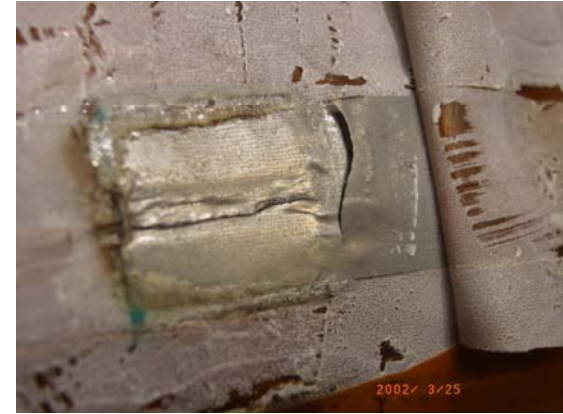
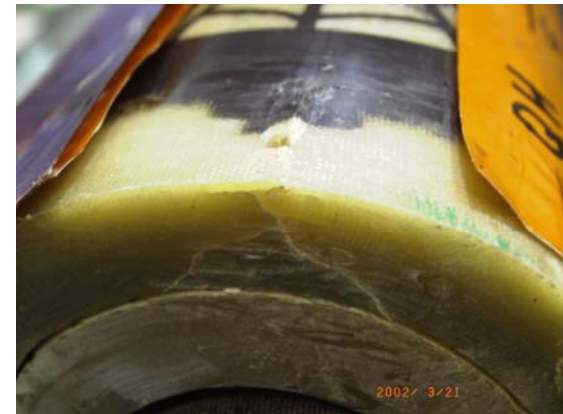
Failure location. Class 2

| Failed circuit | Failure location | | Failure discovered at |
|---|---|---|---|
| LF = 2 (16.7%) | CS = 4 (33.3%) | Up = 11 (84.6%) | warm = 6 (50%) |
| HF = 10 (83.3%) | NCS = 8 (66.6%) | Lo = 2 (15.4%) | cold = 6 (50%) |

In normal operation the dipoles are protected by the HF circuit

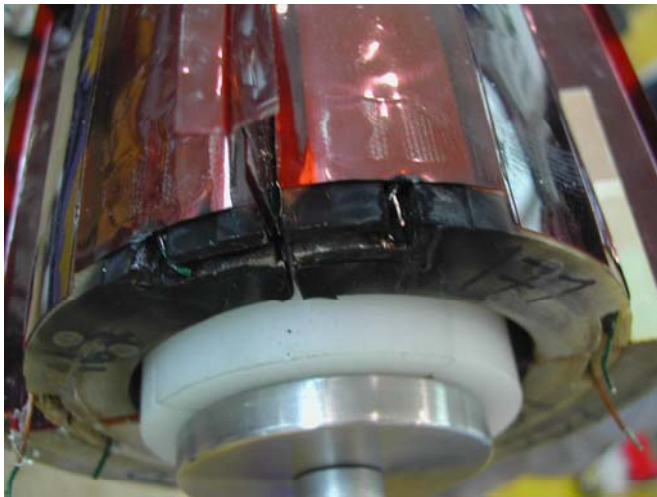
To be remarked that in all cases the problem was in the instrumentation wires of the QHs.

This problem however was also seen during the production of the MQY magnets but CURED

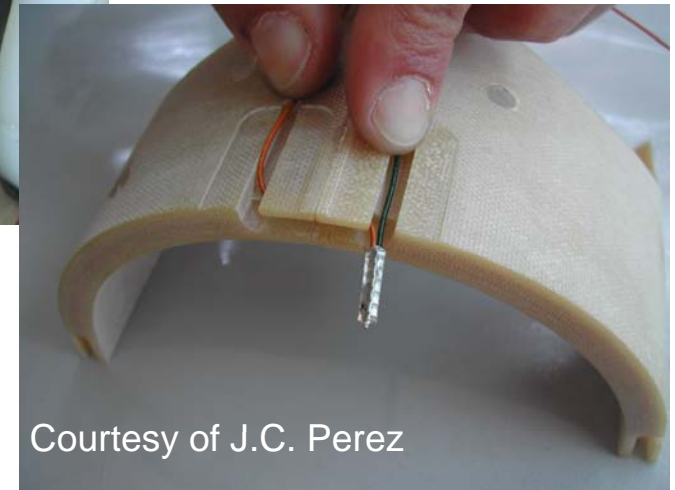
From aperture 21 (so magnet 10) onwards the design changed

So magnets 1 to 9 could have problems!
