WWFP #2

E-XFEL Power Coupler status

July, 12-13, 2016

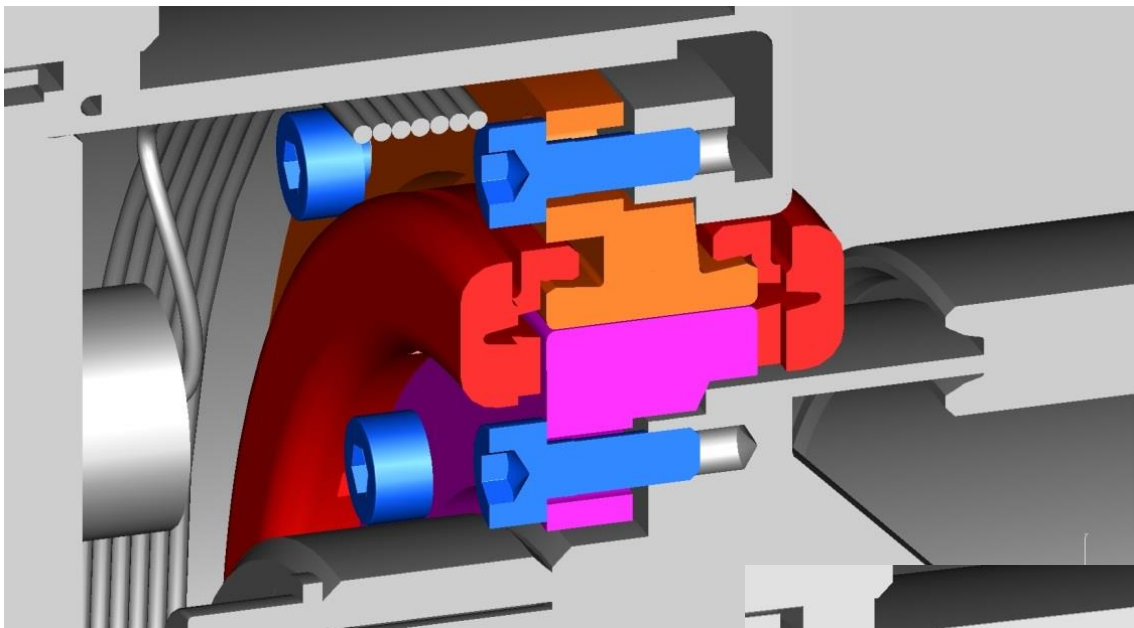
Replacement Installation

The capacitor will be replaced by a short
 → the RF leak is suppressed

- The CPI coupler have no capacitor
 → no need for replacement
- Has to be done at all modules, also in the tunnel
- Coupler vacuum is not involved
- Material arrived at DESY, work has started
- No more RF operation with capacitor
- Exchange and commissioning will be still within time frame of XFEL
- The DC insulation of inner conductor is foreseen for bias application as multipacting remedy, was never needed in FLASH
