The real "life" of operation

V. Baglin CERN TE-VSC, Geneva

Vacuum, Surfaces & Coatings Group Technology Department

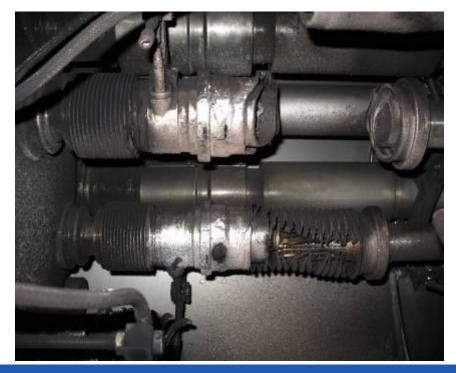
The Sector 3-4 incident (just before the 1st ramp)

19th September 2008 at 11:18.36 last test of the last sector: 7kA (4TeV) towards 9.3 kA (5TeV) Electrical arc at 8.7 kA in the interconnection Rupture of bellows, expansion of liquid Helium with superinsulation debris

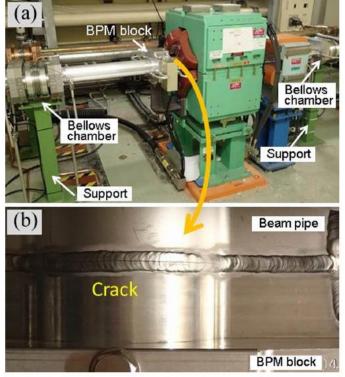
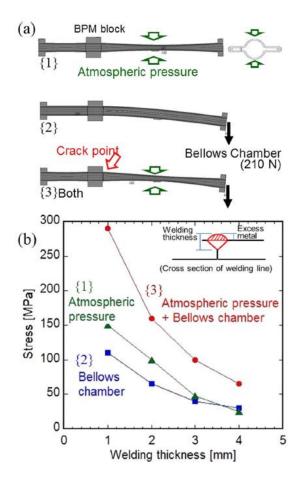
Leak at welds: mechanical analysis

• The stress at the level of the weld increases under vacuum and weight (and thermal stress)

- Example of SuperKEKB:
 - Supporting of below before evacuation
 - Rewelding if too thin thickness

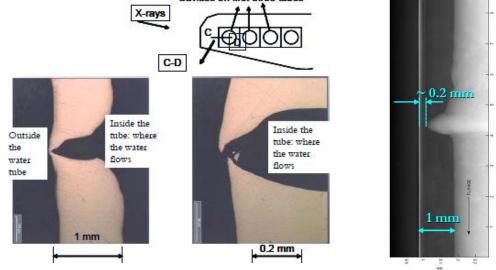
- The crotch is a photon absorber (~ kw), used in SR machines. It need to be water cooled ...
- Example ESRF crotch, March 2005
- Water leak:
 - 50 m vented
 - water inside the vacuum system!
 - 5 days lost

Origin: de-ionised water+ Copper + radiations

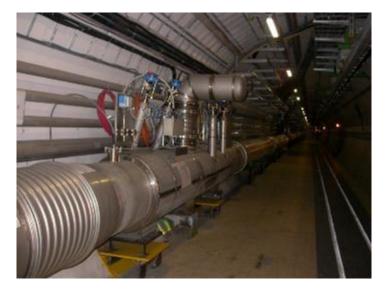
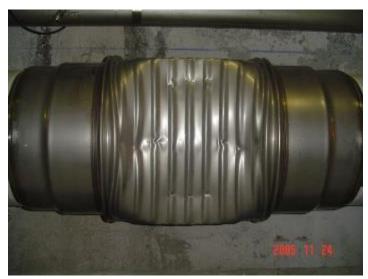
Production of bellows for the LHC QRL:

- design: convolution height "at the limit"
- non-conform production
- not traced !
- Cured by mechanical consolidation
- Production follow-up shall be appropriate !

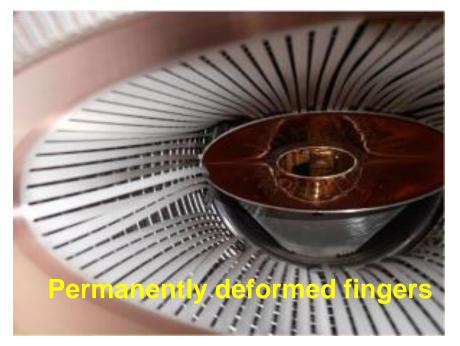
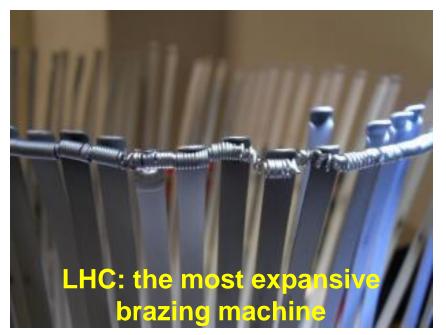
Heating due to Re[Z]

• Origin of the systematic default was identified to be due to a poor contact between the RF finger and the transition tube.

• Lesson : always validate the design of your components (even under schedule pressure)

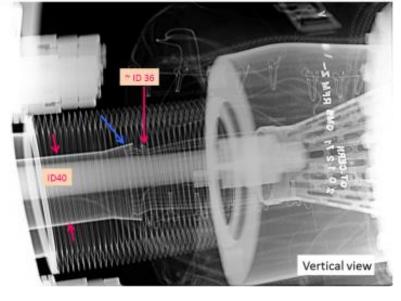
• In 2011, frequent pressure spikes, some up to 10⁻⁶ mbar, were observed at CMS, 18 m, right side.

• When the local pressure was above 10⁻⁸ mbar, CMS background was larger than 100 % thereby reducing the detector capability

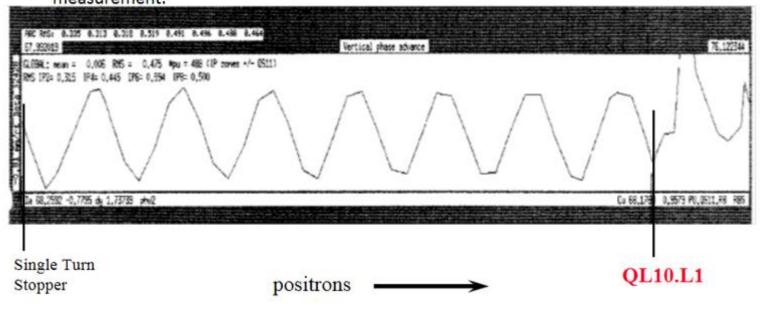
Unexpected beam aperture restriction in LEP around IP1 22 June 1996

Could not get the beam to circulate more than 15 turns even with large bumps all around the ring. Use single turn orbit system and normalised the measurement.

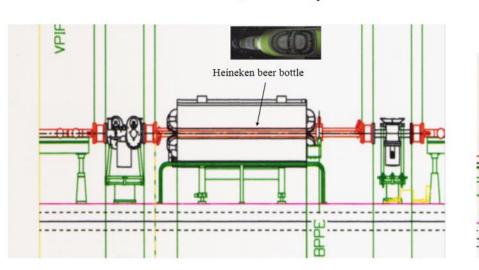
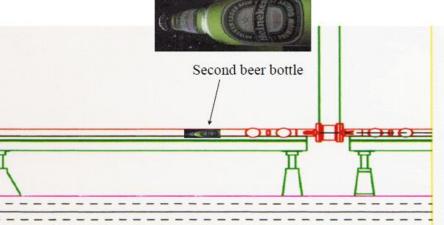
Zoom in on Quadrupole

Unexpected beam aperture restriction in LEP around IP1 22 June 1996

Unsociable sabotage: both bottles were empty!!
