MKI ERRATIC 02/09/16

M.J. Barnes, W. Bartmann, E. Carlier, A. Lechner

MPP, 16th September, 2016

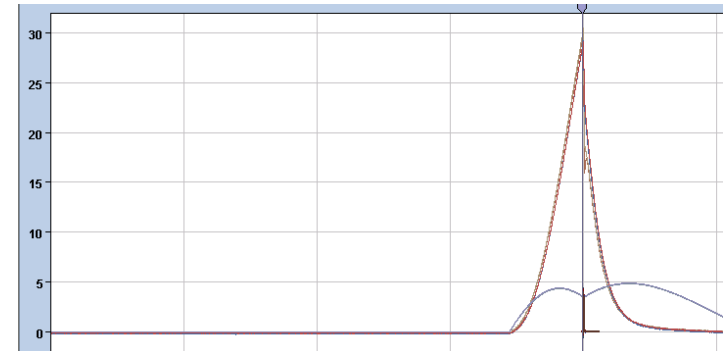
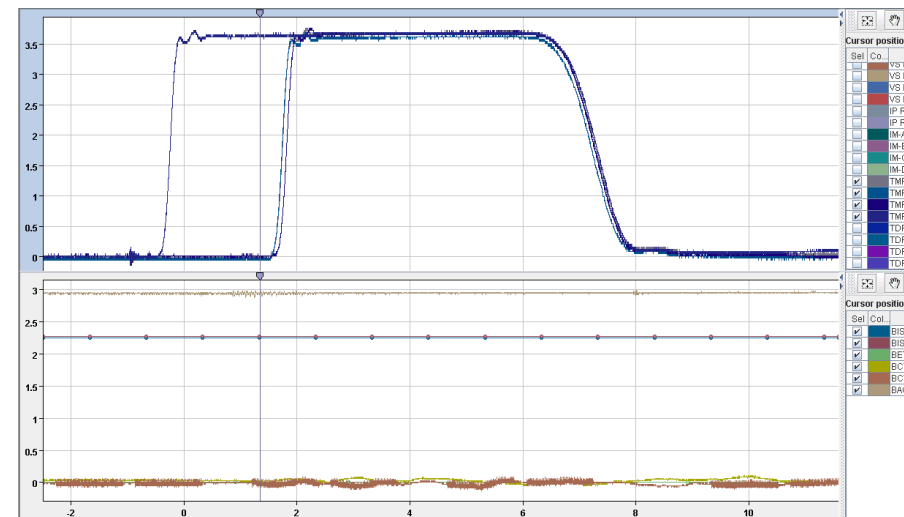
- 02/09/2016 at 04:44:36
- 876 circulating bunches
- Erratic on the main switch of MKI2D at 35 kV PFN voltage
- The other three main switches were turned on within 1.9 - 2 us
 - Current in magnet C rises 90 ns after current in A and B – no compensation for e.g. turn-on delay when retriggering
- Controls turned on the MKI2D dump switch (and also the other units) within ~2 us of MKI2D erratic
- 18% of nominal kick for about 2 us – half a batch of circulating beam grazing on lower TDI jaw;
- Then 3.5 batches with high TDI impact parameter (70% of MKI kick)
- A few bunches again grazing during the fall time
- Q2 at the onset of a quench; no quench of D1 and Q3
- Vacuum valves closed
