Electro-migration driven failures on miniature silver fuses at the Large Hadron Collider

Nikolaos TRIKOUPIS¹, Juan CASAS-CUBILLOS¹, Ana Teresa PEREZ FONTENLA²

¹ CERN, Technology Department, Cryogenics group ² CERN, Engineering Department, Mechanics and Materials Engineering group

TWEPP 2017
Topical Workshop on Electronics for Particle Physics,
Santa Cruz, California, USA, September 11-15, 2017.

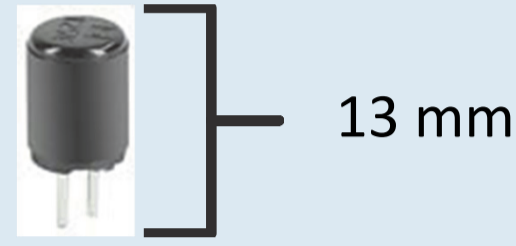
The fuse family used to protect the electronic cards:
Schurter MSF125 0034.xxxx.

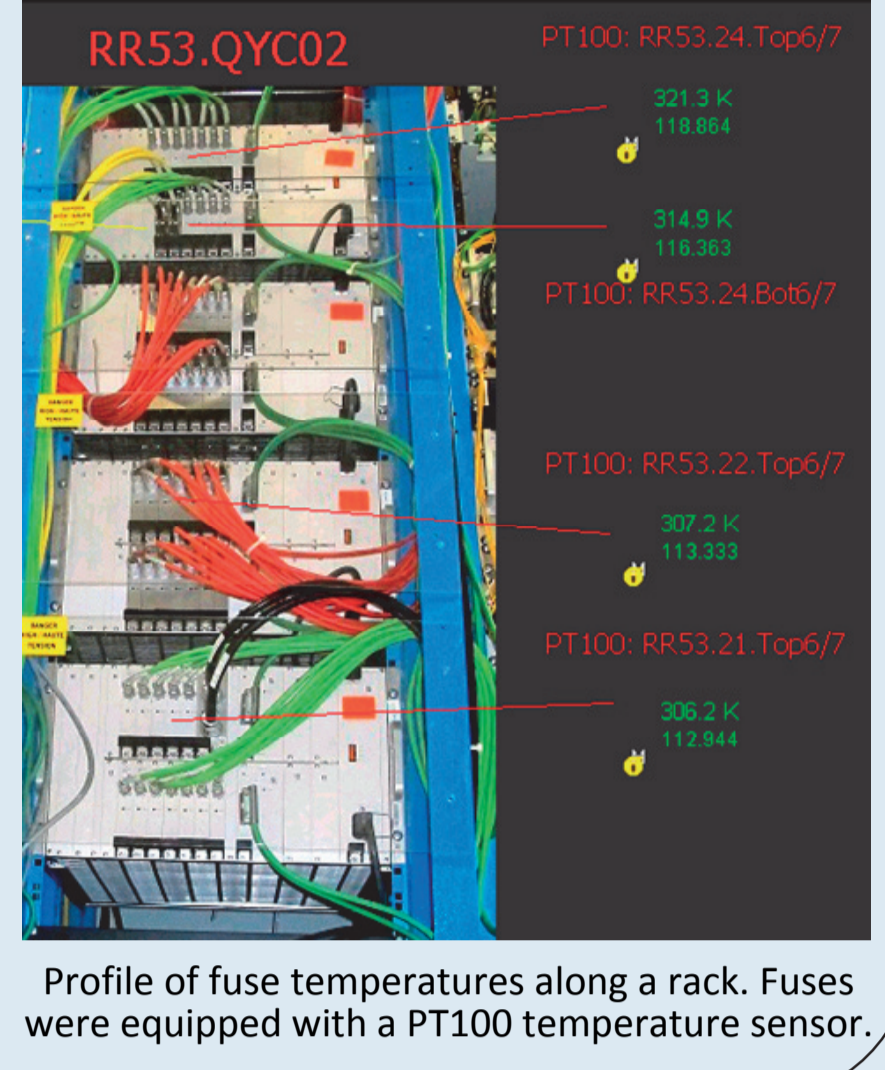
On the left, the racks containing LHC cryogenics instrumentation electronics are shown. Those racks are placed at 2 LHC locations where the most failures were observed during the periods 2008 - 2010 and 2014 - 2016. Each rack contains 3 or 4 double-level crates with various electronic cards. The failing card type is shown with a dark purple colour. The cards that actually failed are visualized with a blue square. After the first period, some of those cards were upgraded to another family as per updated requirements; no failures were observed at those newer cards which operate at a lower supply current.

It was observed that the failures were occurring mostly at the top level of the double crates indicating a possible correlation with the operating temperature. Those 2 LHC locations are among the warmest and in addition the cards were tightly packed without sufficient ventilation. Their operating temperature was measured in the range of 50 - 60 °C.

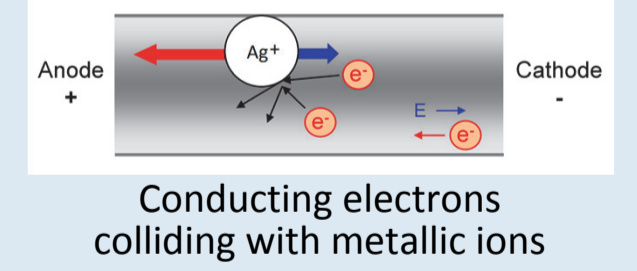
The SEM images revealed effects identical to electromigration. Electromigration is the transport of material due to the momentum transfer between conducting electrons and diffusing metal atoms. The dislocated atoms may form voids at their original location and depositions at their final location.

Bibliography studies have shown that pure silver is highly susceptible to electromigration due to its low activation energy and high mobility of its grain boundaries. Other metals such as aluminium and copper behave in a similar way. One of the methods for reducing the effects of electromigration is using alloys which tend to increase the activation energy and reduce the mobility of the grain boundaries.
