## Issues faced during the XFEL mass production

Walid KAABI- LAL/CNRS

CERN, June 27<sup>th</sup> 2017

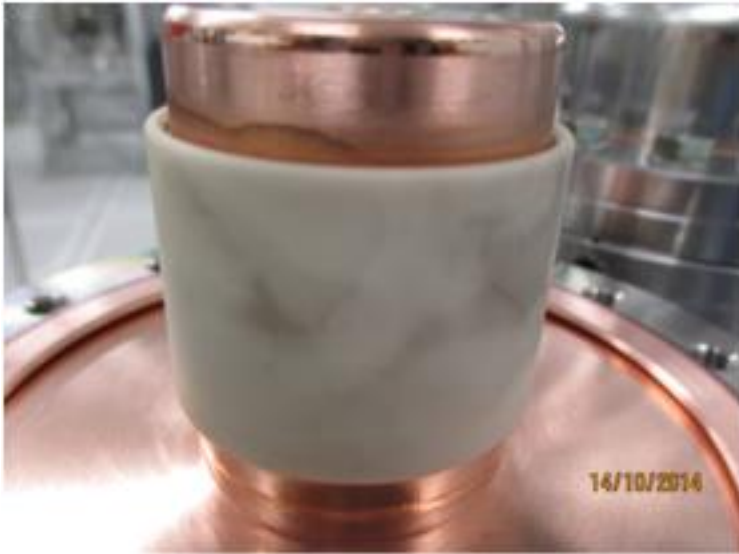
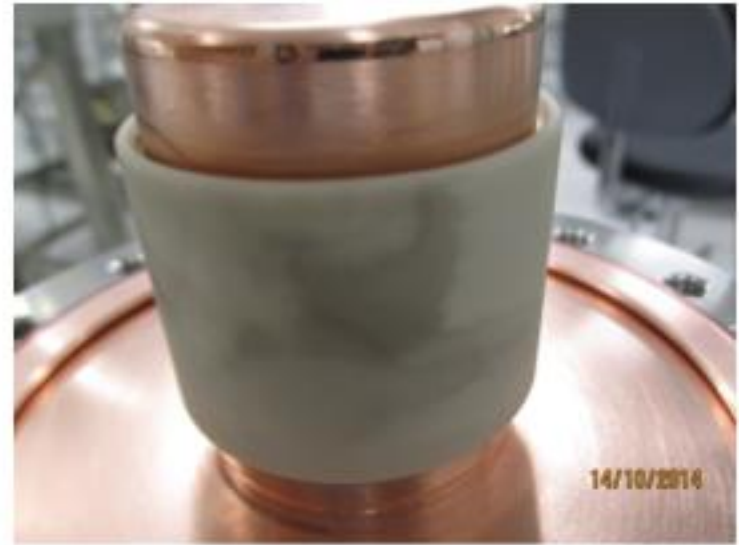
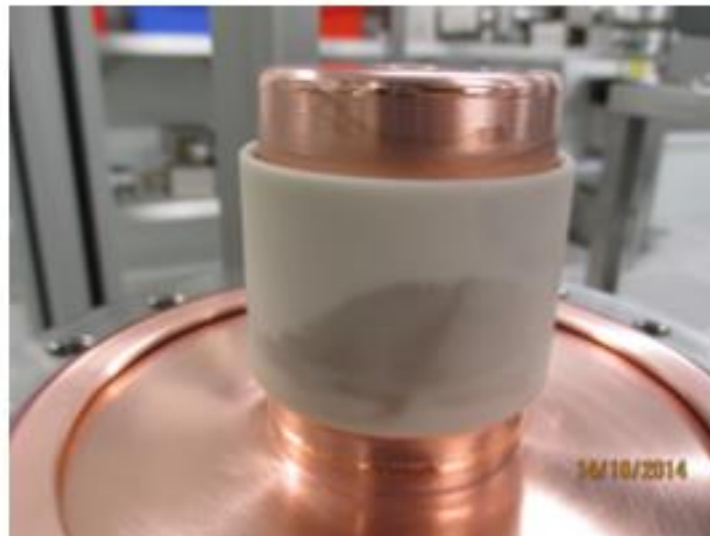
CP 331\_Pair 115  
Upstream coupler

Main defect discovered during the final inspection: **Dark layer in cold ceramic window**

# Troubles on the track: Dark layer on cold ceramic

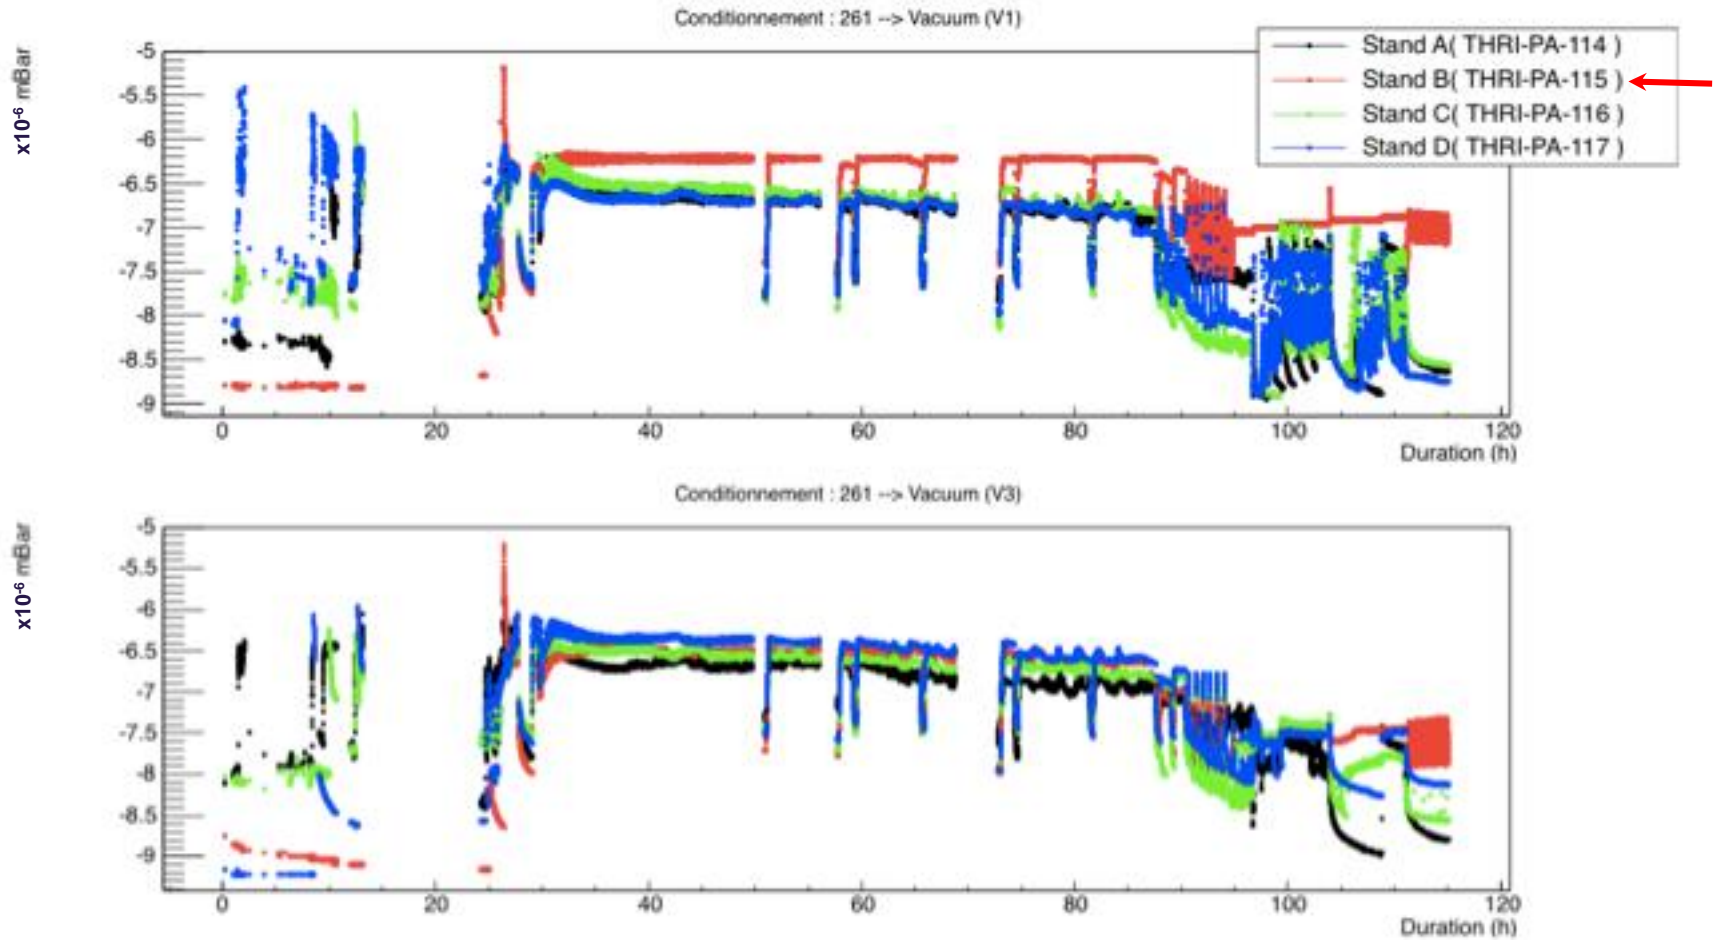
# Troubles on the track: Dark layer on cold ceramic

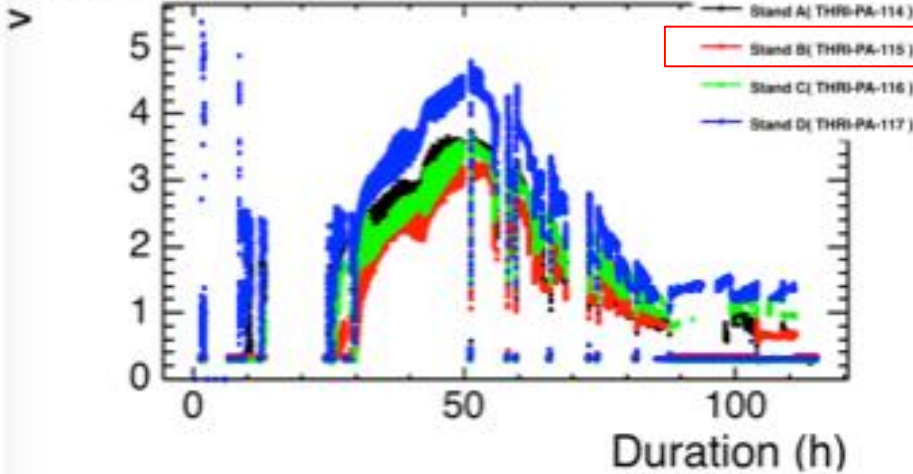
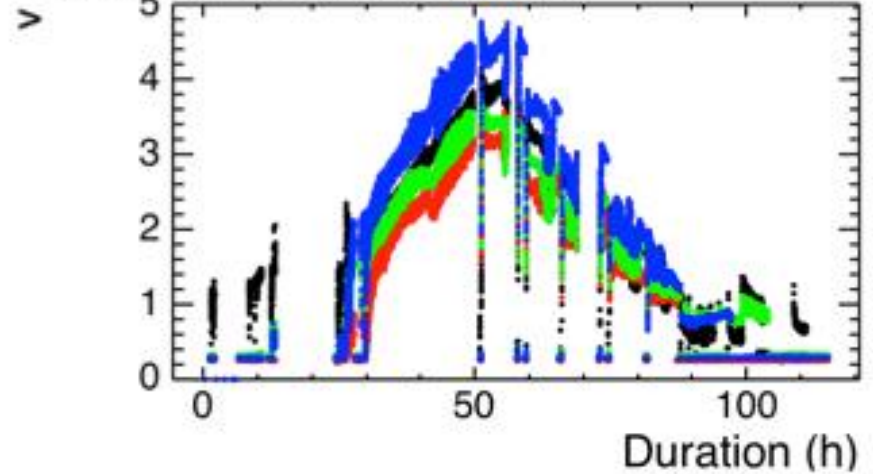
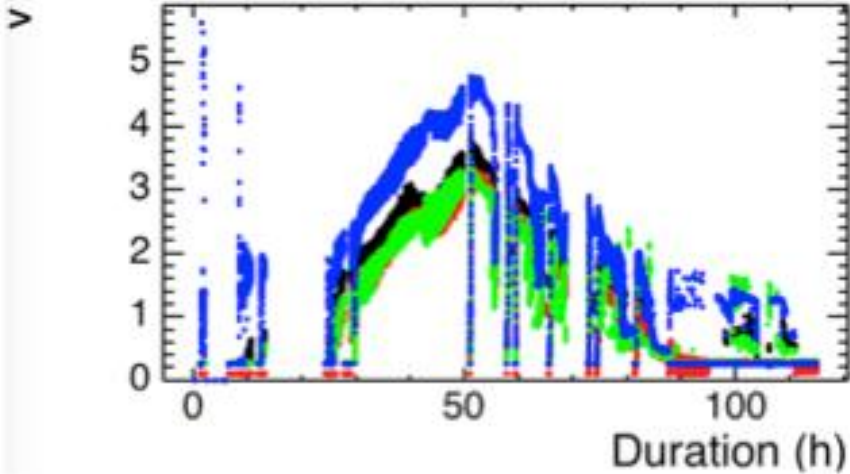
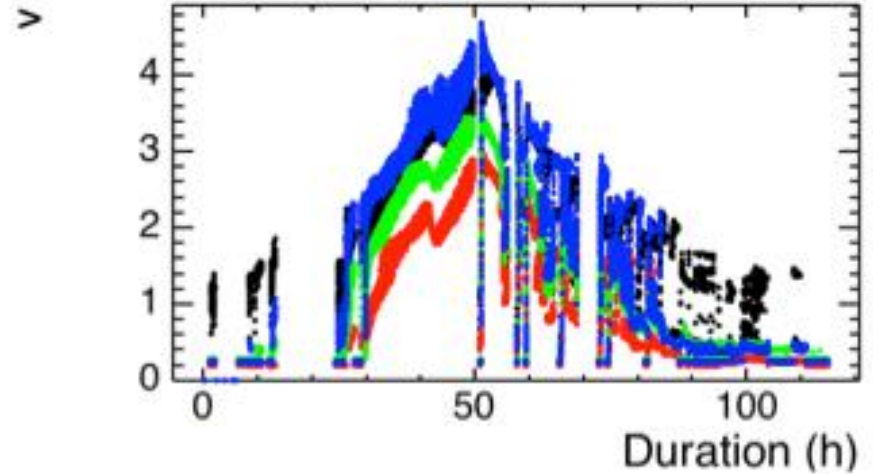
# Troubles on the track: Dark layer on cold ceramic

Conditionnement : 261 → Pickup (le1C1), All steps

Conditionnement : 261 → Pickup (le1C2), All steps

Conditionnement : 261 → Pickup (le2C1), All steps

Conditionnement : 261 → Pickup (le2C2), All steps

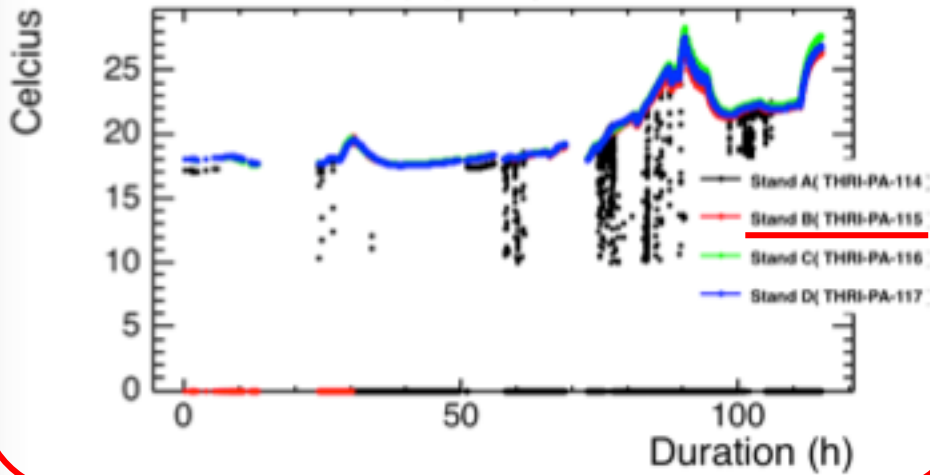
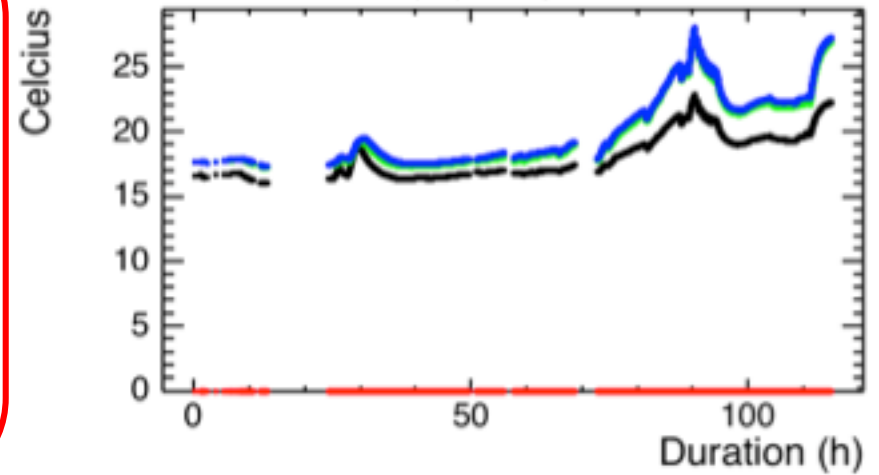
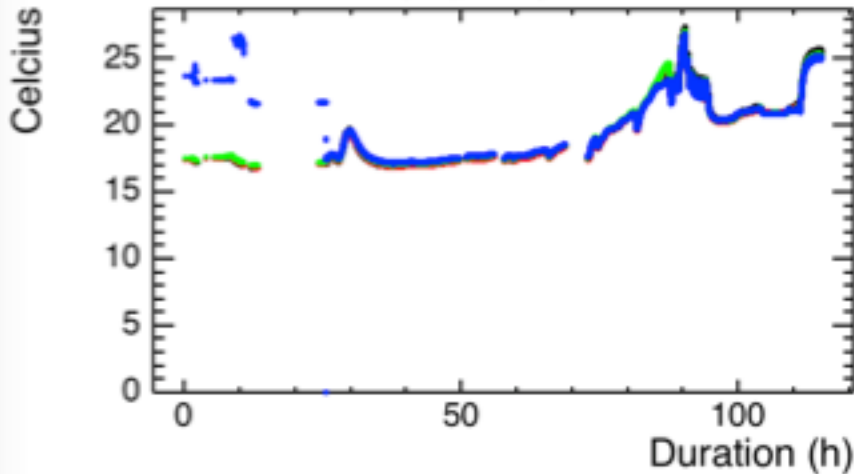
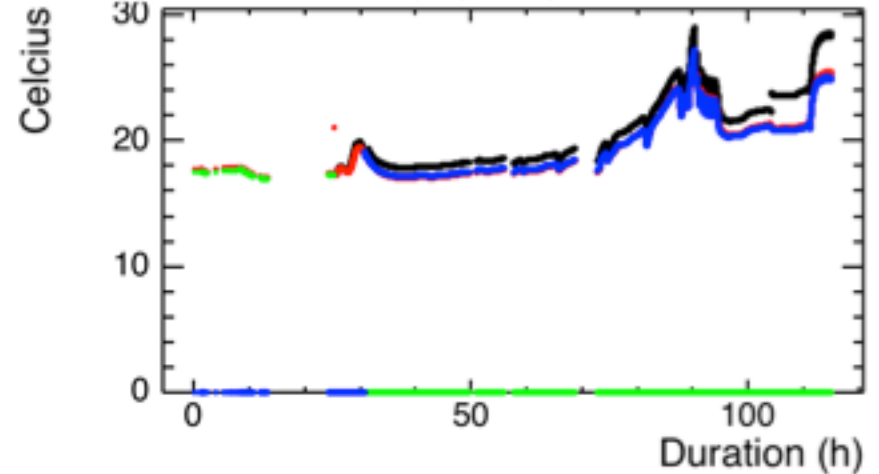
# Troubles on the track: Dark layer on cold ceramic

Conditionnement : 261 -> Vacuum (T1c), All steps

Conditionnement : 261 -> Vacuum (T2c), All steps

Conditionnement : 261 -> Vacuum (T1w), All steps

Conditionnement : 261 -> Vacuum (T2w), All steps

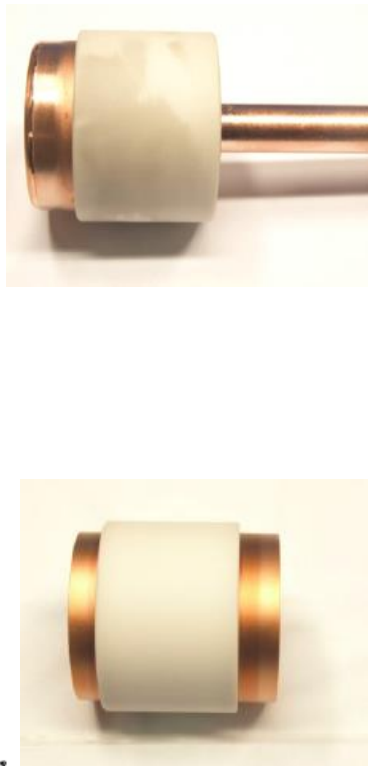
Figure 4: Details of the TOF-SIMS spectra of negative secondary ions

- In the spectra of sample 2 (not discolored) mass signals of **titanium**, **titanium oxides** and **silicon oxides** as well as mixed **silicon/titanium oxides** are distinctly observed (look at figures 4 and 5 on pages 8 and 9). Moreover **chlorine**, **higher fatty acids** (figure 5 on page 9) and the additive **4,4'-Bis(diethylamino)benzophenone** are detected with high signal intensities.
- In the spectra of both preparations **sodium**, **potassium**, **calcium** and **CN/CNO-** as well as **SO<sub>2</sub> anions** are identified with high signal intensities.
- Only in the spectra of the discolored sample 1 the lubricant **erucamide** (figure 5 on page 9) and **soot-like carbon anions** (C<sub>2</sub>H<sup>-</sup>, figure 4 on page 8) as well as **alkylsulfates** (figure 5 on page 9) are clearly detected.

While in the spectra of the not discolored sample the ceramic material is distinctly observed, particularly erucamide and soot-like carbon anions are detected in the spectra of the discolored surface. The former compound can probably be attributed to the plastic wrapping of this sample (→ as-received condition). However the soot-like carbon anions (→ carbon black) can possibly be associated with the observed discoloration.

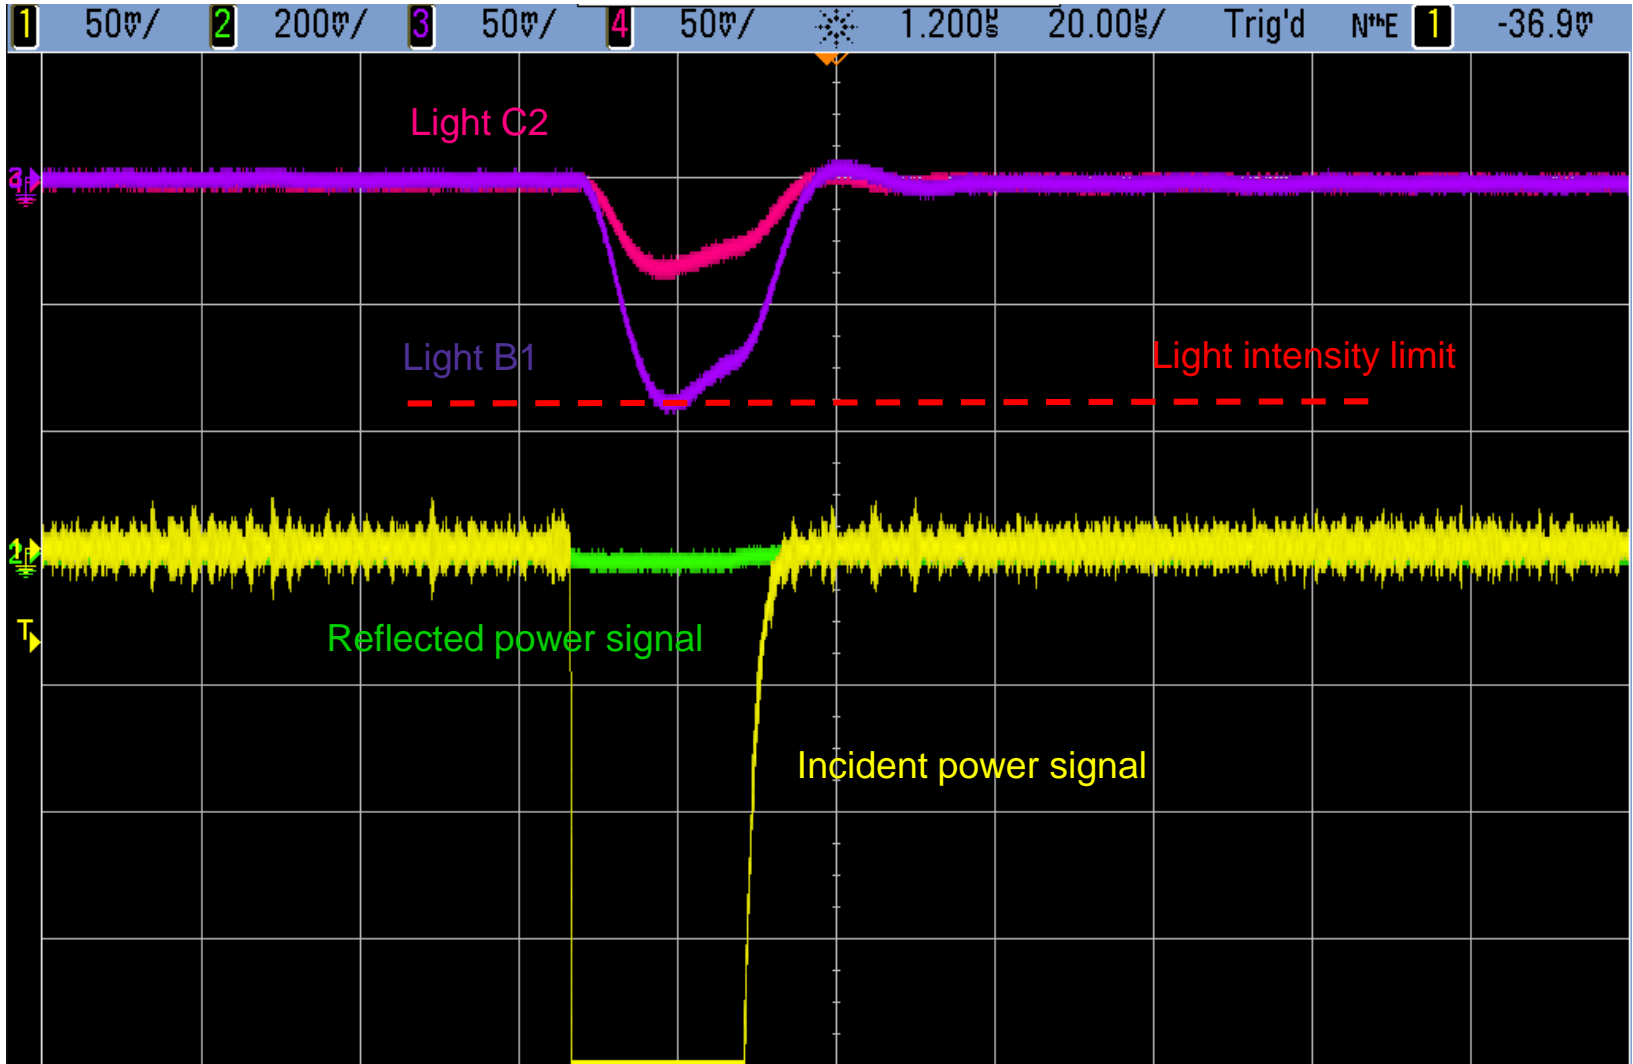
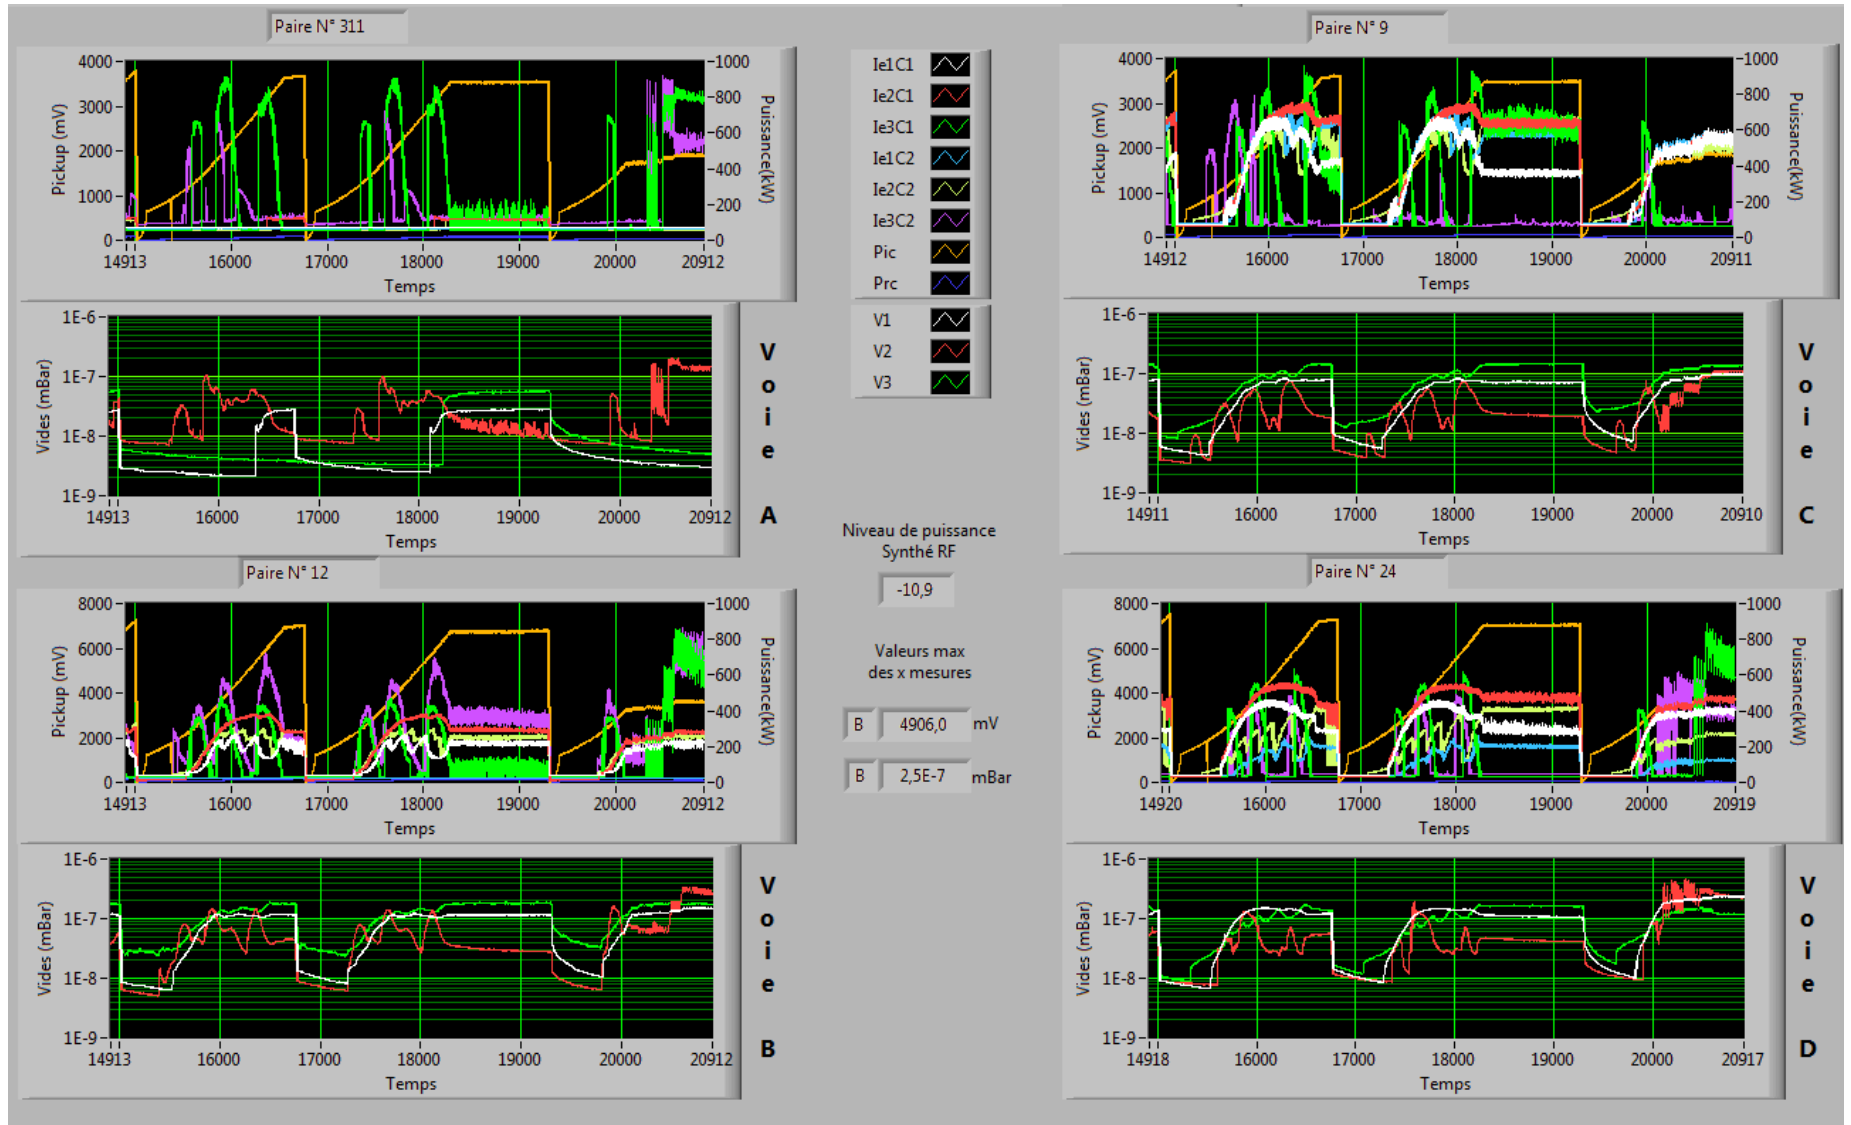
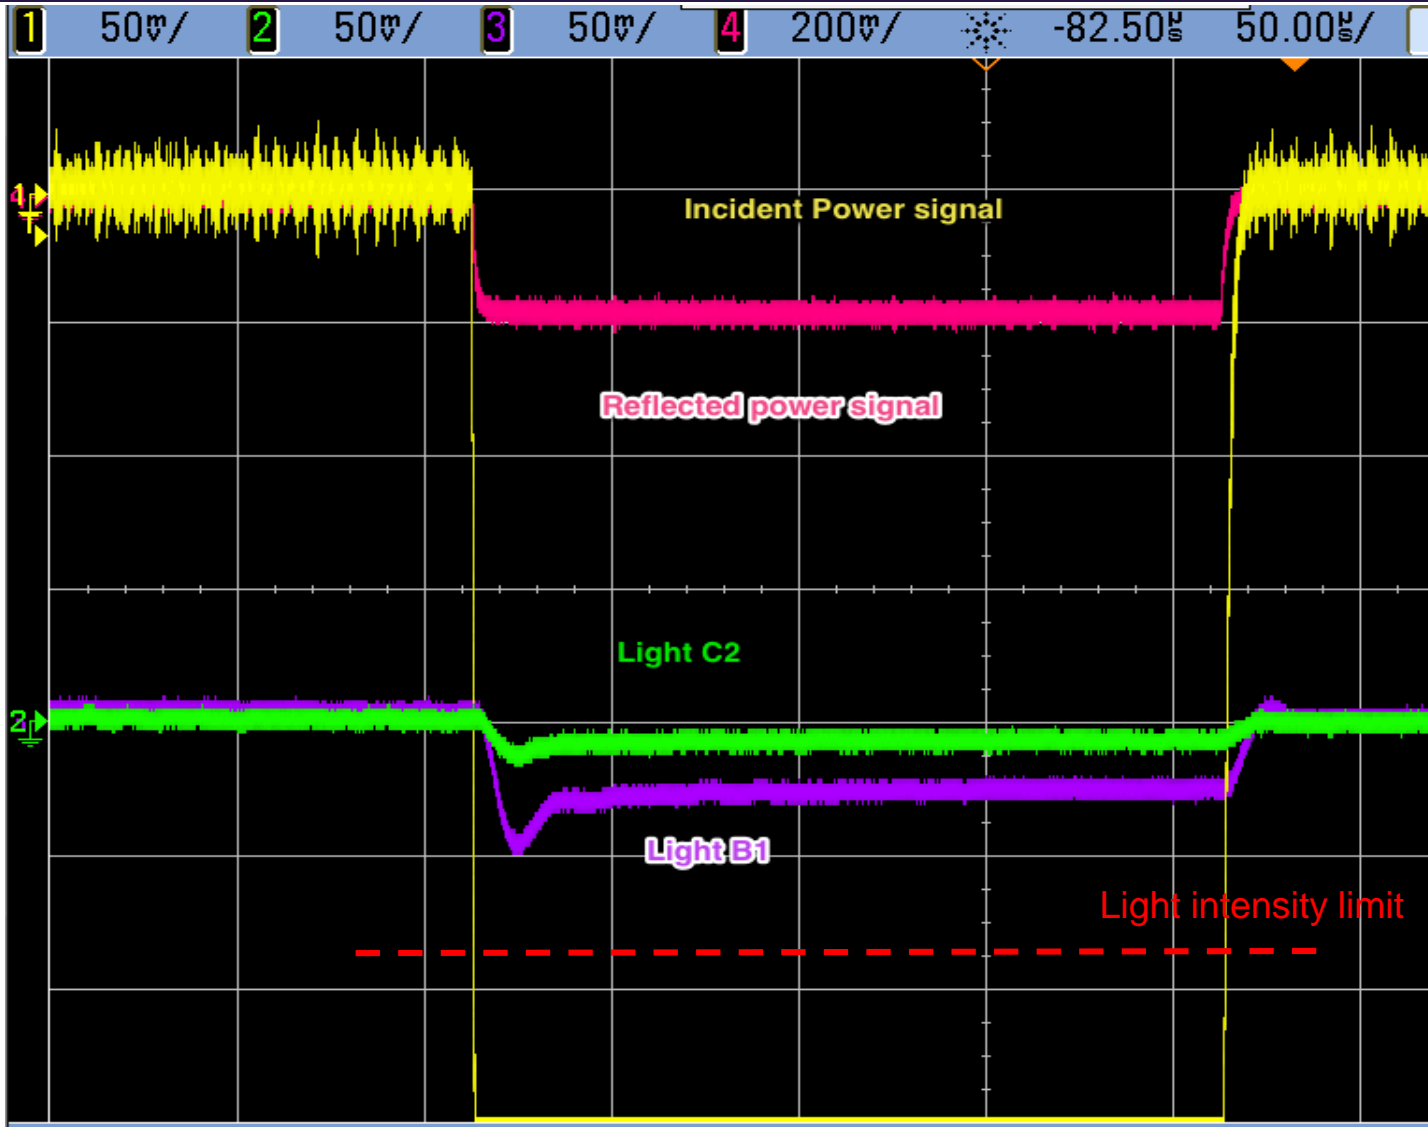
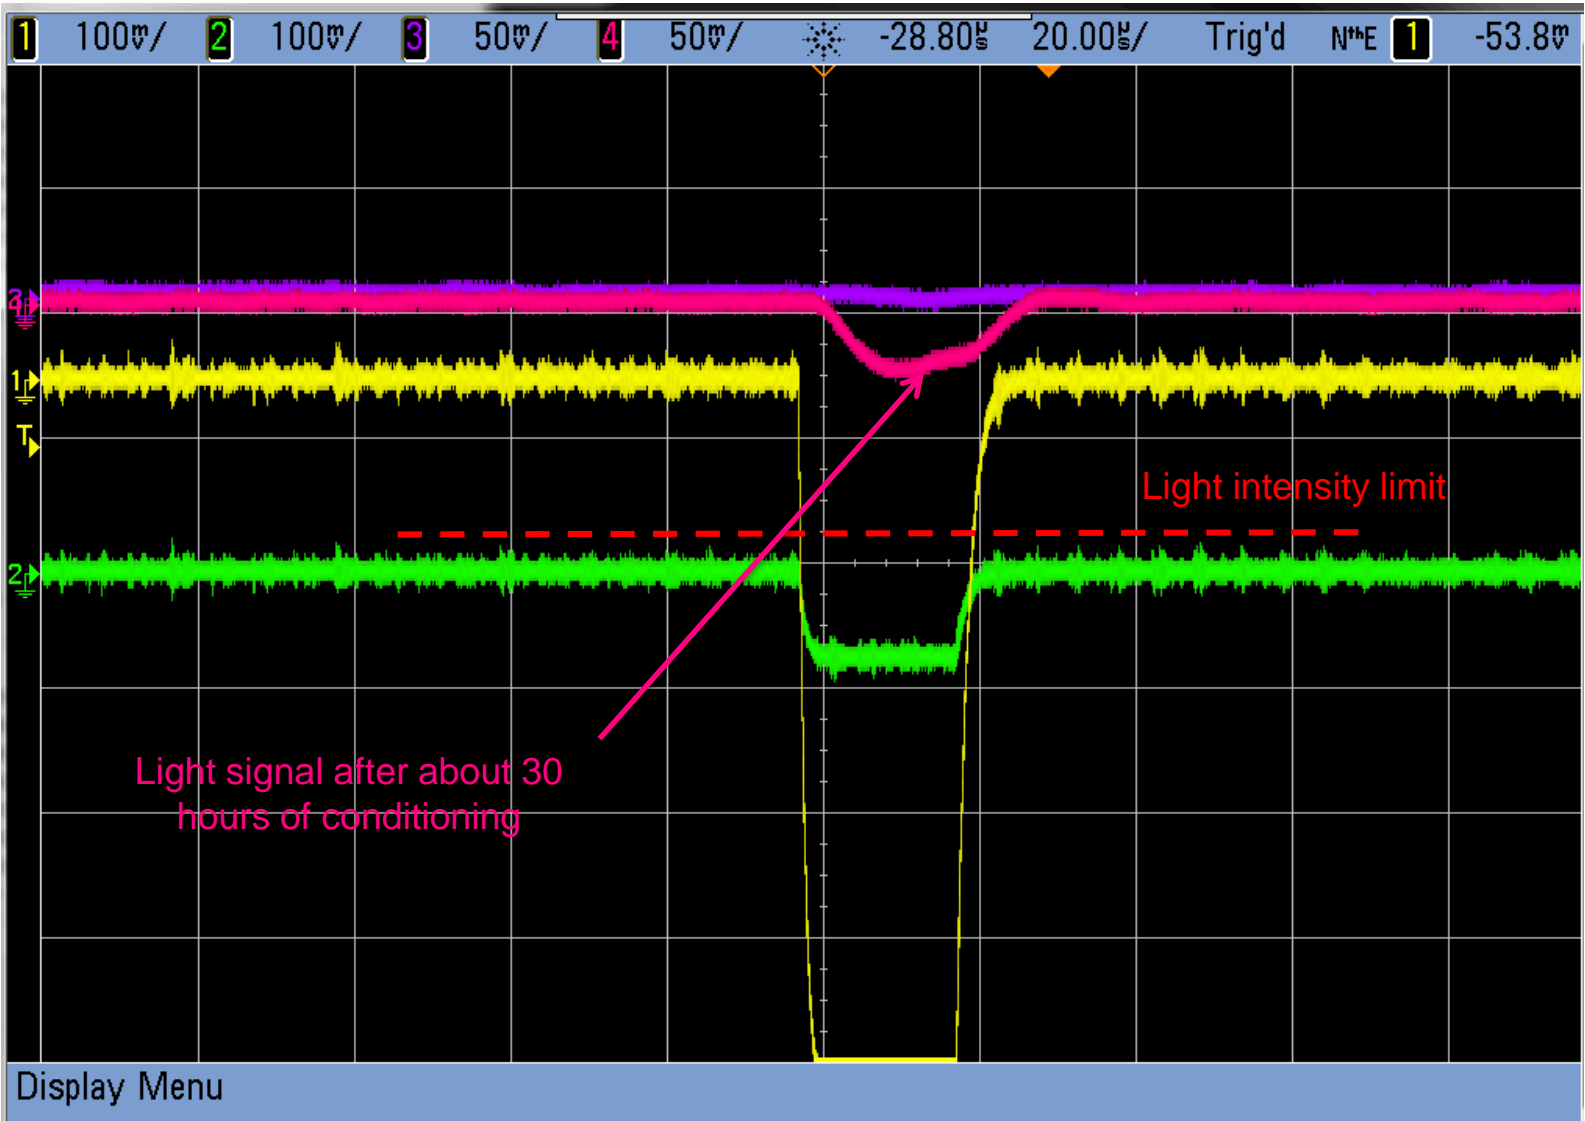
# Troubles on the track: Light & arcing in the warm windows

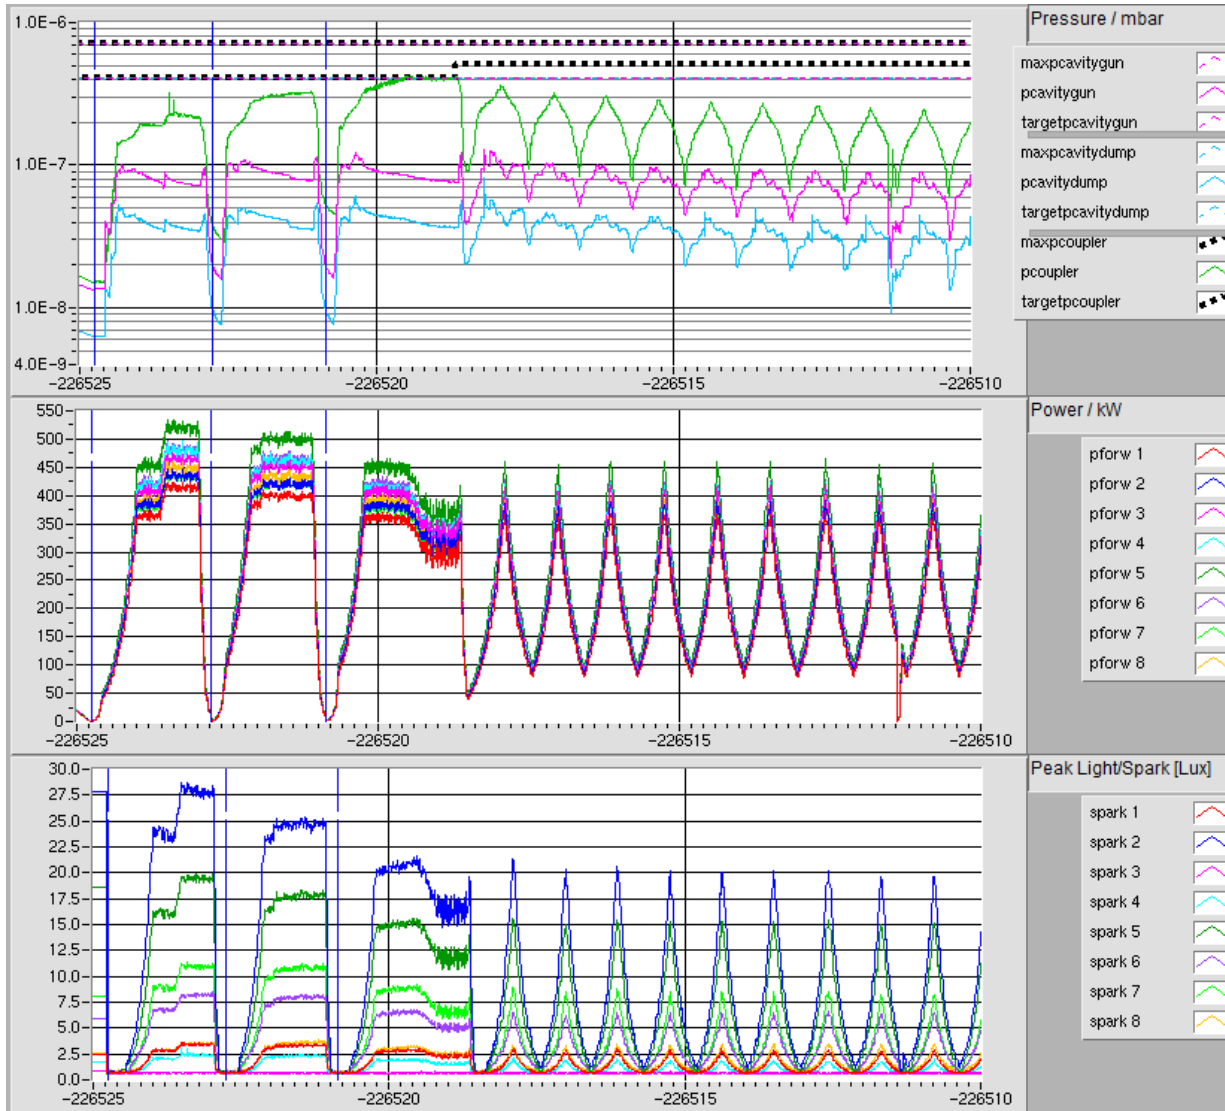
Module XM-1 couplers conditioning:  
Light signal on spark sensors

Sudden increase of the light intensity causing arc interlock: generally occurs at low power (under 250 kW) at the shortest pulse (20us) → impossible to go further: the pair is removed from the test stand.

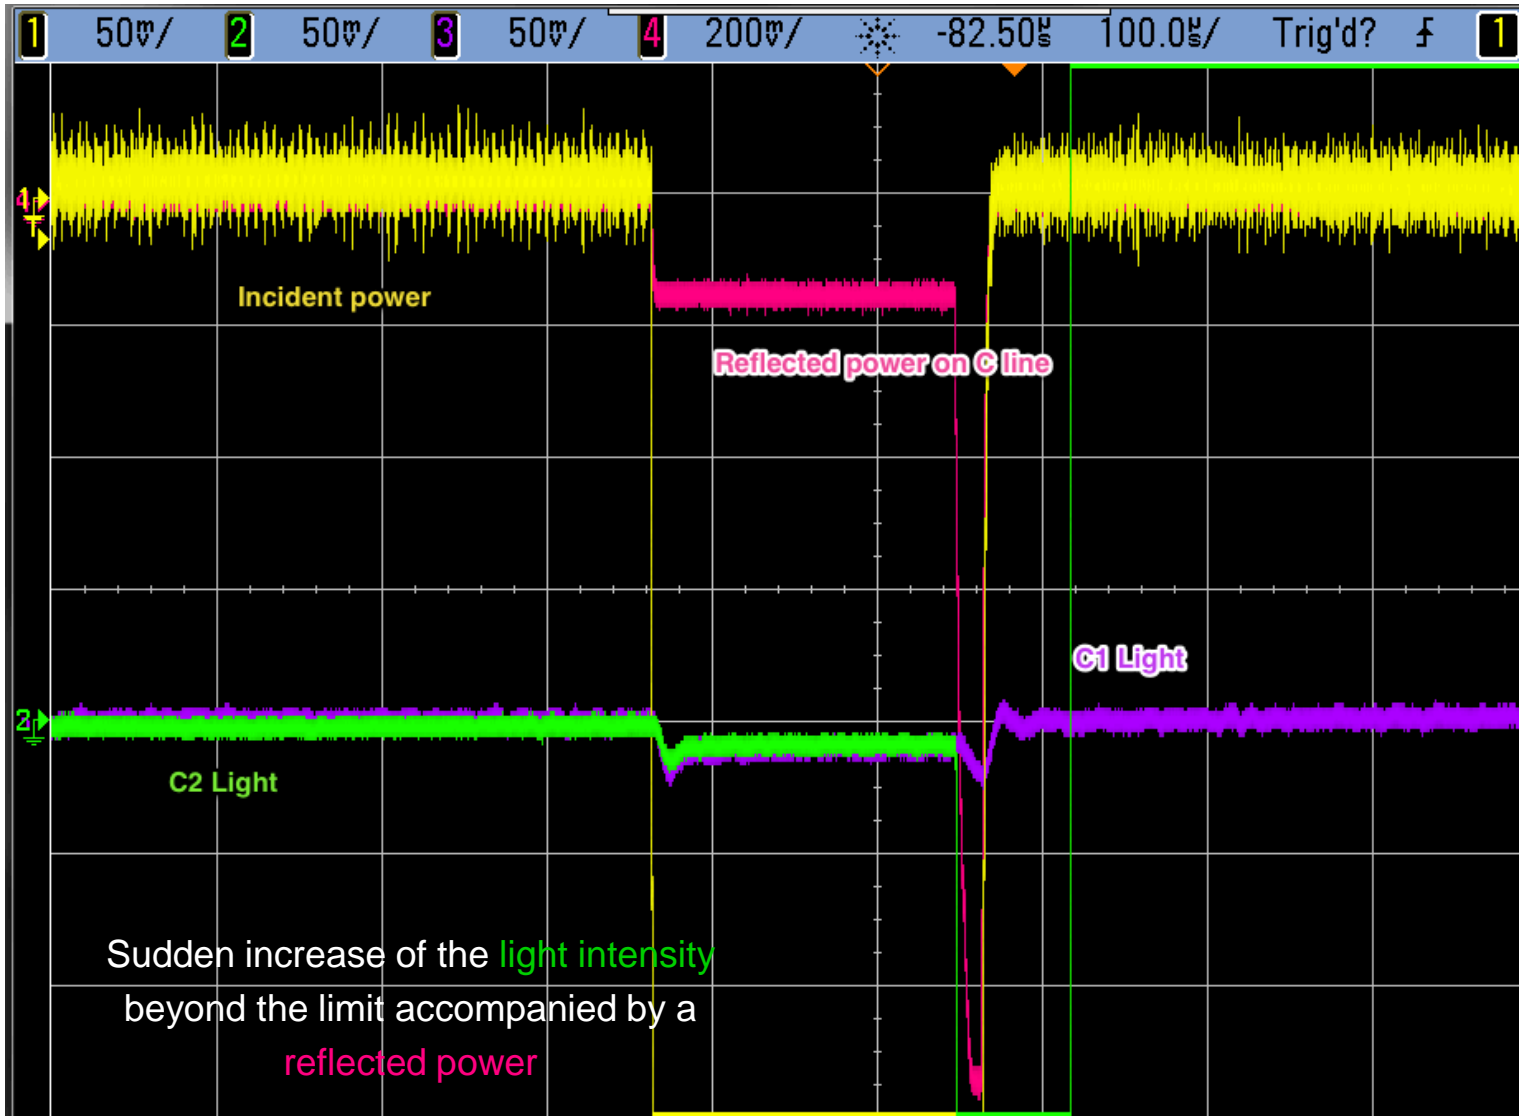
# Troubles on the track: Light & arcing in the warm windows

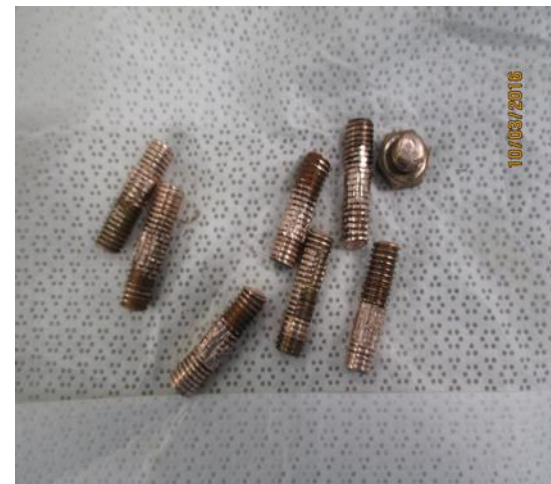
First, we faced difficulties to remove the WP because of the tilted threaded rods, blocked in the flange.

The 7 rods were then removed with a pliers, with the risk to heat the cold ceramic in case of bad handling, and to contaminate the parts with metallic particles.
