Disaster mitigation strategies for adobe houses: A case study of District Awaran, Balochistan, Pakistan

Mamoon U R Mengal, Waqas A Mahar

Department of Architecture, Balochistan University of Information Technology,
Engineering & Management Sciences (BUIEMS) Quetta.
e-mail: mamoonmengal@gmail.com, architectwaqas@hotmail.com.

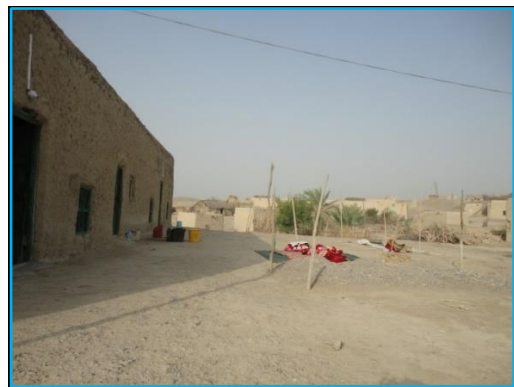
After the survey at Mangoli the team moved to Kullar town in Mashkay. The team was then split into two groups. One group did the survey in the twin towns of Kullar and Gajjar whereas the other group moved further north towards the villages of Nok Jo and Jabry. The twin towns of Kullar and Gajjar lie on either bank of the ravine, locally known as ‘Kaur’. The town of Kullar is on the South-Eastern bank of this ravine whereas Gajjar is on the North-Western bank. There is a marked difference in the devastation caused by the earthquake in Kullar and Gajjar. While the town of Gajjar has been completely destroyed as shown in figure 4(a), Kullar has only been partially damaged as shown in figure 4(b). This trend can be found throughout the district. The places that are on the North-Western side of the ravine (presumably there is a fault underneath) have been more damaged compared to those on the South-Eastern side, which includes Awaran town, the district headquarter of Awaran.

Figure 4(b). Houses standing at Kullar town

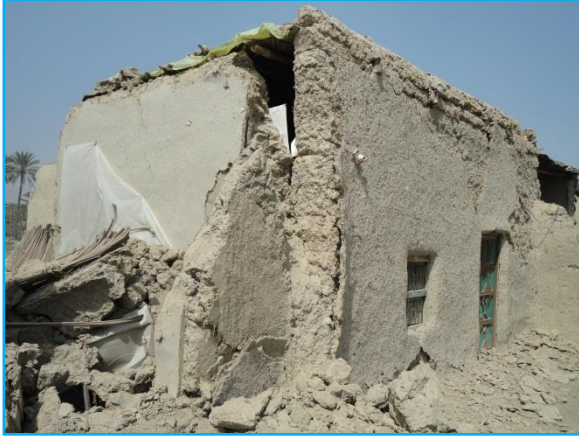
For mud stack walls, wheat husk and animal dung are usually mixed with the mud in order to strengthen the mud, figure 9(a). The foundations are normally laid 1-2 ft. in the ground (30.4-61 cm) with the same mud-stacks but slightly wider than the actual wall. No stiffeners are used anywhere in the wall in horizontal as well as vertical directions. Wooden lintels are sometimes provided on the top of windows and doors in isolation, which have little affect towards strengthening the wall. Whereas the bricks are made from a mixture mainly consist of mud but, small stones with organic materials like weeds and reeds are also used to strengthen the brick. The brick size was, 4"x6"x12" (10.1x15.2x30.4 cm) constant throughout the district. A steel mould is used for this purpose which is open from top and bottom. Moulded bricks are left on the open ground to get dry. The foundations are normally laid 1-2 ft. (30.4-61 cm) in the ground constructed of the same bricks as used in the walls. Foundations with stone boulders were also seen at some locations. No stiffeners are used in brick walls which is similar to the mud stack walls, figure 9(b). Moreover, wooden lintels are also placed on top of the doors and windows, which does not strengthen the walls.

Figure 9(a). Mud-stack walls

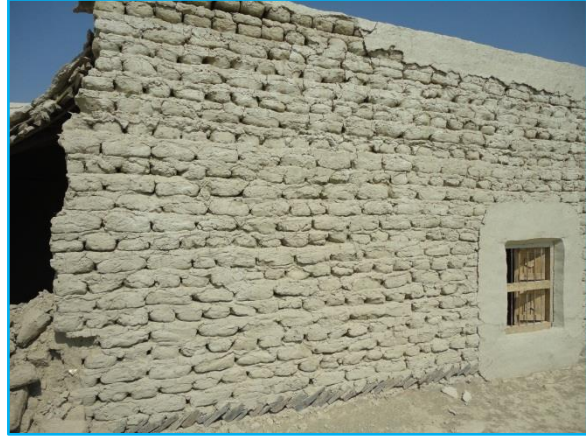
Figure 9(b). Mud-brick walls

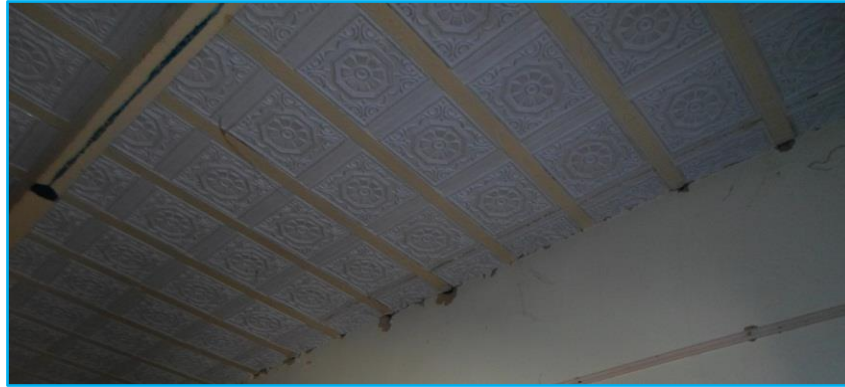
Figure 10(a) shows the roof constructed of t-iron and girders which is also called tiled roof because of the use of terracotta roof tiles. In this type of roof t-shaped steel sections are placed over the I-shaped steel girders and terracotta tiles are placed on the T-shaped iron bars. The terracotta tile used for this purpose was of the size 12"x12" (30.4x30.4 cm) with a thickness of 1.5" (3.8 cm). A plastic sheet is usually placed on the top to insulate the roof against rainwater then the screed of mud mortar is spread

Figure 10(a). T-Iron and girder roofs with terracotta tiles

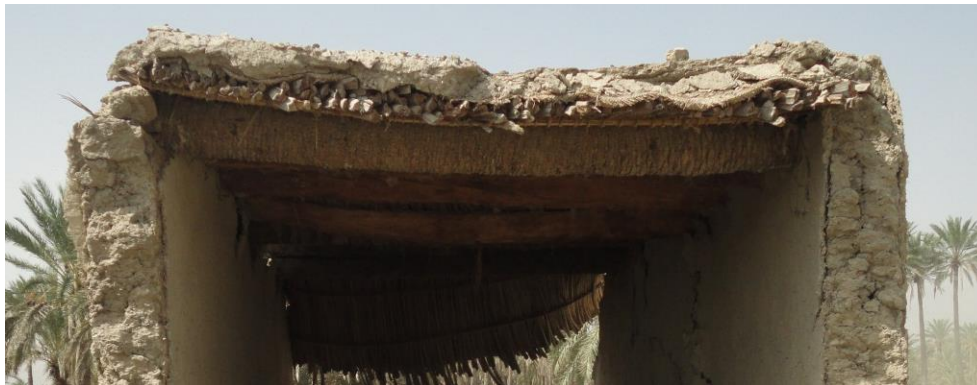
Date palm roofs as shown in the figure 10(b) are very common in most of the houses, since the date palm is locally available in the region. According to local tale, the date palm is termite proof if cut in the winter season. The roof consists the joists made from date palm tree trunk. The use of steel girder and telephone line poles was also seen in some houses. The joists or girders are placed directly on top of the walls without using lintel band or ring beam. A net made of date palm branches is commonly used on the top of joists or girders. A mat is placed on the date palm branches then a plastic sheet for insulation against water. At the top, finally a layer of mud mortar is laid for the insulation against heat.

Figure 10(b). Roof made of Date-Palm joists and Date-Palm branches serving as purlins

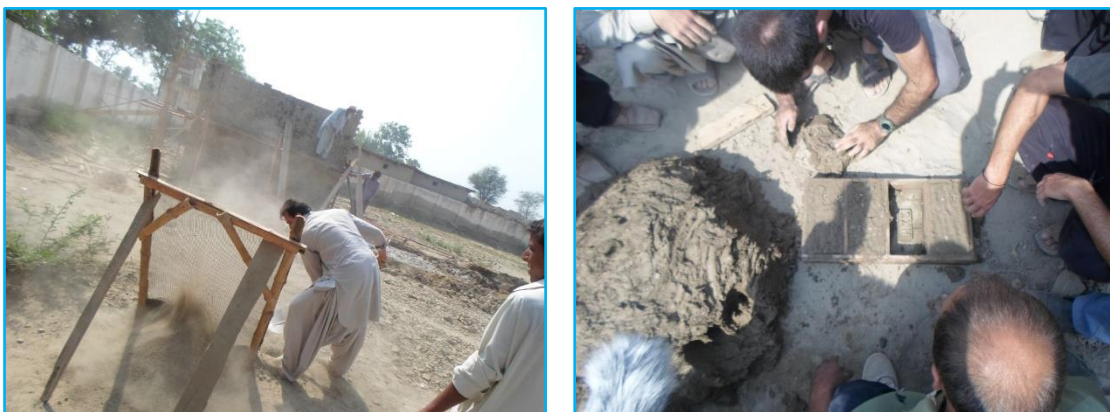
Figure 17(a) and 17(b). Brick making

It is necessary to make the brick of proper and even size. The soil should be first passed through the sieve to separate the gravels and small stones before formation of the mix. The proper moulds should be used to mould the bricks and then moulded bricks must be placed on even ground or surface to let it dry, figure 17(a) and 17(b).

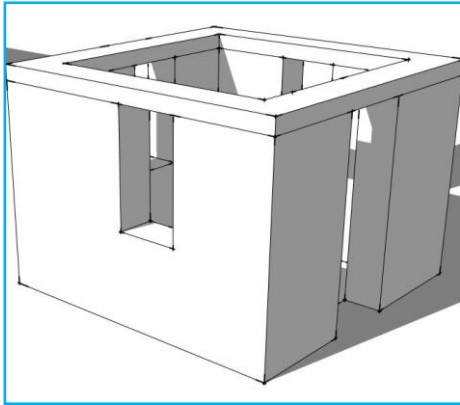
Figure 18(a). Bond beams on wall tops
Source: (Shah S. , 2014)

are important to reduce danger to adobe from earthquakes. Using a strong bond beam on top of the walls, figure 18(a) and adding mesh-reinforced plaster to inner and outer walls that is tied together through the walls can preserve a low-strength earthen building through an earthquake. Either wood or bamboos can be used for a ring beam and must be overlapped and braced at corners. Opening like doors and windows should be kept away from each other and the corners as shows in figure 18(b).

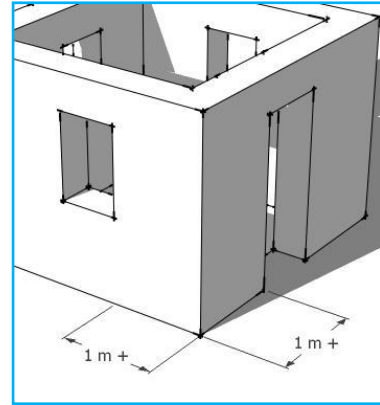
Figure 18(b). Doors & windows far from the corners
Source: (Shah S. , 2014)

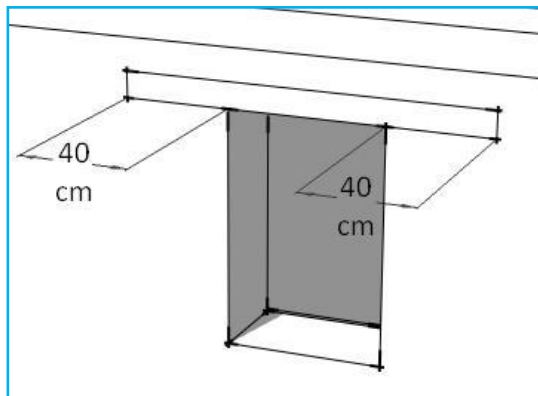
Figure 19(a). Extra-long lintels
Source: (Shah S. , 2014)

Using long lintels on the doors and windows would provide better reinforcement, Figure 19(a). One of the cheapest way to reinforce this type of wall against earthquakes is by adding piers or buttresses, shown in the Figure 19(b). The mass of the corner structures helps to reduce the damage to walls. Buttresses of same type must be used at all the corners and at the distance of every 5-6 m on long straight walls. Piers or buttresses do not need to be vertical but can tapered or diagonal as the walls rise.

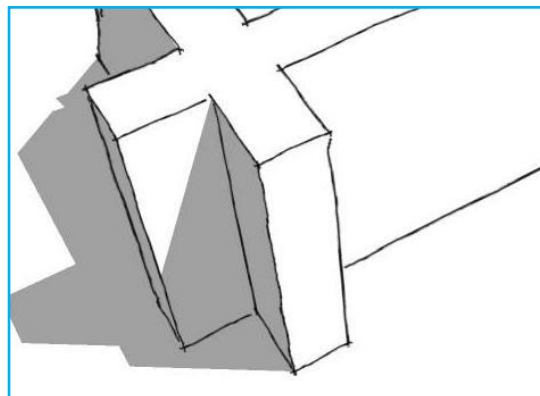
Figure 19(b). Buttresses at wall corners
Source: (Shah S. , 2014)

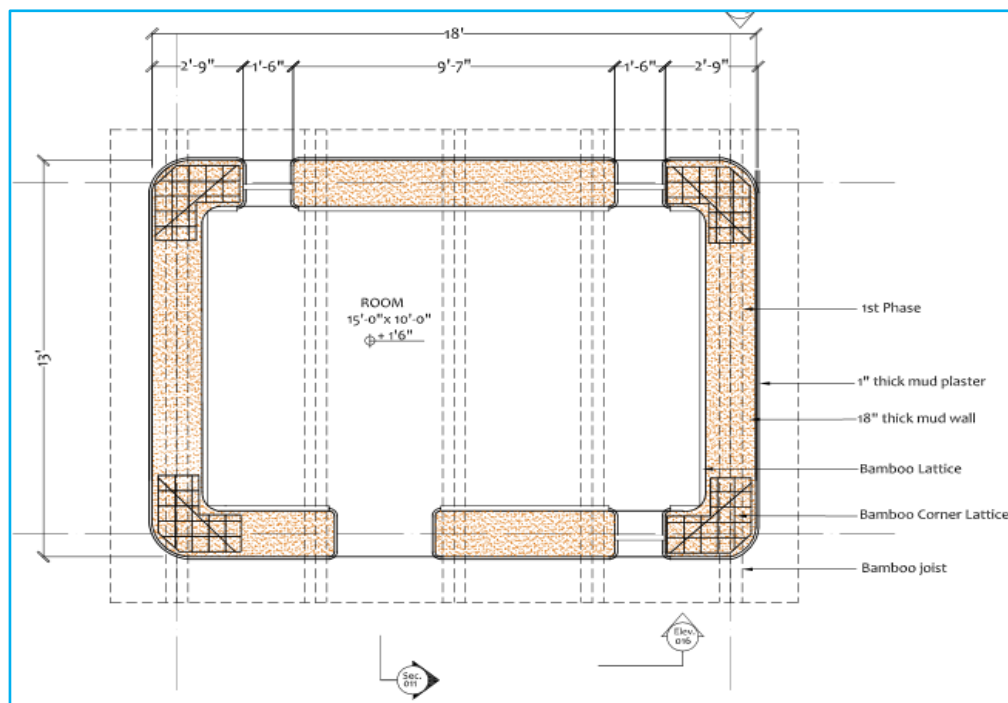
Figure 21. Corner strengthening using bamboos as reinforcement
Source: (HPF, 2013)

As mentioned in section 4.2 that the improper brick bond was also a cause of damages. The bricks should be properly bounded to strengthen the bond. The corner can be strengthened by using bamboos as reinforcement on the corner which is shown in figure 21.

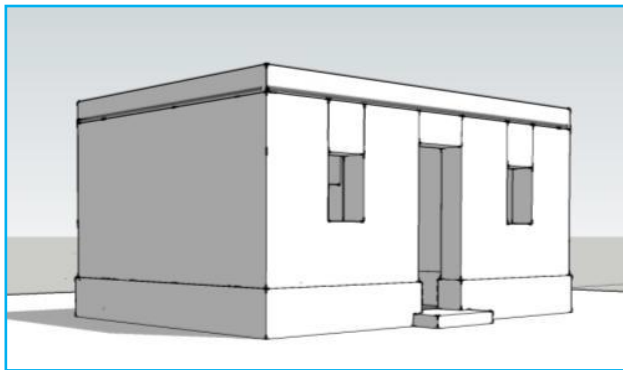
Figure 22(a). Walls for a light roof
Source: (Shah S. , 2014)

Several buildings fail in the earthquake as the unevenly distributed weight of heavy roof pushes the walls in one direction. Light roofs reduce stress on walls in earthquakes. Lighter walls with a light weight roof can survive even severe quake vibrations with little reinforcement better than heavy walls and roofs. The adobe house shown in Figure 22(a) can hold up a light-weight roof. It must consist a special base and plastic mesh to reinforce the walls. The same size house shown in Figure 22(b) with a heavy-weight roof should have heavy earth piers at all corners to help brace the walls against the weight of the roof moving in an earthquake.

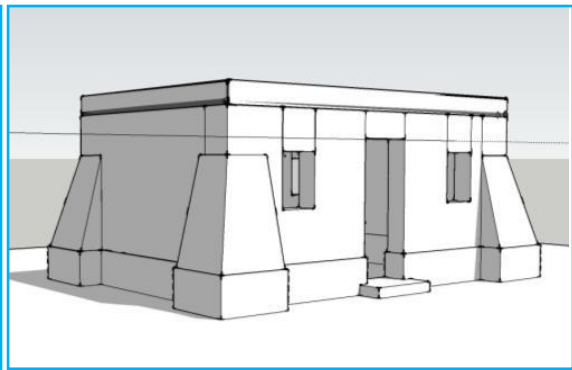
Figure 22(b). Walls and piers for a heavy roof
Source: (Shah S. , 2014)

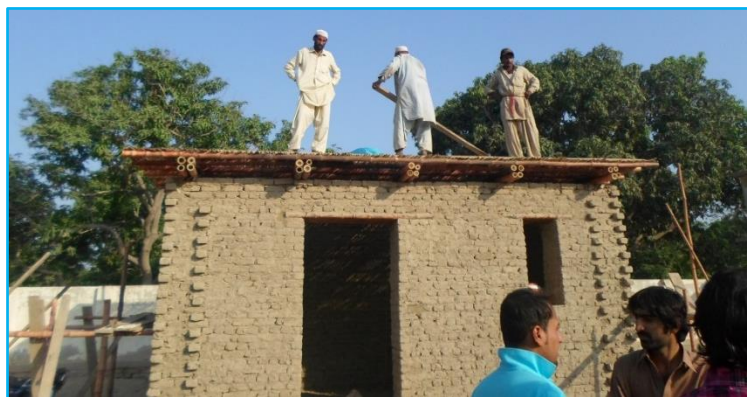
Figure 23. Roof construction and the projection

The construction of roof using bamboo purlins is shown in the figure 23, the roof projections on all four sides can also be seen.

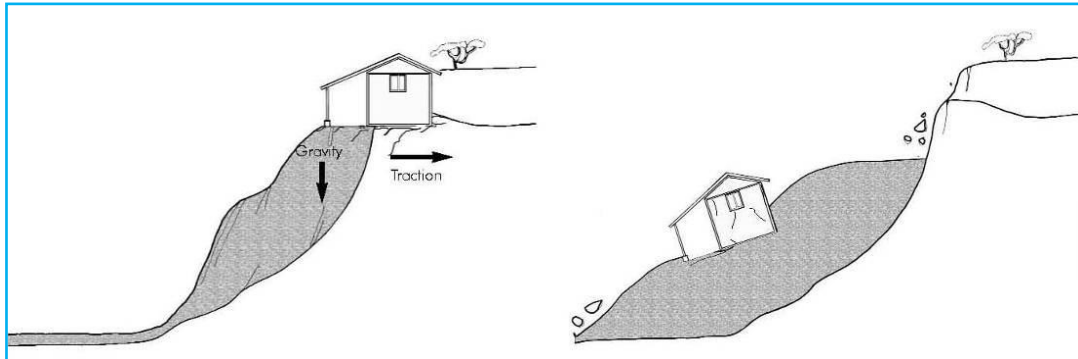
A house should not be constructed near steep and unstable slopes. The cliffs made of soft or crumbly, clay loam; or deposits materials, etc. should be avoided. Figure 24 shows the failure of house due to the location on unstable slope.

Figure 24. Failure of house due to steep or unstable slopes
Source: (Shah S. , 2014)

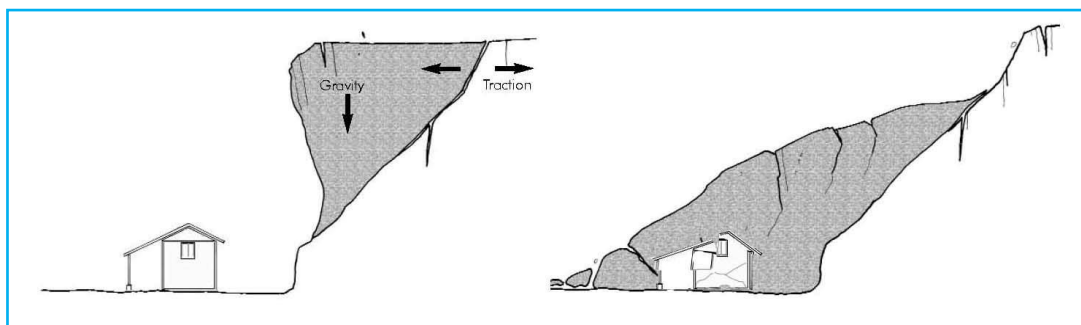
Landslides or rock fall areas should be avoided while selecting a site for building construction, figure 25. Apparently, some slopes may look stable, but failure could be triggered by an earthquake. Landslides and rock fall can damage buildings partially or completely. However, building in these areas can be constructed after providing proper retaining walls and green barriers. Simple indication of sustained stability of a slope is the presence of upright standing trees on it. Abnormally inclined trees on a slope indicate instability of the hill slope.

Figure 25. Building damage due to landslide or rock falling
Source: (Shah S. , 2014)

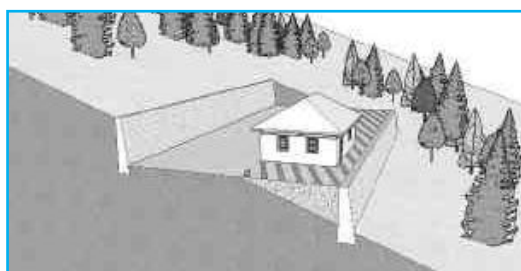
A house should not be constructed on loose fill or soil. In a filled ground, the bearing capacity of foundation subsoil is low, and settlement of foundation may occur, figure 26.

Figure 26. House in filled ground; Source: (Shah S. , 2014)

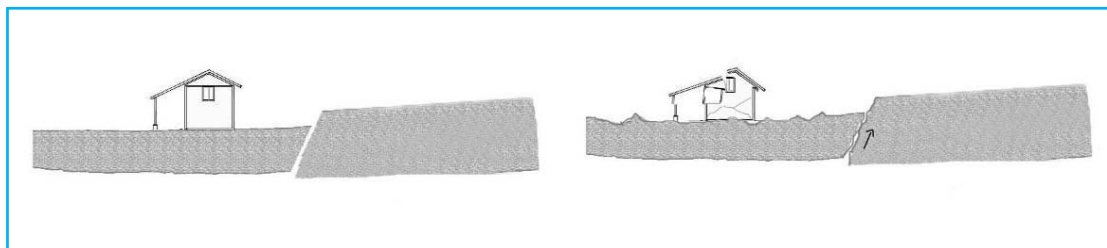
Geological fault and ruptured areas are usually visible, permanent, deep, and active. These are not suitable for the construction of a building, figure 28. A house may preferably be built at a distance of at least 250 m from such fault lines.

Figure 28. House near geological fault areas.

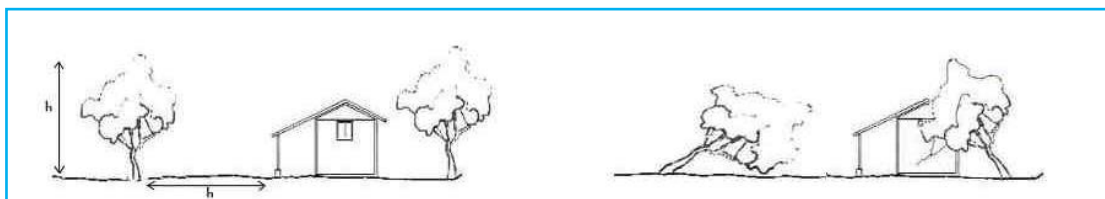
The forests are useful to stop landslides, but buildings should not be constructed close to any big tree, as there might be a possibility of falling of the trees during earthquake. The distance between tree and house should preferably be at least equal to the height of tree or house, whichever is greater, figure 29.

Figure 29. Distance of house from the tree

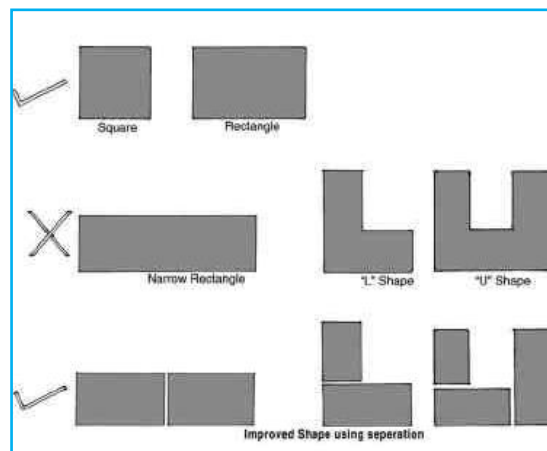
Figure 31. Building shapes
Source: (Shah S. , 2014)

Regular shaped buildings like square, rectangular, or circular resist the earthquakes more effectively as compared to irregular buildings and are therefore preferable in earthquake prone areas. During the earthquake movements the corners of nonuniform buildings are stressed more and may be damaged. Complex shaped buildings, shall therefore be made simple by providing gaps at appropriate locations. Some complex shapes and their simplified solutions are shown in figure 31.

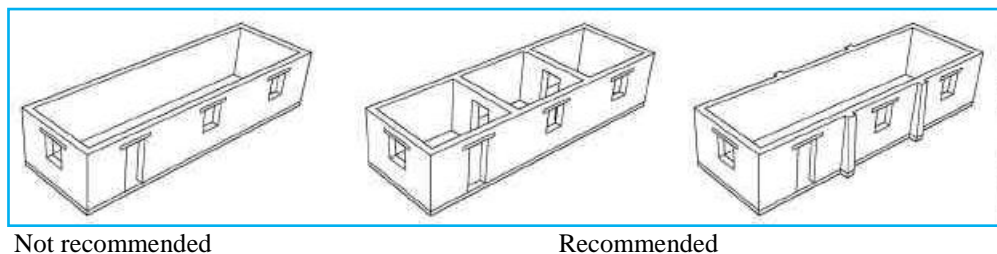
Figure 32. Short and long wall lengths
Source: (Shah S. , 2014)

In long and narrow buildings, longer wall is weak against earthquake forces and can easily fell during an earthquake. Therefore, if long and narrow buildings are constructed, they should be divided into two or more blocks with sufficient gap between them. The individual length of separate blocks should not exceed three times its width. The foundation of these blocks may be connected to each other and separation can be made only in the superstructure. The other alternatives include provision of cross walls and buttresses as shown in figure 32.

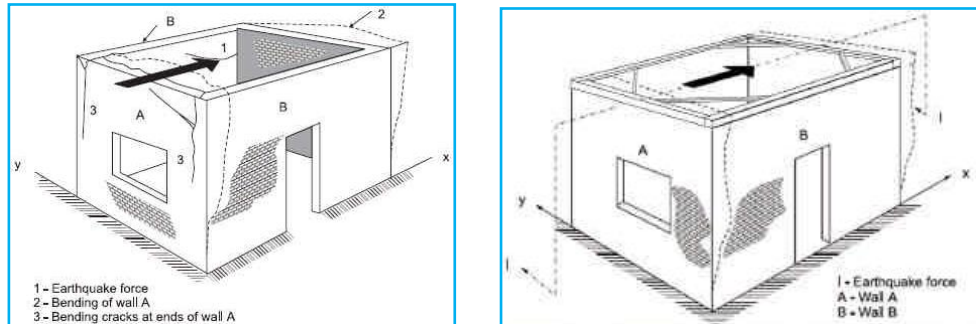
Figures 33(a) and 33(b). Box effect

One of the essential principles of earthquake-resistant construction is to use a compact, box type layout. Furthermore, all the components of the building such as walls, floor, and roof structure, should be well tied up with each other, so the building could act as a box during earthquake vibration. The

maximum length of wall between cross walls shall preferably be limited to 15 ft. (4.5 m) for an effective box action, figures 33(a) and 33(b)

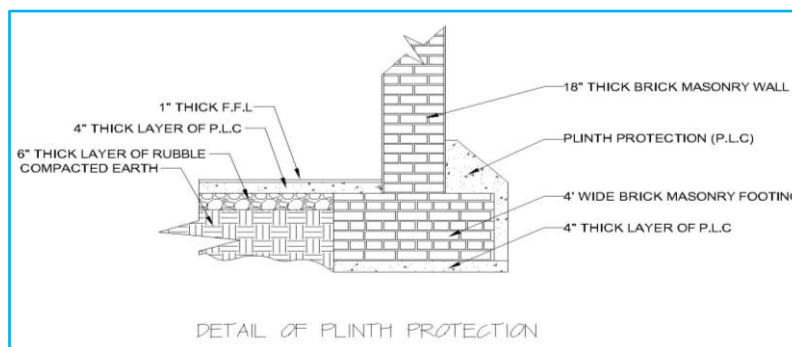
Figure 34. Detail of plinth protection

The plinth masonry should preferably be constructed using stone or burnt bricks laid in cement mortar. Cement mortar or lime mortar is stronger than mud mortar in binding the stones or bricks in the wall together to resist earthquake forces. The height of the plinth should be above the flood water line or a minimum of 1 ft. (30.4 cm) above ground level. Wherever possible the height of plinth shall not be more than 2.5 ft. (76.2 cm). Where higher plinths are required the thickness of walls below plinth shall be increased. A details of plinth protection is shown in the figure 34.
