# The LHC Main Magnet Electrical Interconnections:

the Subtle Size of Superconductivity

Lucio Rossi

**CERN**

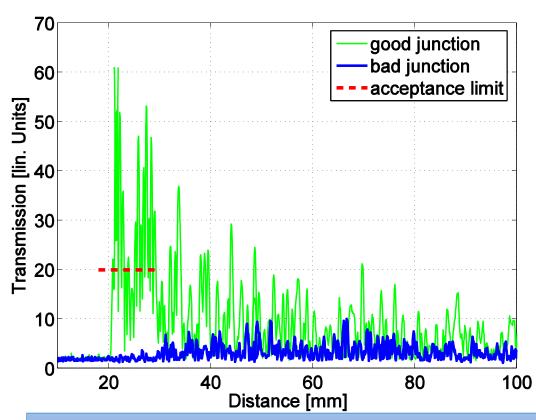
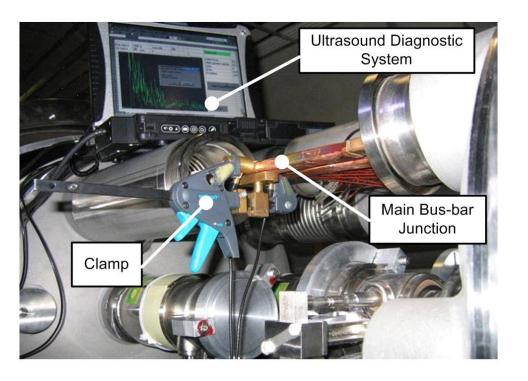
## An on-line QA: U.S. introduced very late- results not always clear

Used extensively only in last sector; one defect intercepted.

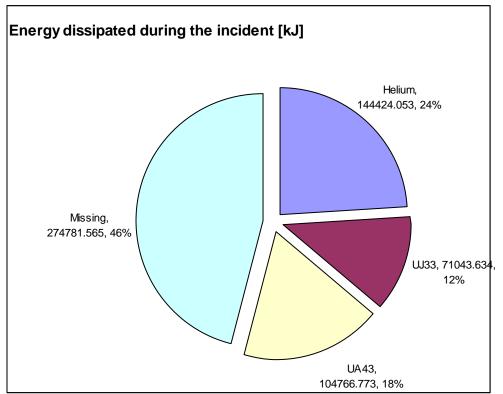
#### **Energy balance in dipole circuit**

Energy	MJ	%		
Stored in the magnets	595.0	100		
Dissipated in UJ33	71.0	12		
Dissipated in UA43	104.8	18		
Dissipated in cold mass	144.4	24		
Dissipated in electrical arcs	274.8	46

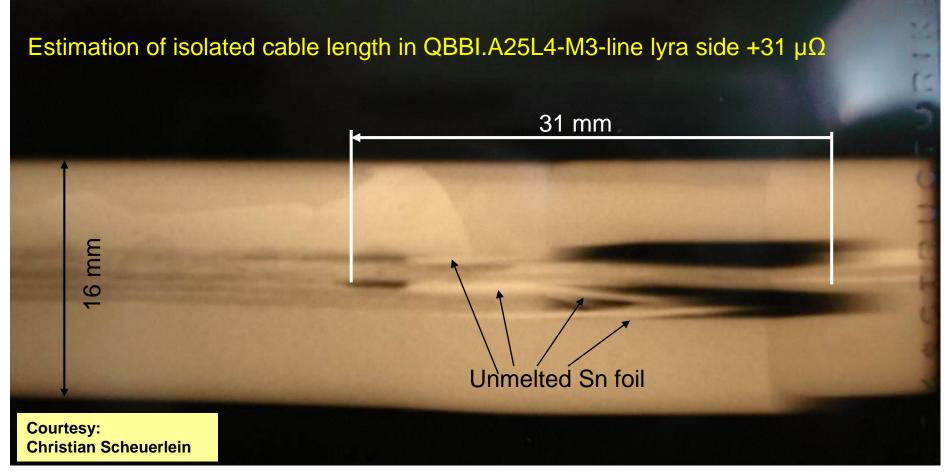
## This failure mode is more frequent for under- or overheating during melting

After the incident, simple Copper Stabilzing Resistance Measurement introduced: very effective. Most attention shifted from the  $n\Omega$  of SC splice to Cu  $\mu\Omega$

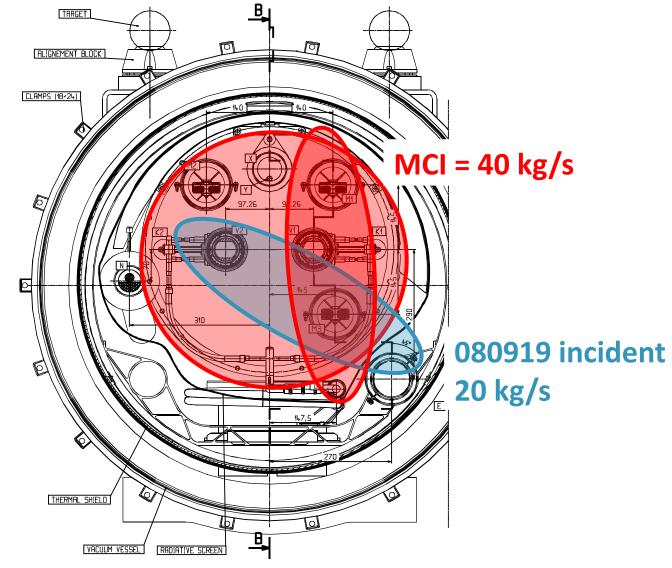
### Revision of MCI for electrical arc

Before the incident the MCI was set at 2kg/s of LH2 flowing into the vacuum vessel.

- Incident: peak at 20 kg/s
- New MCI: 40 kg/s

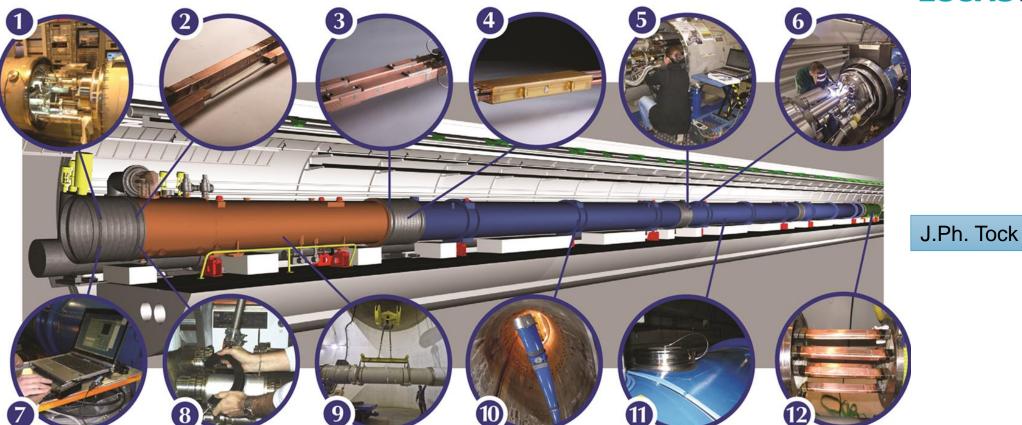
Improvement in QPS and we could measure all Continuity Copper Stabilizer at 20 K: elimination of silent killer!
