EUCAS 2017 3L04-04
20/Sep. /2017

Protection against the ground fault for 275 kV HTS cable and experiment

T. Takagi, M. Yagi, H. Fukushima, S. Mukoyama
(Furukawa Electric)

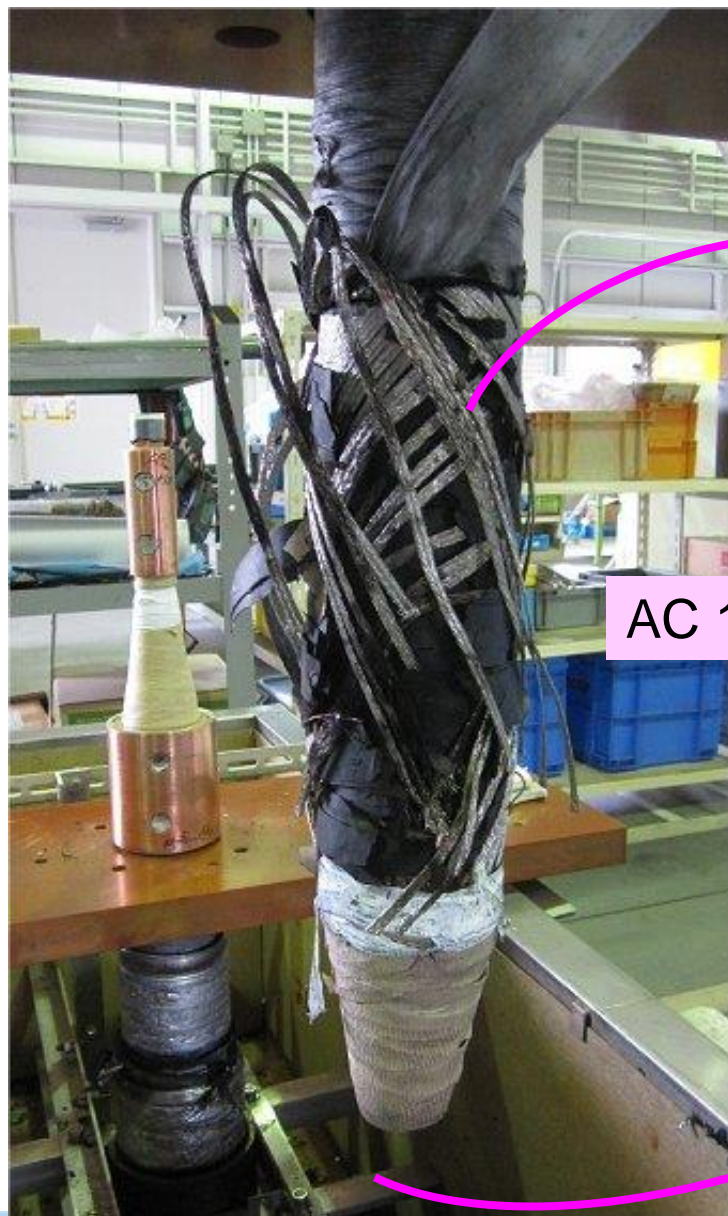
Results (w/o protection)

Core

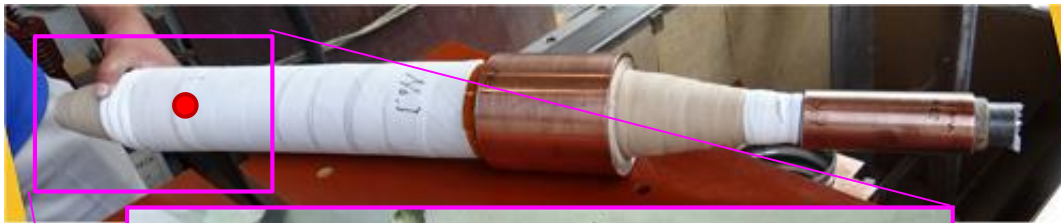
Effect of protections

The protection on the core was severely damaged, as well as the core itself.

The protection on the inner pipe was damaged thermally, in spite of its outer soundness. (common to sample A and B)
