## MQXS inner layer quench heaters

S. Izquierdo Bermudez, J. Ferradas Troitino, P. Ferracin, J. C. Perez, F-O. Pincot, G. Vallone, S. Florence Gayot, S. Tavares, G. Maury, N. Bourcey

# Our problem – MQXFS3

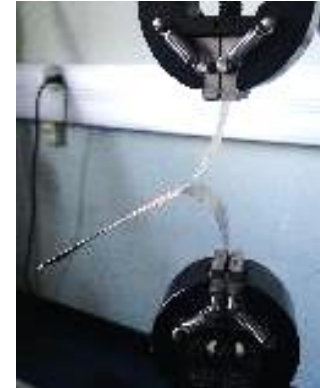
SAMPLE TYPE	TEST	LOAD (N)	ASPECT AFTER TEST	COMMENT
Metal/ impregnated fibre	90°	~ 0

<b>VERY GOOD ADHESION</b> between polyimide from trace and impregnated Hexcel fibre → Polyimide ripped before being peeled off !

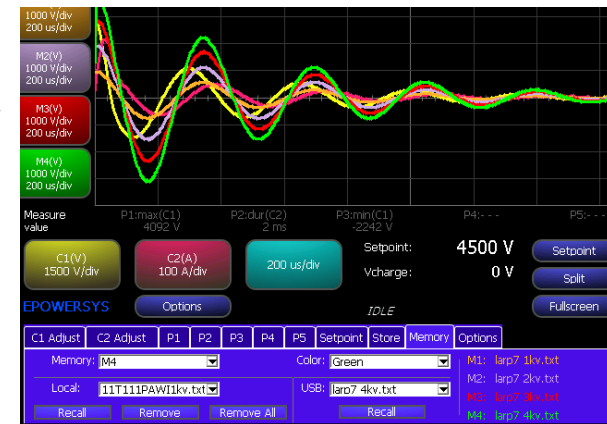
QHs-Endshoe NCS Brd @ 3kV

- Coil discharge test : Pb @ 4.5kV
