Study of delamination between inner layer trace and inner impregnation layer after quench training of MQXFS coils

EDMS n° 1842073

May-Aug 2017

TE-MSC-MDT

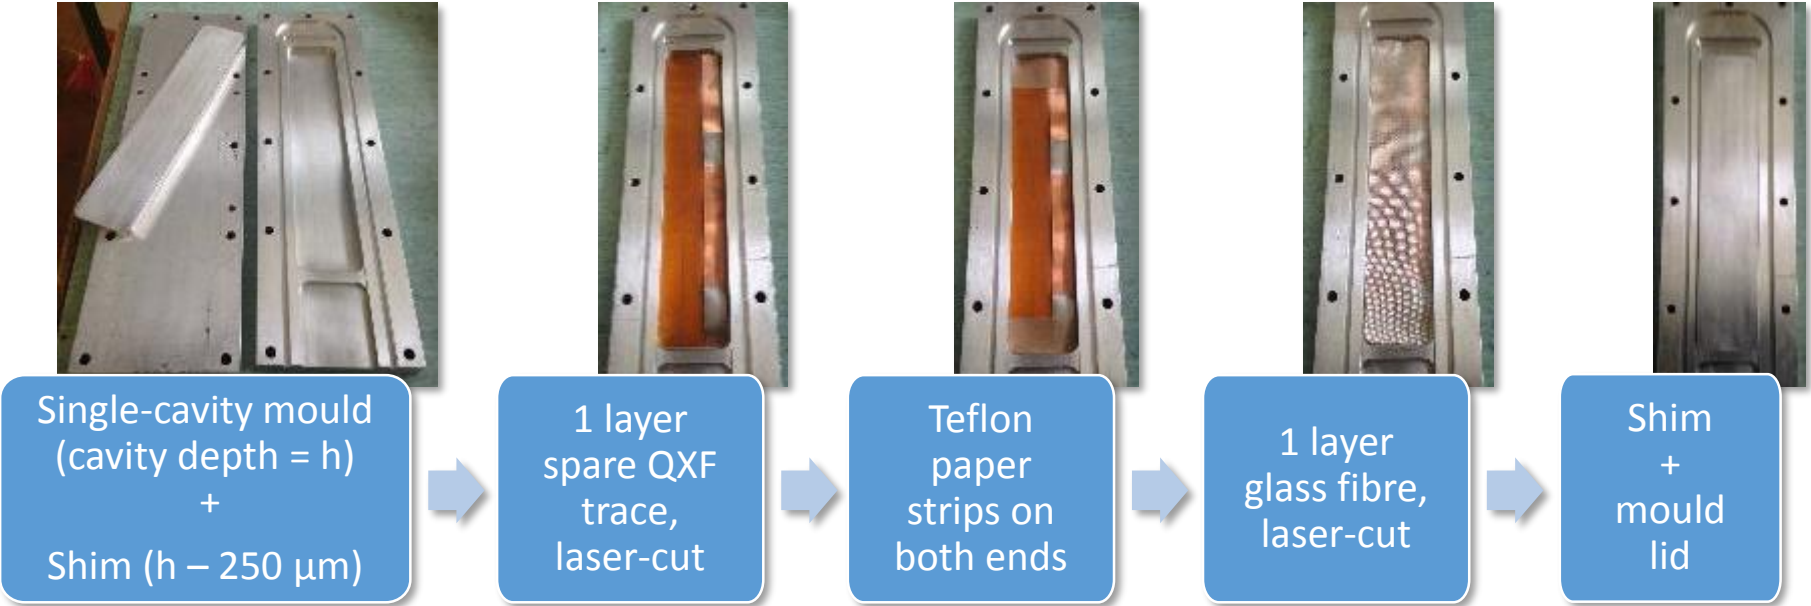
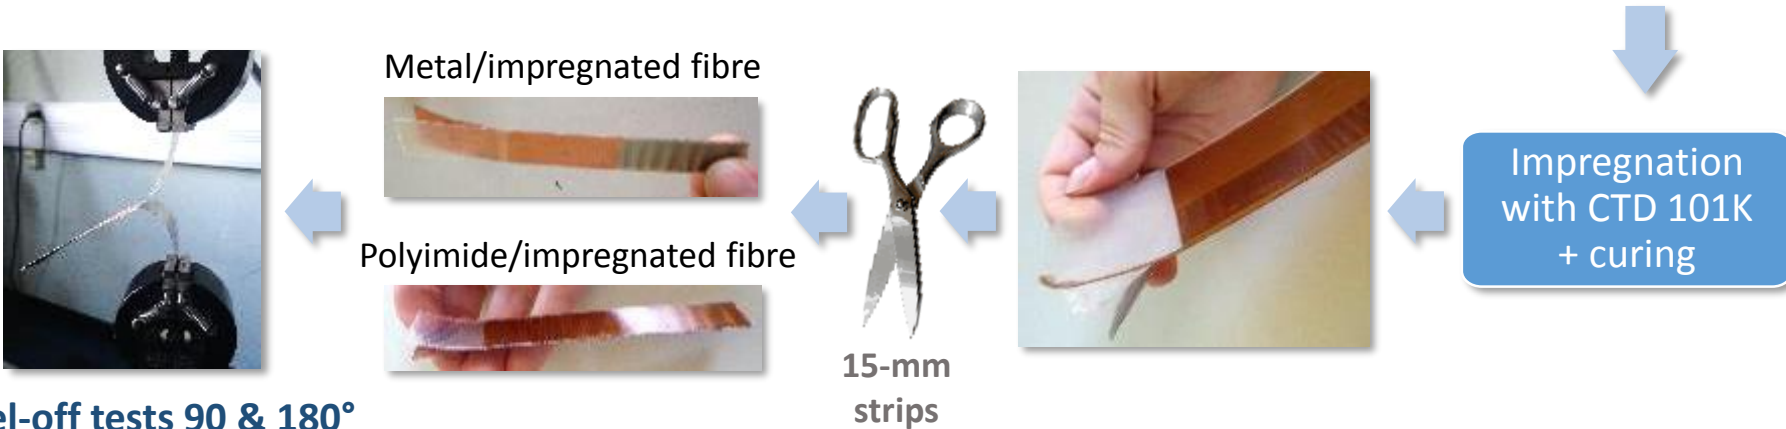
PRINCIPLE OF PEELING TESTS

Peel-off tests 90 & 180°
 UTS tensile machine
 1KN load, 7mm/min

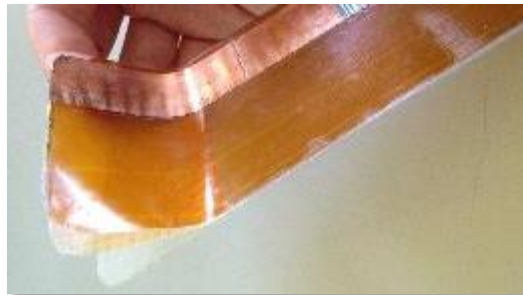
- needs to perform 3rd test
 - Simulation of encapsulated fibre:
Hexcel 4522 fibre + REVERSED trace

- Encapsulating the trace between two polyimide sheets

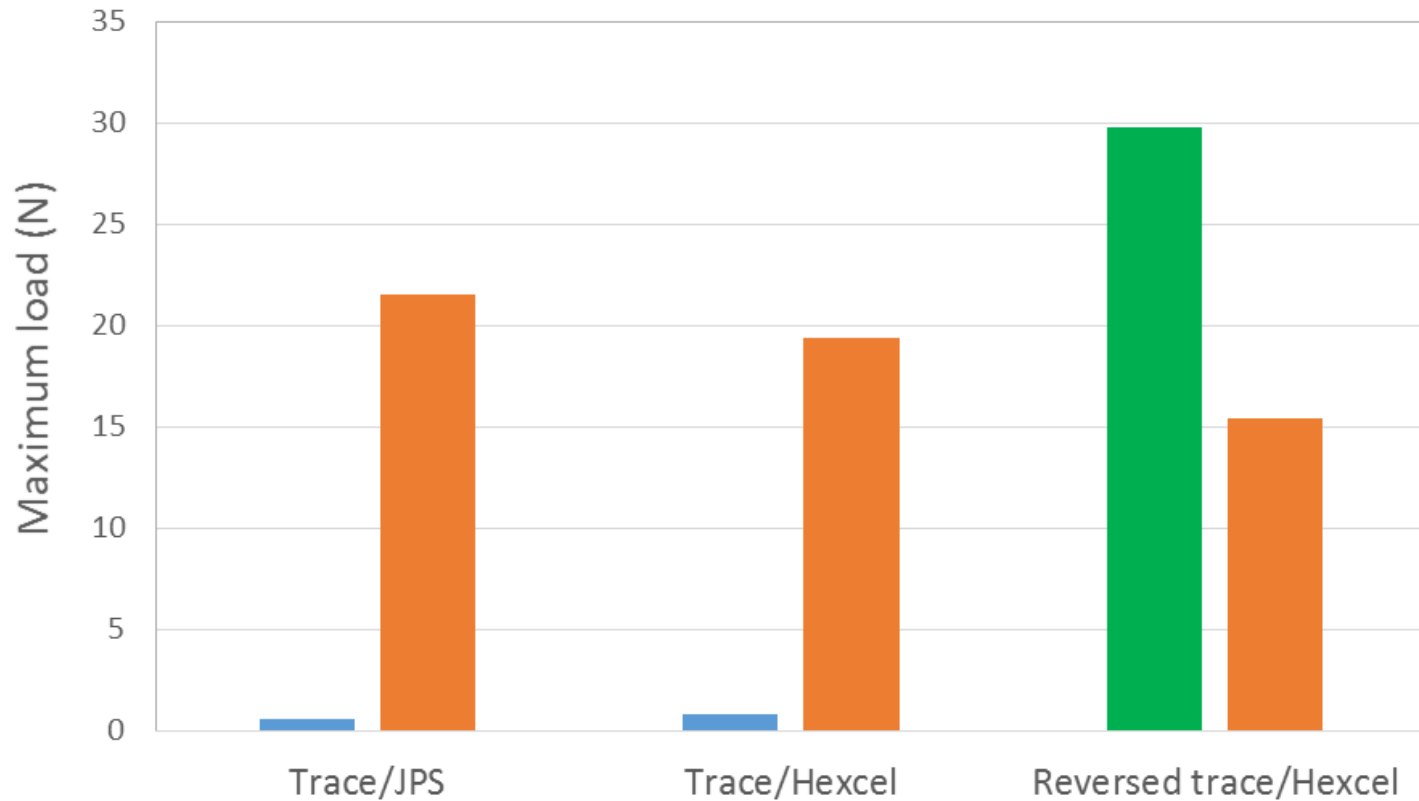
SUMMARY OF RESULTS FROM TESTS 1,2 & 3

■ Metal / impregnated fibre ■ Polyimide / impregnated fibre ■ Simulation of encapsulated metal / impregnated fibre
