3x1x1 operations: Problems found and possible explanations

Laura Manenti & Laura Molina Bueno

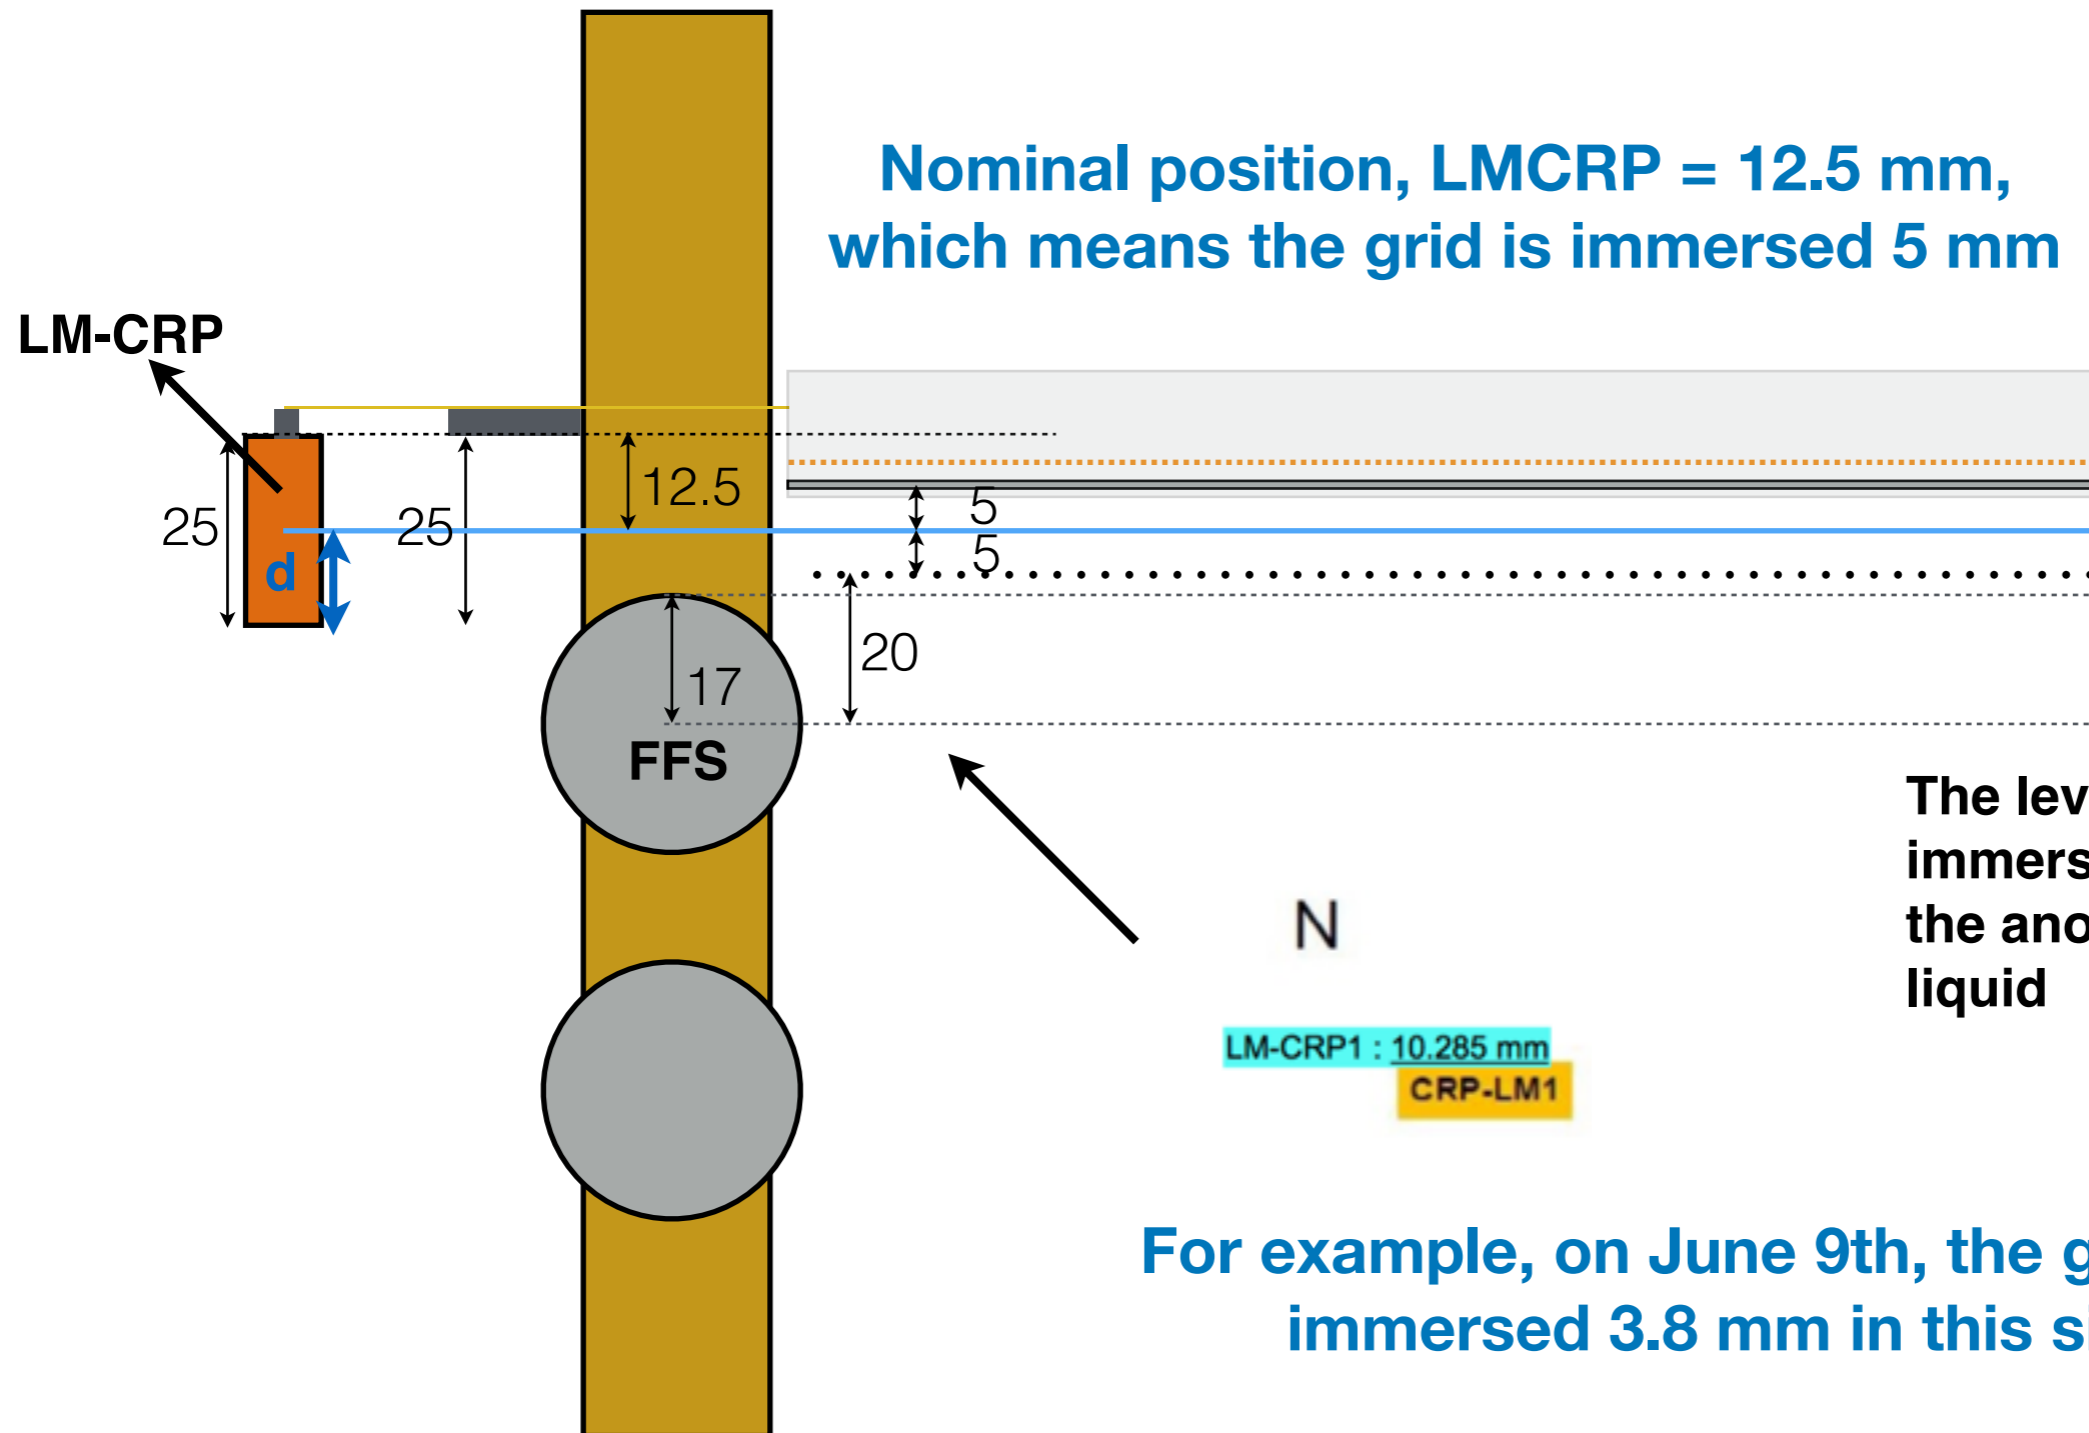
Is the grid completely immersed along the whole CRP?

The level meter is completely immersed when the LEM and the anode are immersed in liquid

For example, on June 9th, the grid was immersed 3.8 mm in this side

The maximum voltage reachable on the grid depends on the liquid level.

We need to have at least 5 mm of liquid above the grid to reach voltages larger than 4 kV.

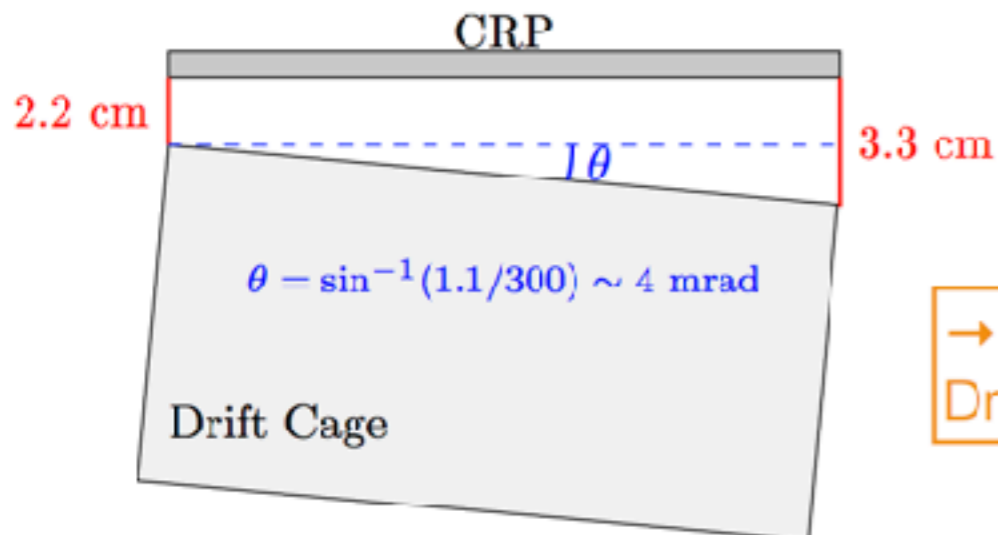
Considering tilt N-S axis only.
Tilt on E-W axis negligible.

→ Now CRP is aligned with the liquid
Drift cage and CRP have a relative tilt of 4 mrad

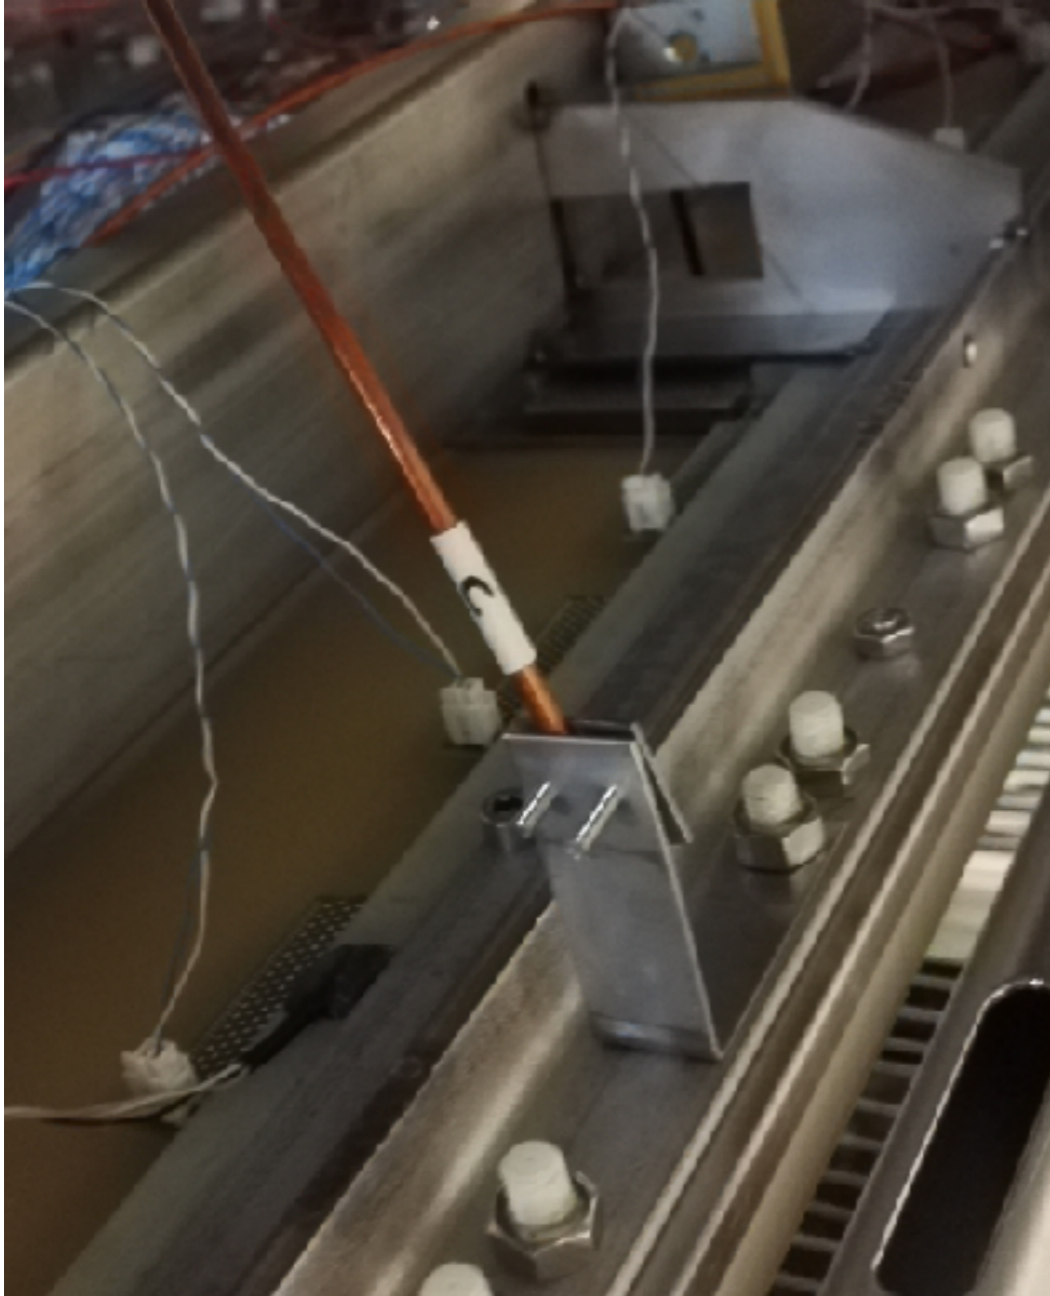
The grid tripped ramping up to 4,8kV Tripped between 3,8 and 4kV corner Manhole

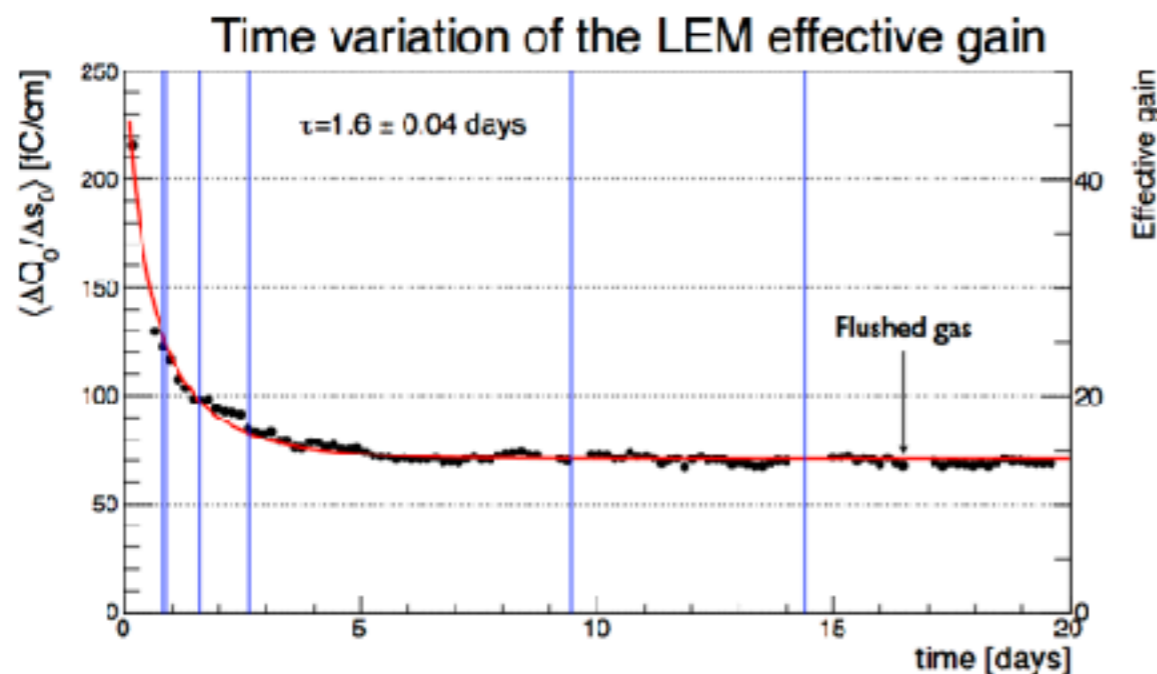
LEM 1,3,10, 12 at lower field

- LEM 28kV/cm
- Extraction field in liquid ~1.9 kV/cm
- Drift 500V/cm
- PMT trigger

In the 3L, a time evolution of the LEM gain was measured with $\tau = 1.6$ days (at 30 kV/cm)

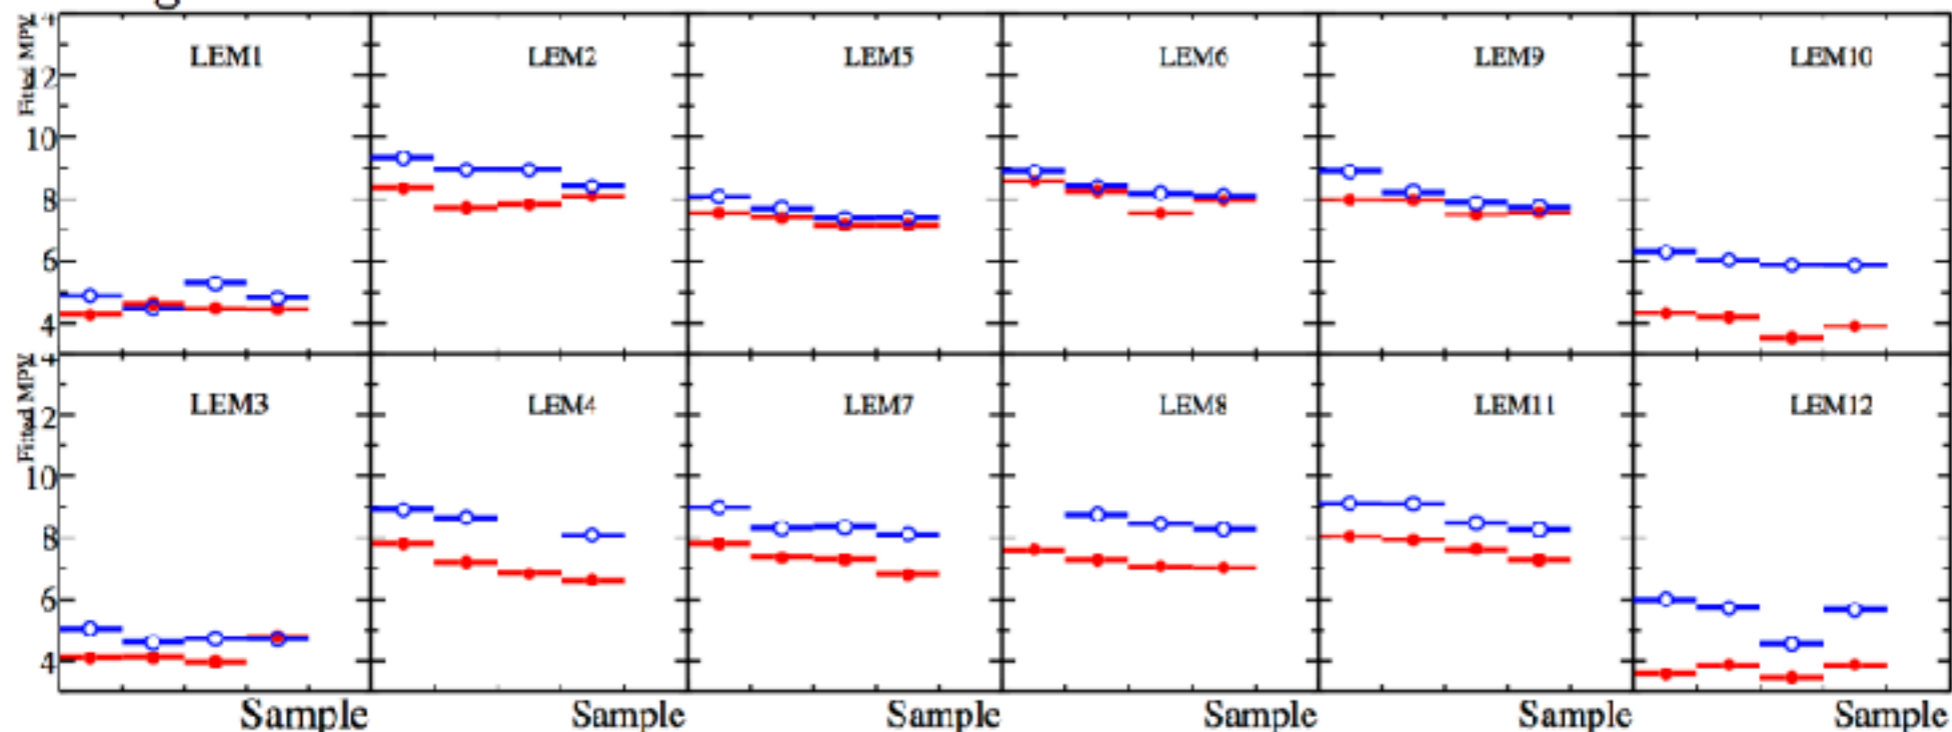
Using MPV fit

A decrease of measured dQ/ds as a function of time can be seen

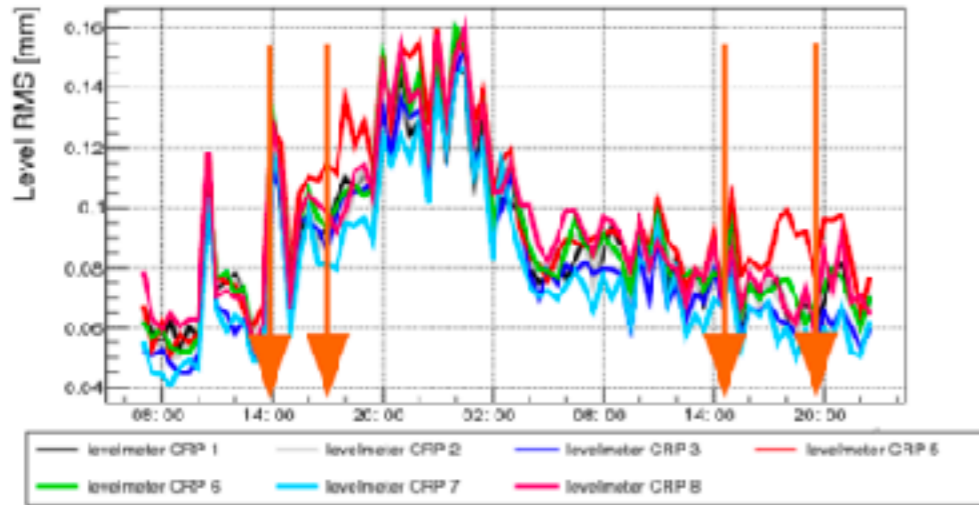
12 → 13.07.2017

3. No obvious correlation between trips and short-time variations of the level, as soon as the grid is immersed.

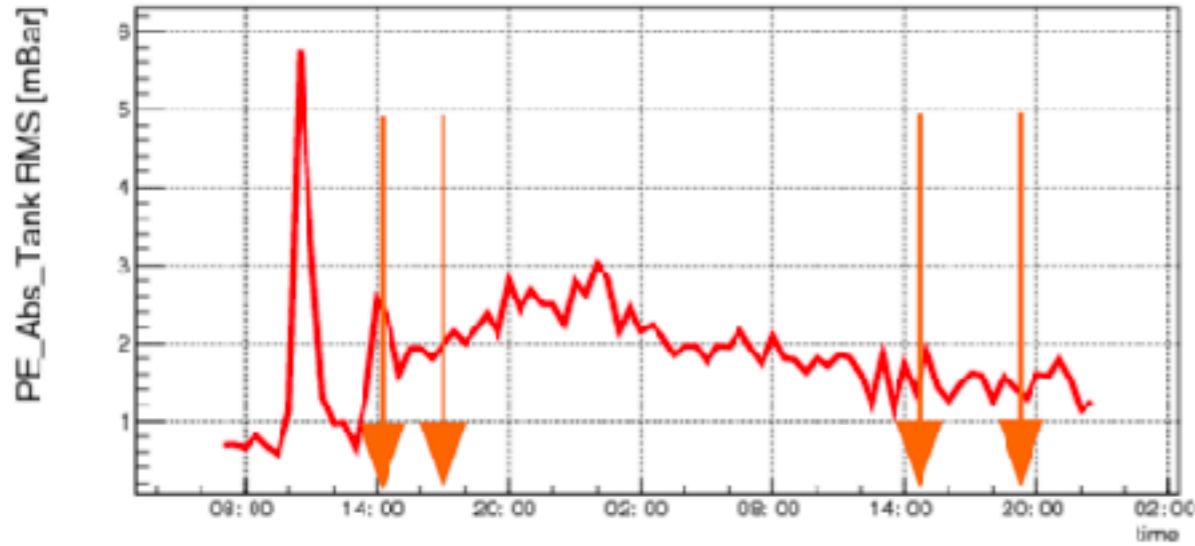
12 → 13.07.2017

2) LAr level and pressure variations

We identify liquid level variations due to instabilities in the cryogenic system

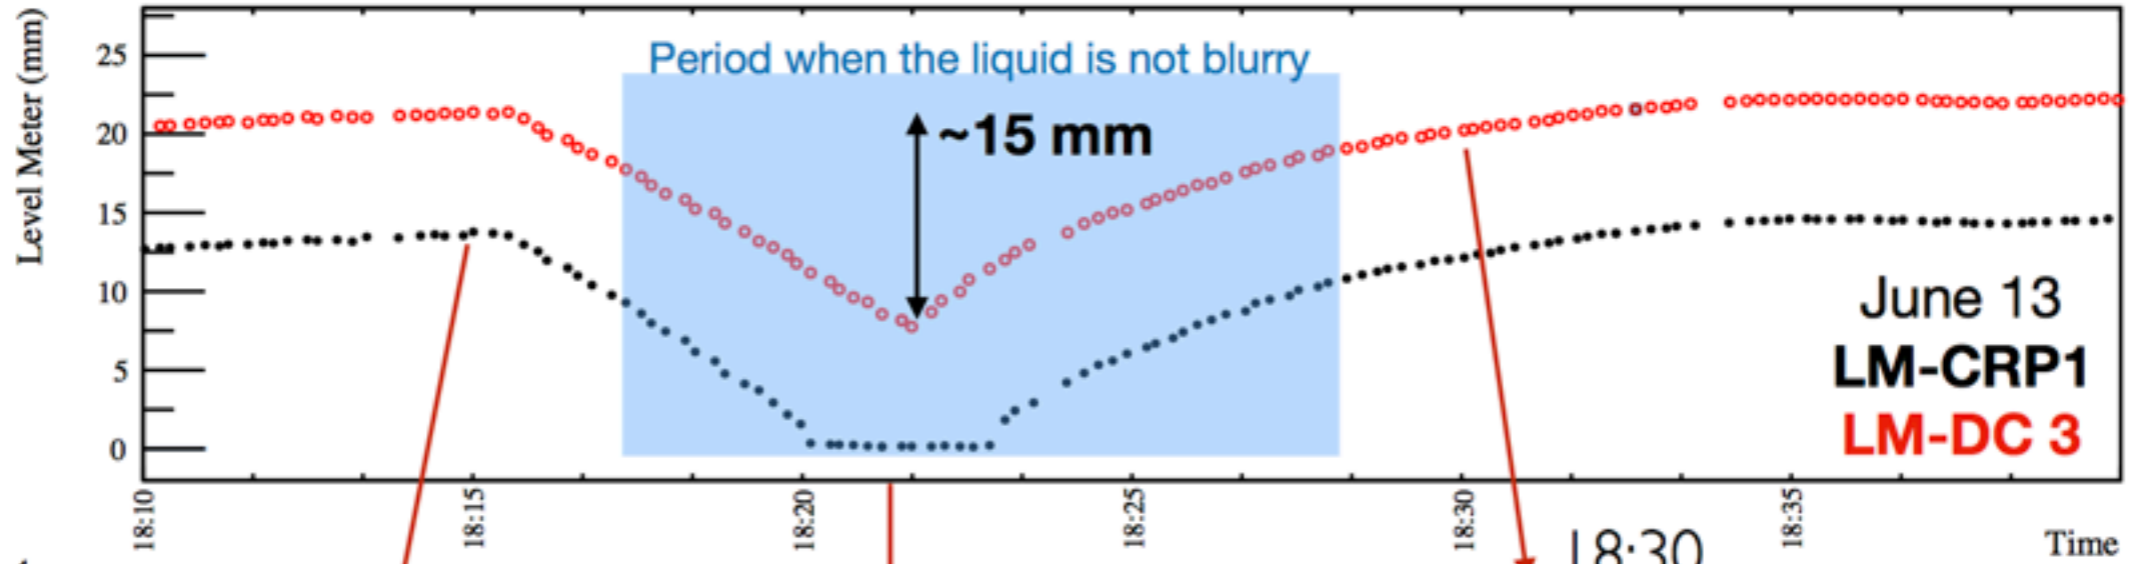
Liquid level during issues with the cryogenic system regulation

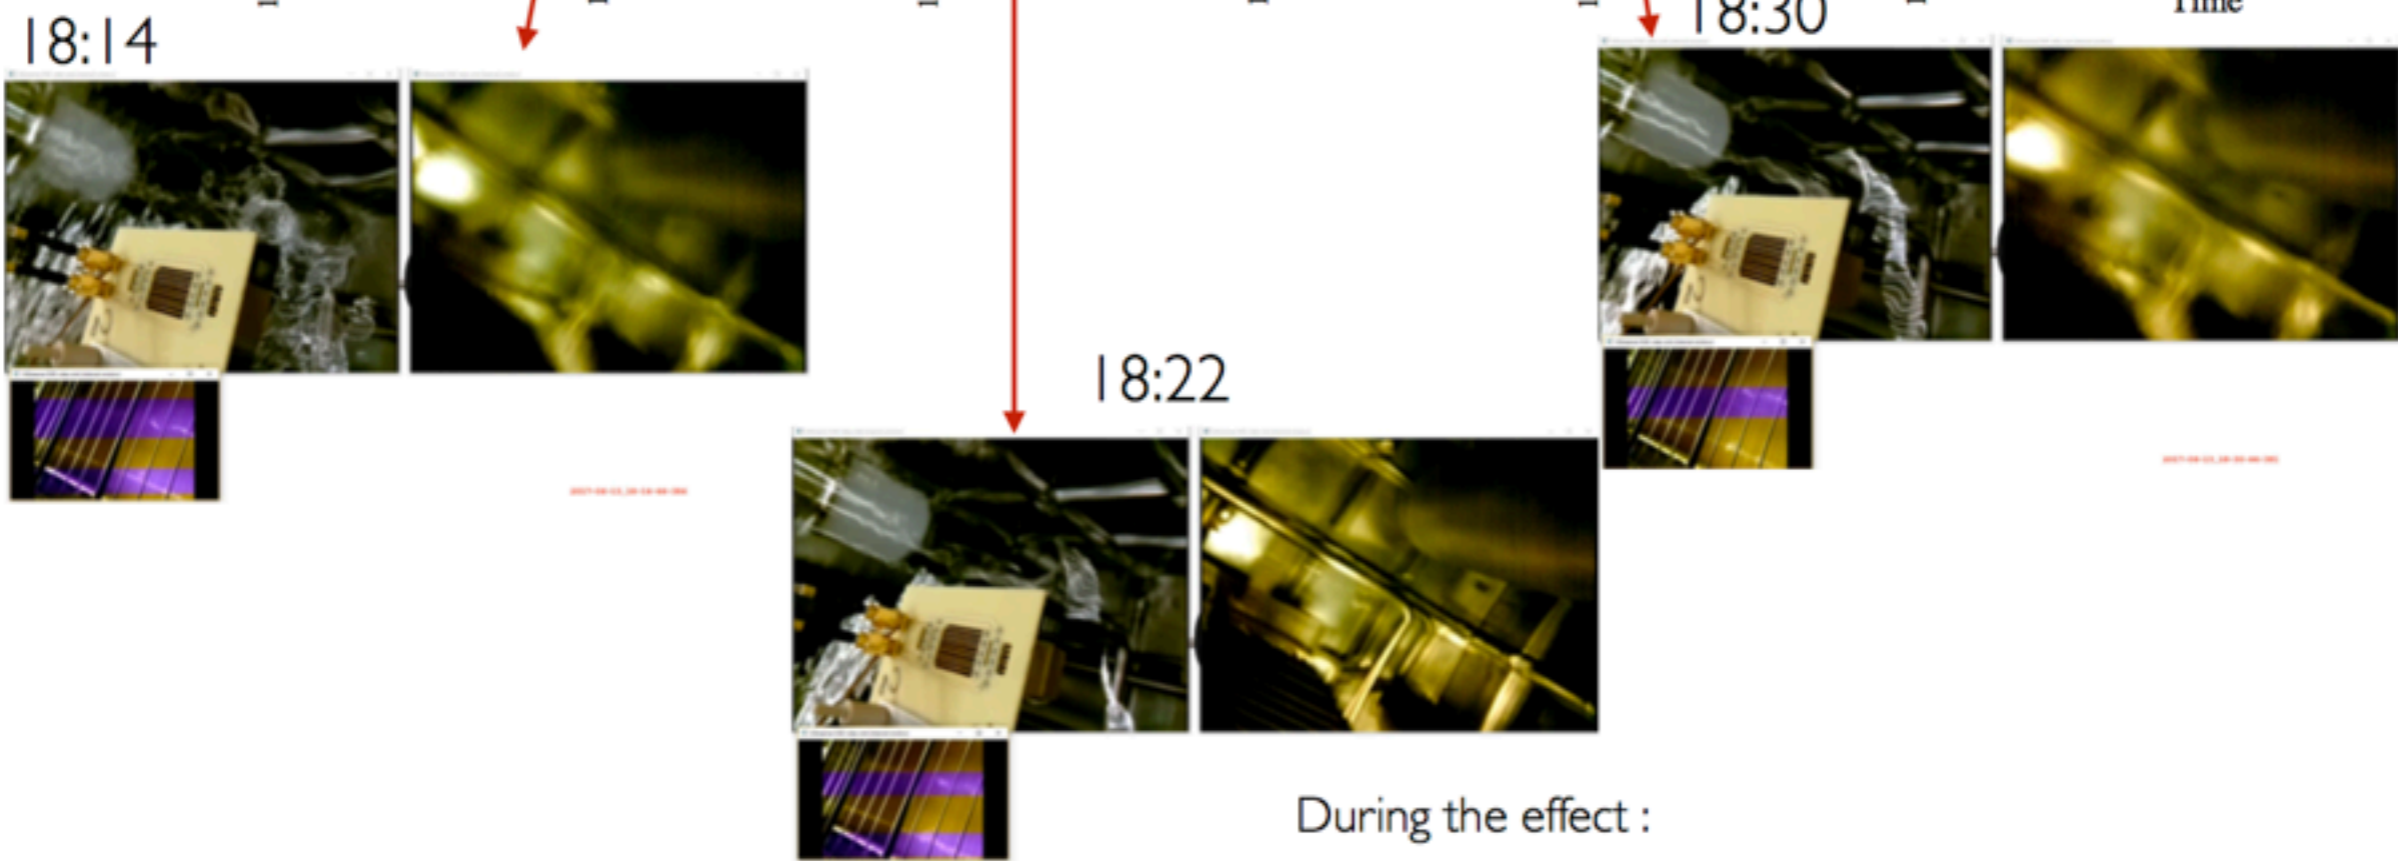
June 13
LM-CRP1
LM-DC 3

During the effect :
• HVFT seems to be moving → optical effect

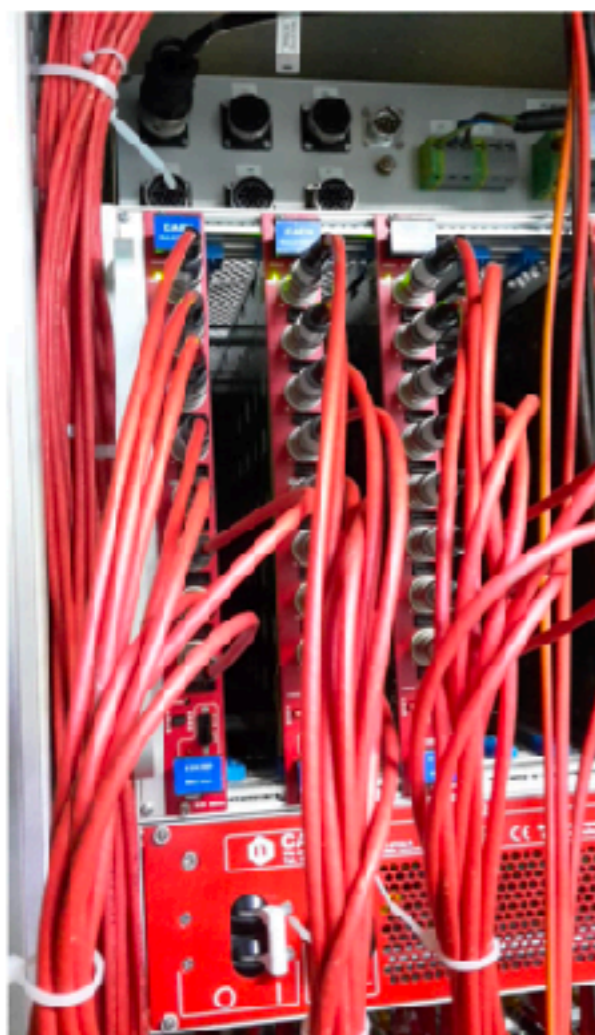
CAEN power supply:

- **June-August:** internal leakage current of the power supply units is increasing on average and has a clear dependency on external temperature. The flow of air in the mainframe is not homogeneous hence we observe a variation of the temperature dependency within different boards: board located on a outer slot of the mainframe suffers more than inner ones.

- When the CAEN boards for the LEM were installed, the group from Kiev tested them and observed a non-zero current in several LEMs: **LEM 3 down, LEM 4 down, LEM 6 down, LEM 8 up, LEM 12 down.**
- During the HV tests in June and July this current was again observed, both during ongoing tests and when everything was disconnected. More LEMs showed a non-zero current compared to the tests by Kiev group.
- For periods with no tests, the current was identified as a non-constant offset of the CAEN power supply.

- **August 23rd 2017:** board 0, 2 and 4 are now fully working, they have been re-calibrated by CAEN Team so we can monitor the evolution of leakage current over time/temperature - better to do now so that we can check evolution over next night and let them know in case. board 11 (the one showing Ext-DIs faulty channel) has been taken for repair and CAEN will let us know by tomorrow - maybe they can repair it here. Board 12 (with Radial connector output) now is a spare but since this is fully connected to DB we can also monitor that too

- **August 24th 2017:** board 11 for repair since yesterday is now installed back in the mainframe. all channels were calibrated by CAEN (offset null for current at $V_{set}=0$). All channels are now floating (no cables connected) and under test to monitor the evolution of residual leakage current. CAEN suggested to do those tests with a not null voltage, so now 50 V are set on each channel.

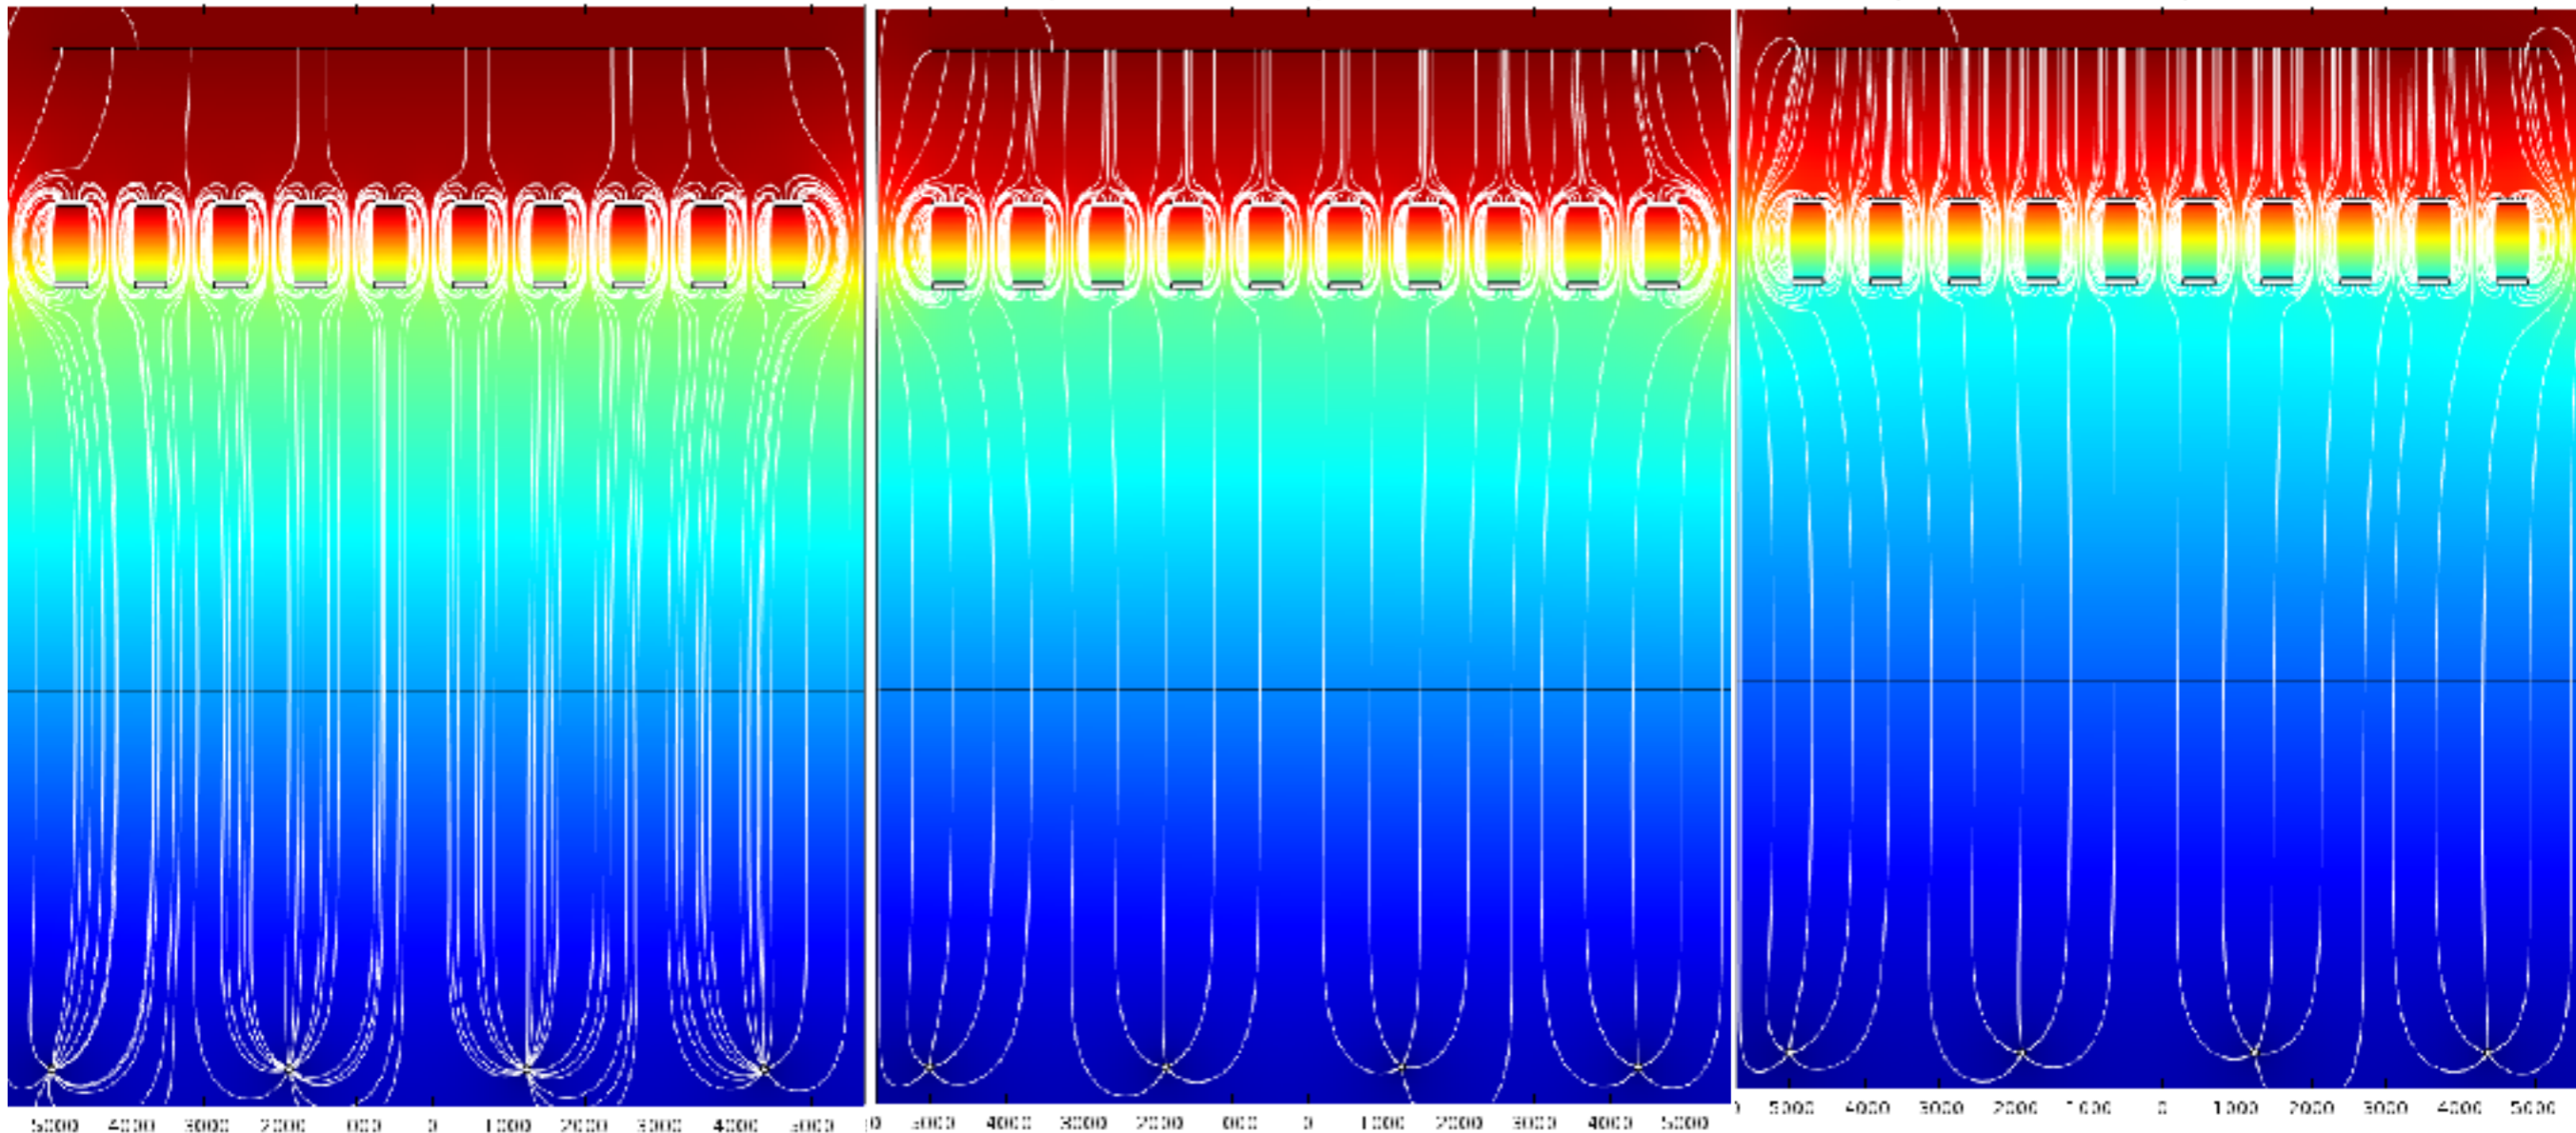
Grid at the nominal voltage, 6.5 kV and amplification of 30kV/cm

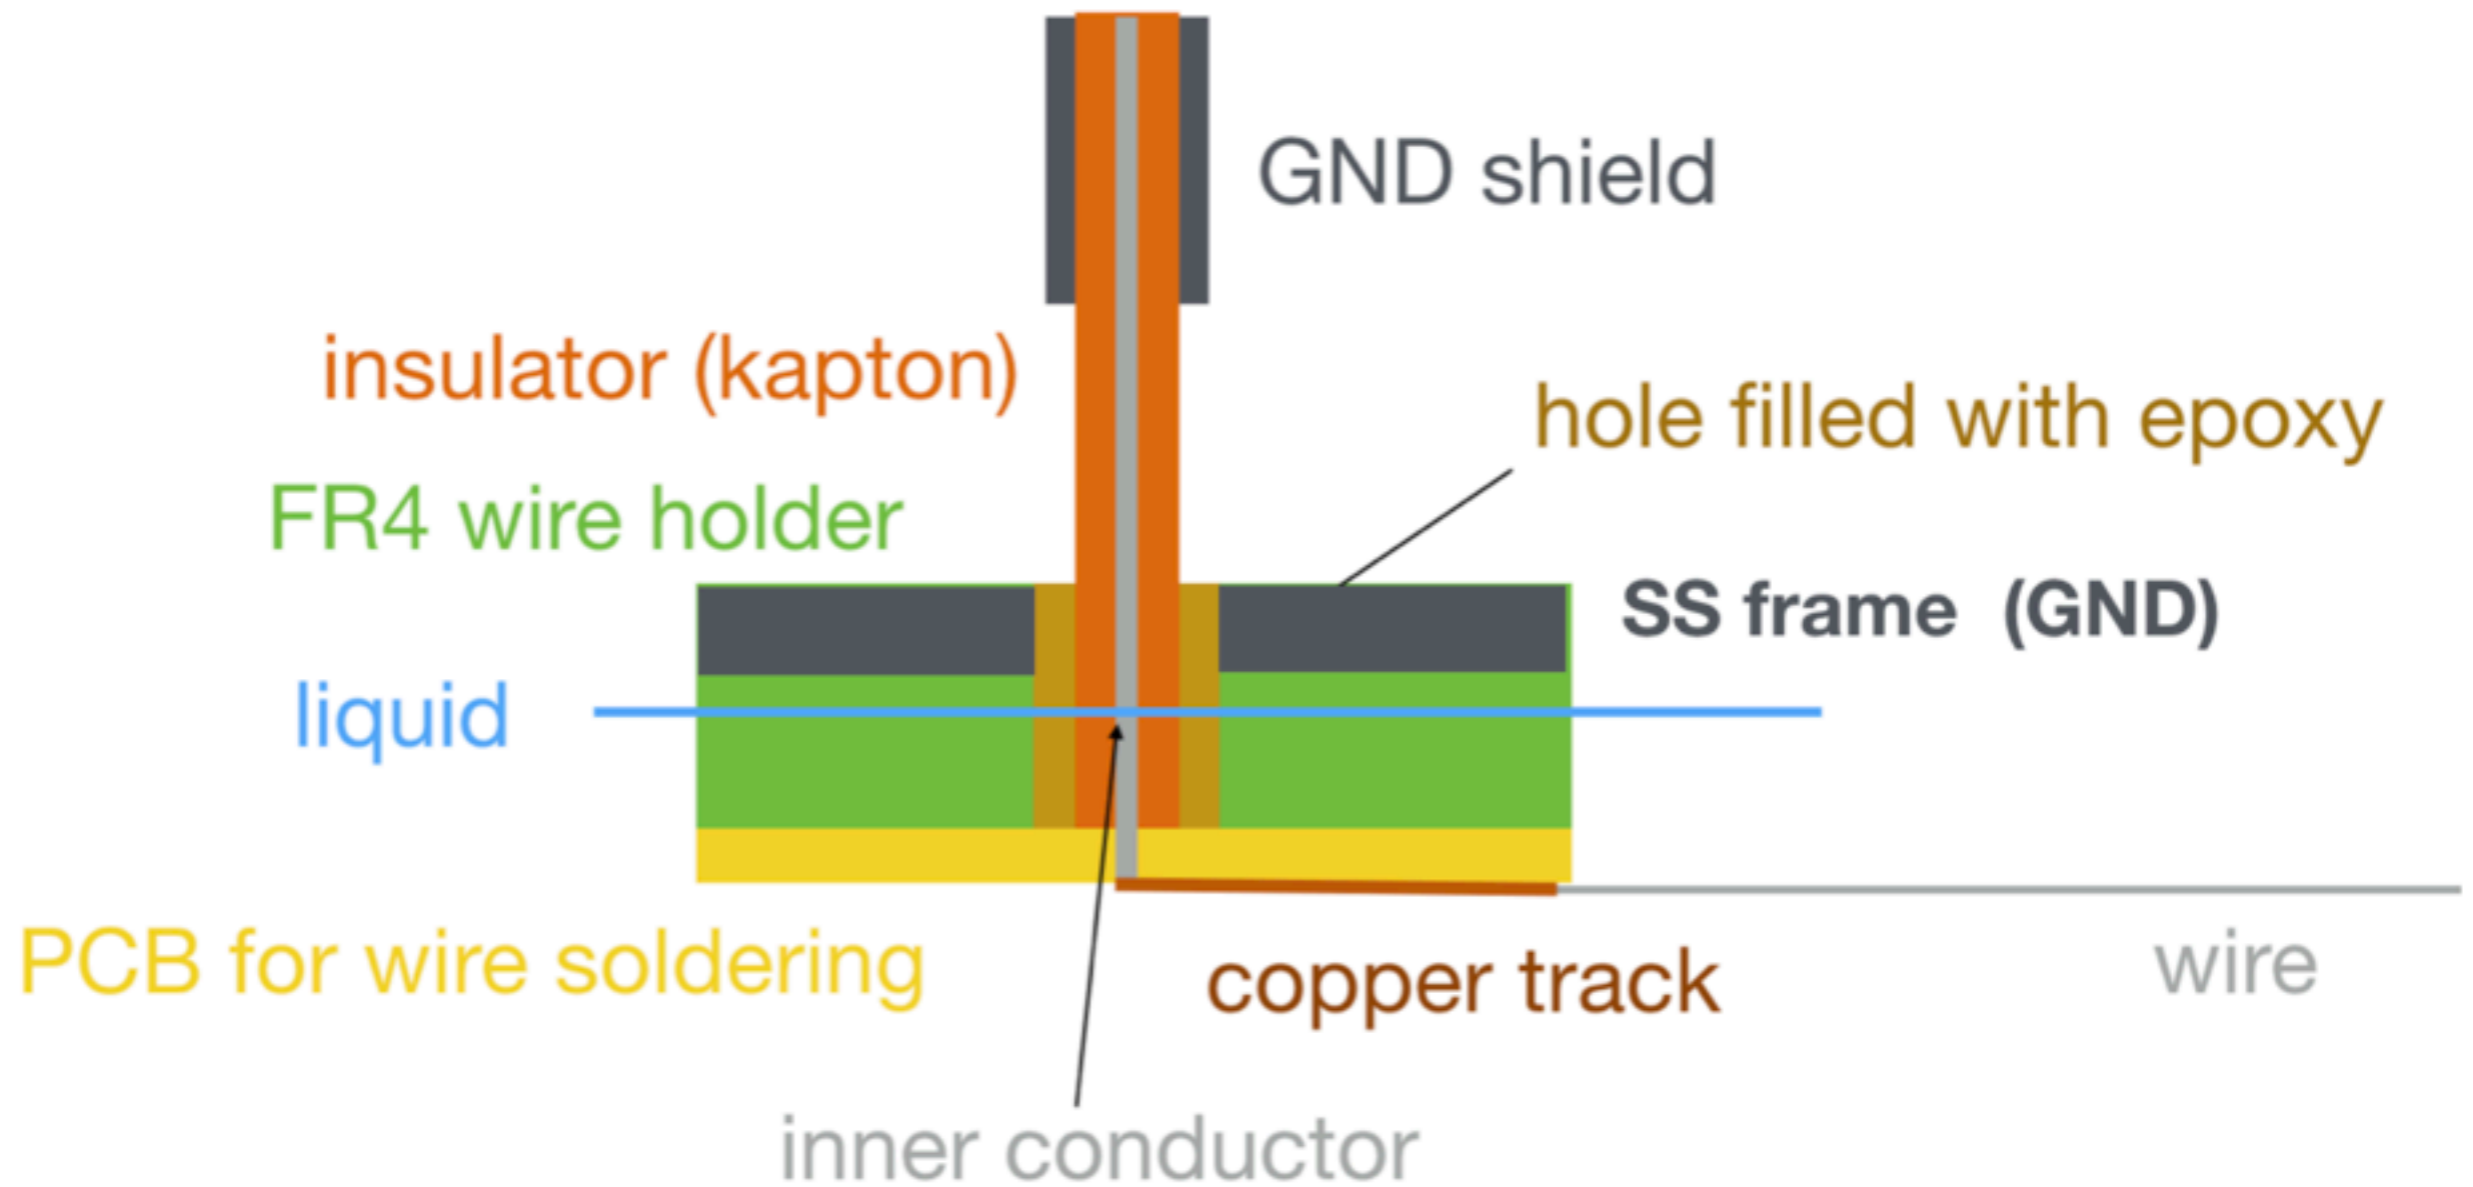
The grid tripped ramping up to 4,8kV Tripped between 3,8 and 4kV corner

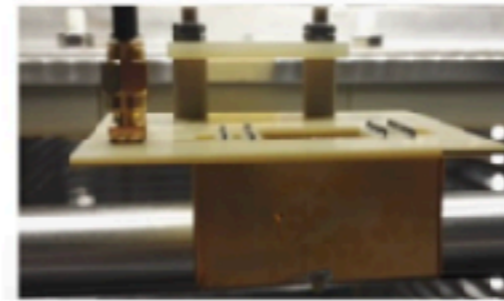
Level Meters

Not working 2 chan

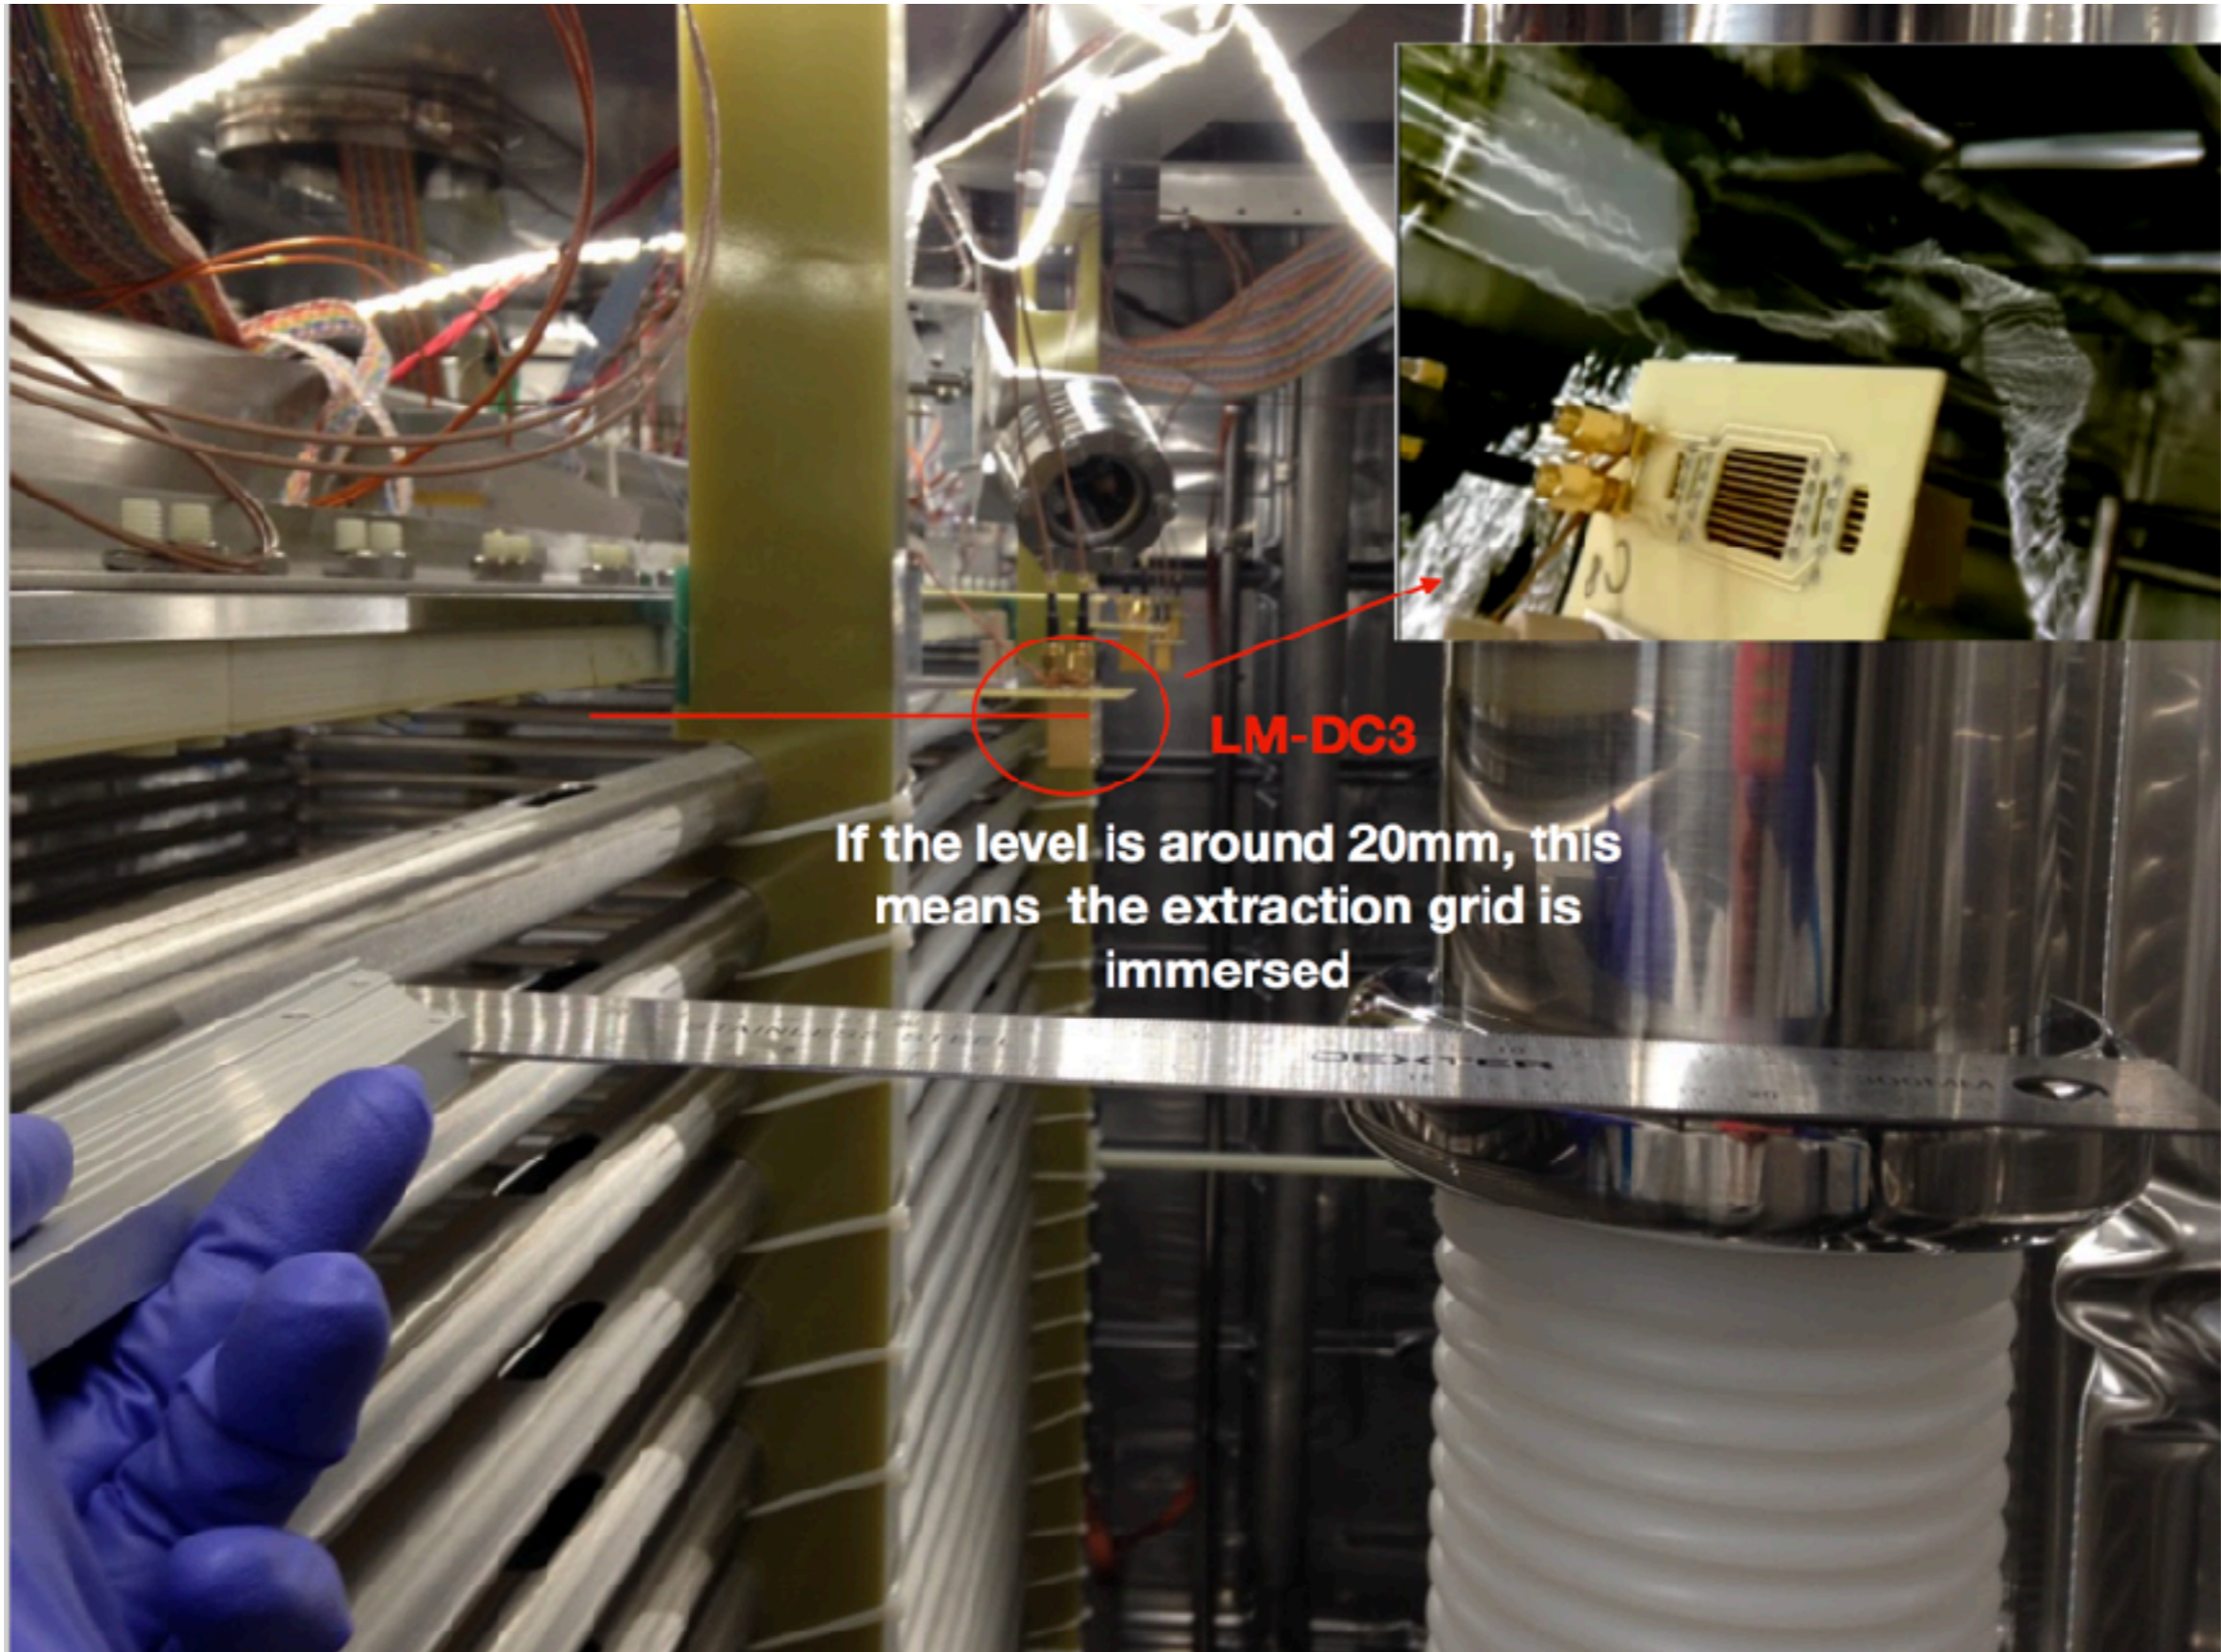
LM drift cage

At least all LM along drift cage need to be immersed more than ~5 mm to guarantee that the FFS is completely immersed
