3x1x1 operations: Problems found and possible explanations

Laura Manenti & Laura Molina Bueno

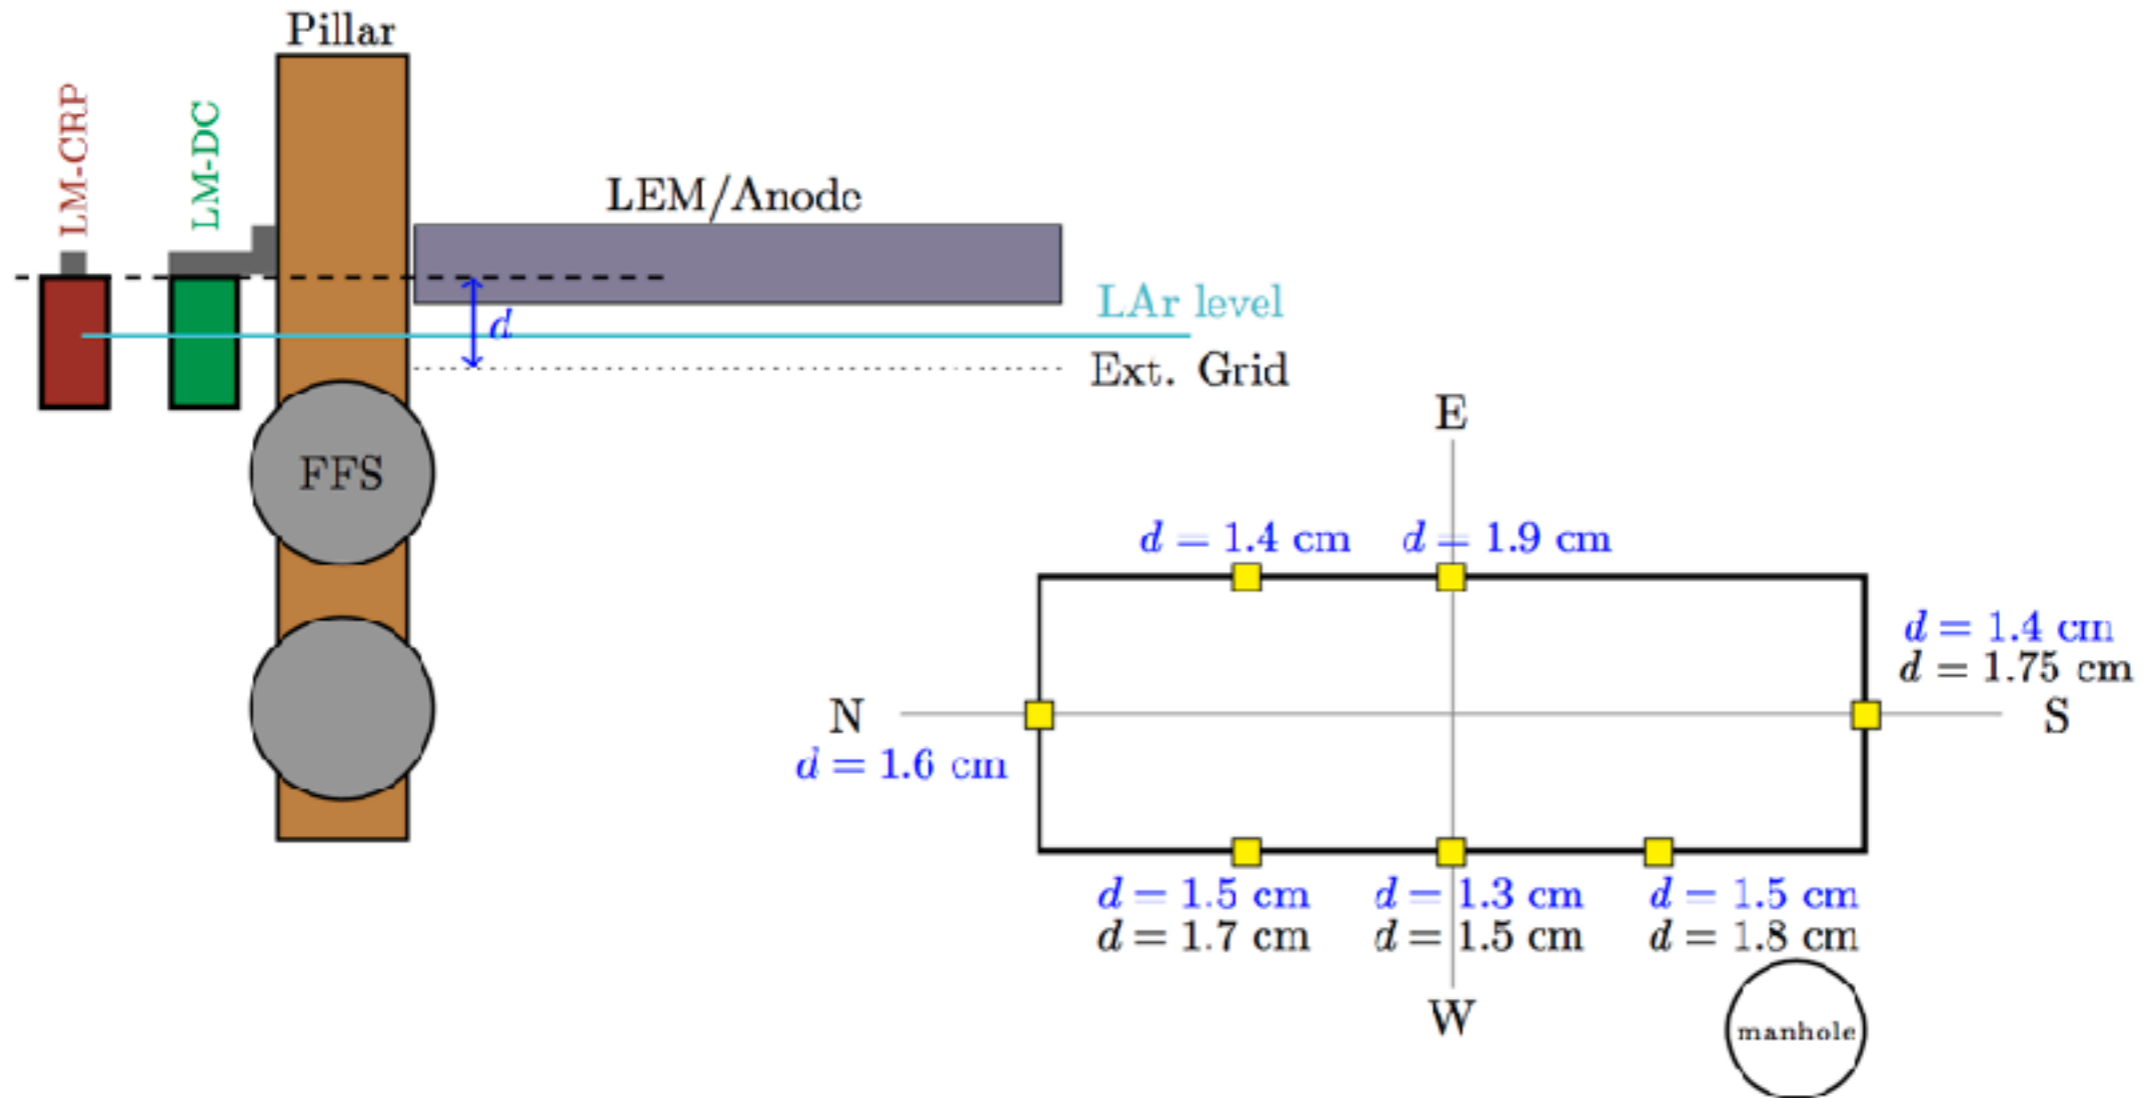
CRP at its highest point.
All d should be = **1.75 cm**.
Within measurement uncertainty,
all LM are aligned with the CRP

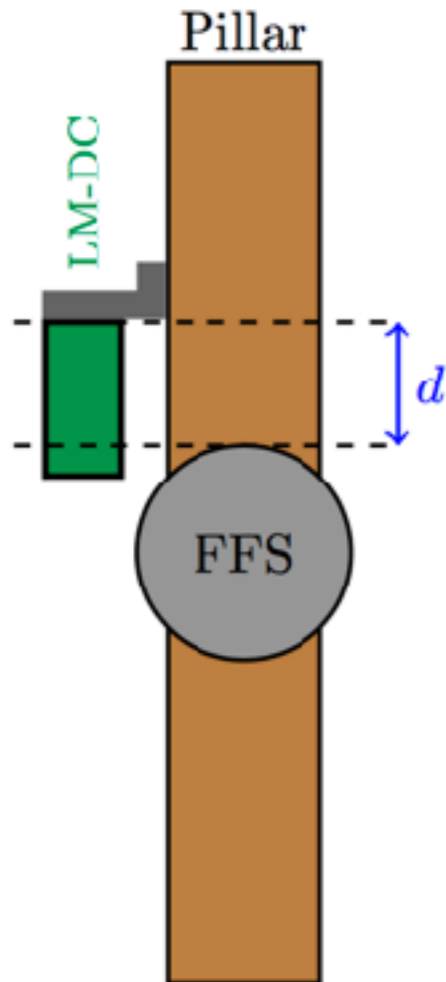
Distance FFS (top tube) to top LM-DC (Level Sensor Drift Cage) - Measurement C -

All d should be = **2.05 cm** (i.e. LM-DC aligned with DC).
They are not. Also DC is tilted (as seen before).
Because of misalignment and tilt :
⇒ **sensor on the N side [LM-DC1] is the highest**
⇒ **sensor on the S side [LM-DC4] is the lowest**
↳ cf elog#219, LM-DC4 was the first one to see LAr

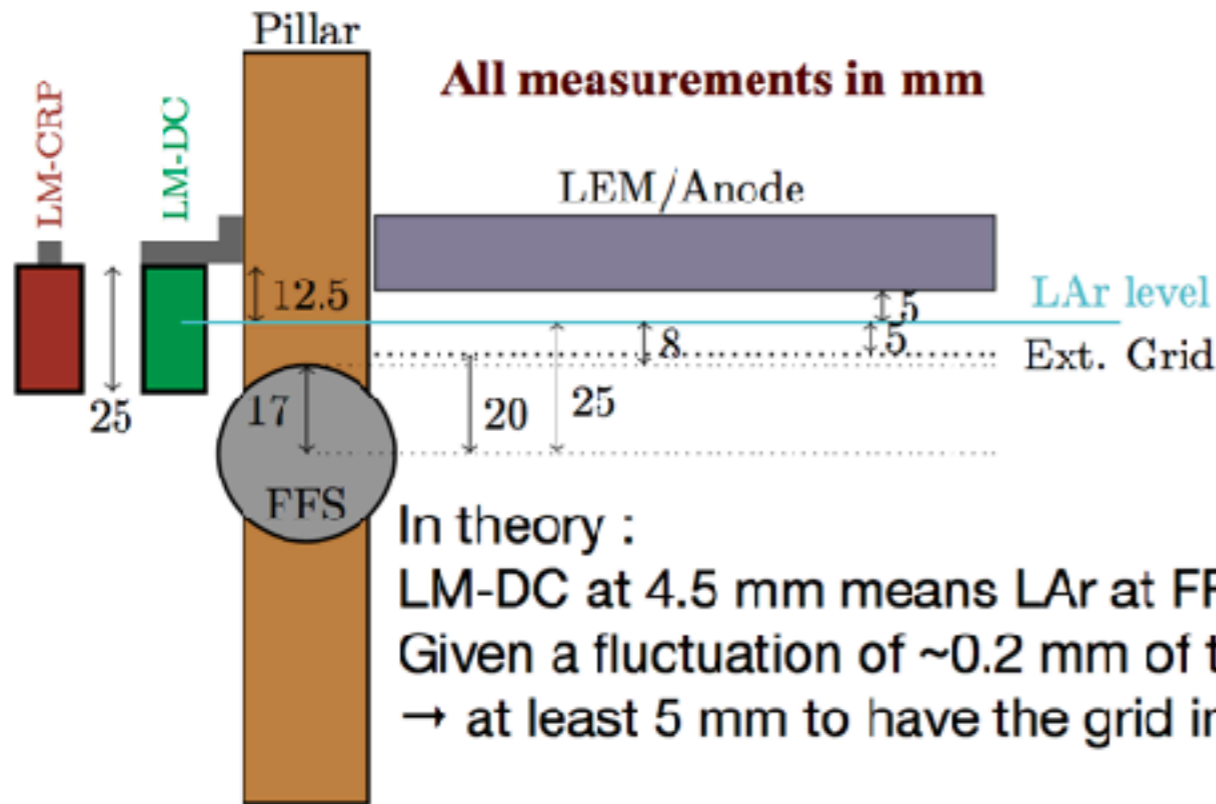
Minimum level of LM-DC to have the FFS immersed

In theory :
 LM-DC at 4.5 mm means LAr at FFS
 Given a fluctuation of ~0.2 mm of the liquid level
 → at least 5 mm to have the grid immersed

As DC is tilted :
 critical for LM-DC 1.
 LM-DC 3, 4 and 5 should be fine

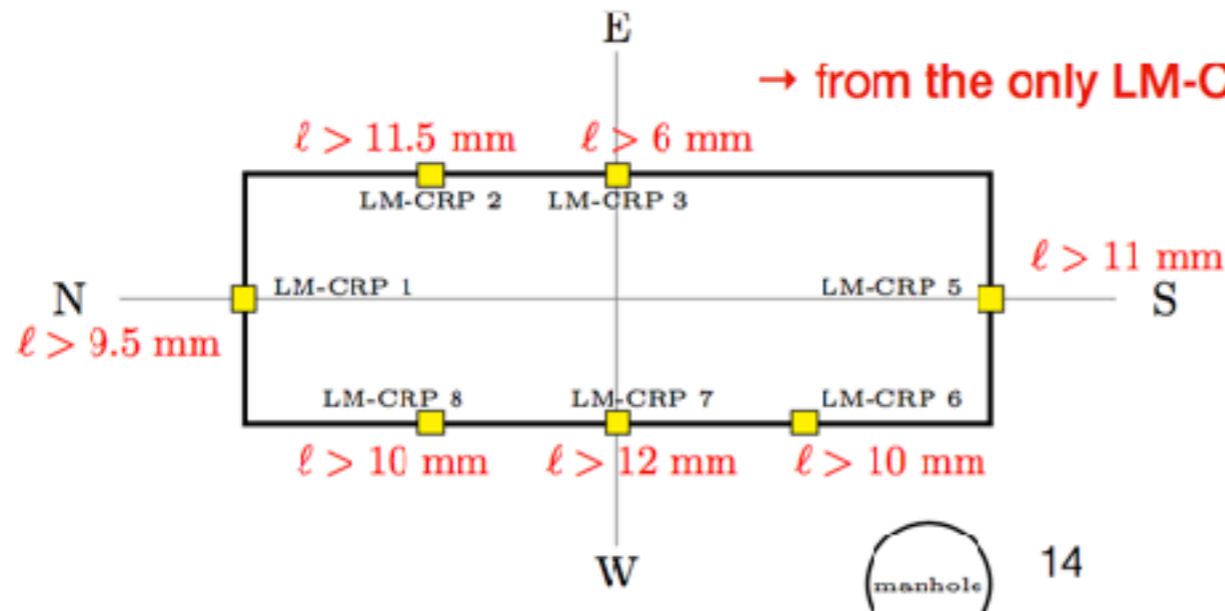
Minimum level of LM-CRP to have the Extr. Grid immersed

→ from the only LM-CRP position measurement, should be careful

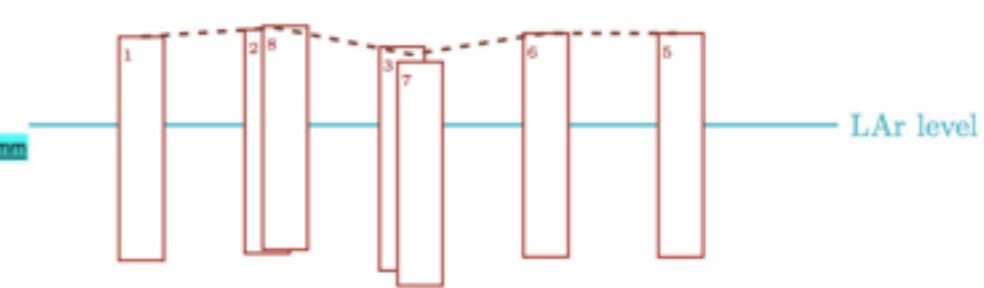
CRP deformation - June 26 at 15:13 -

↳ Central part of the CRP is more immersed ?

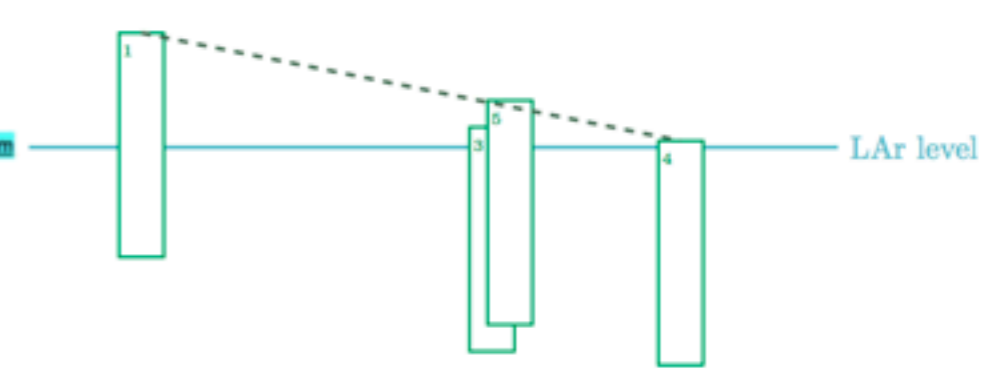
↳ Consistent with 4 mrad tilt
 $\text{asin}(12/3000) \sim 4 \text{ e-3 rad}$
