# Update: Stave 7

WILLIAM HEIDORN  
IOWA STATE UNIVERSITY  
ISU WEEKLY STAVE QA MEETING  
MAY 29, 2018

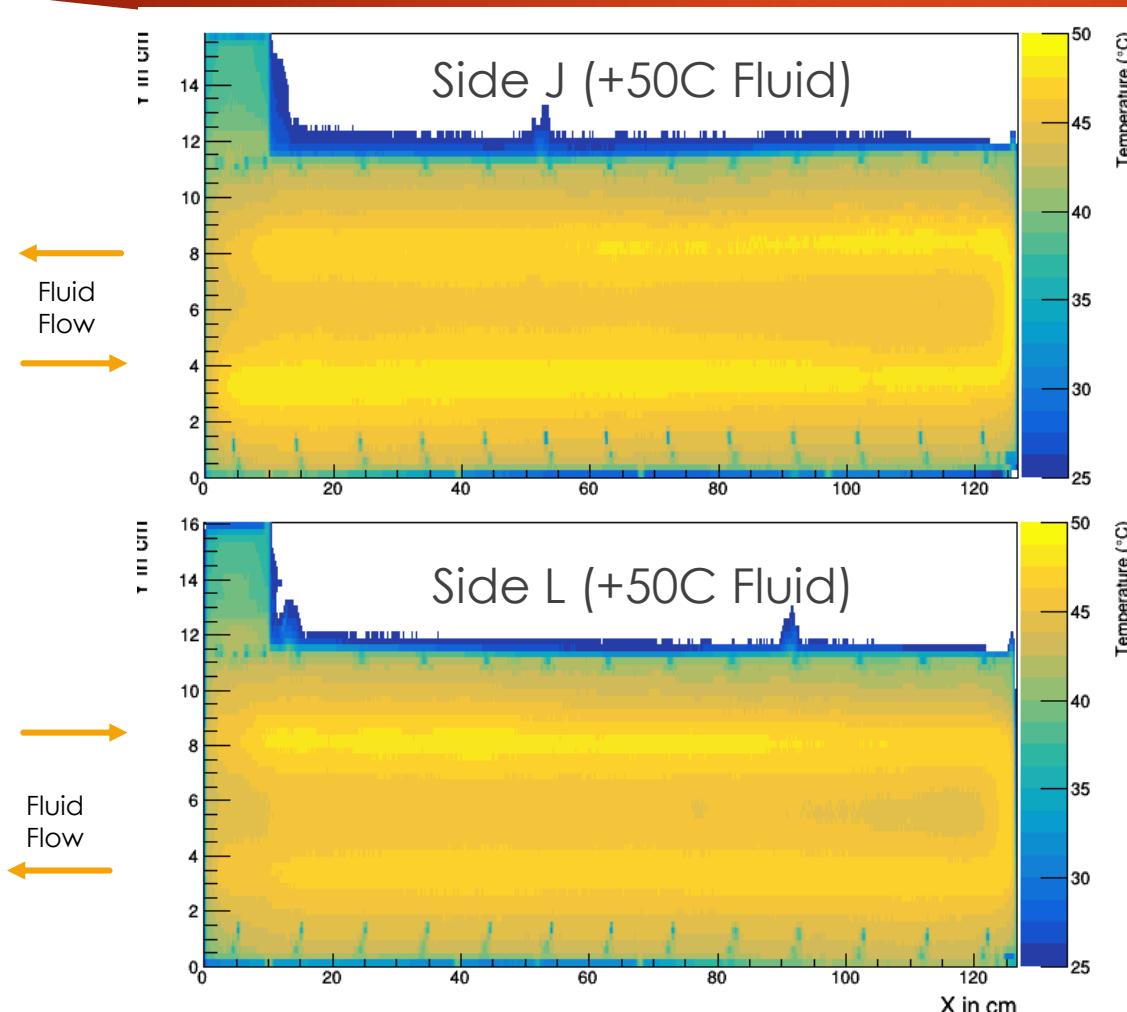
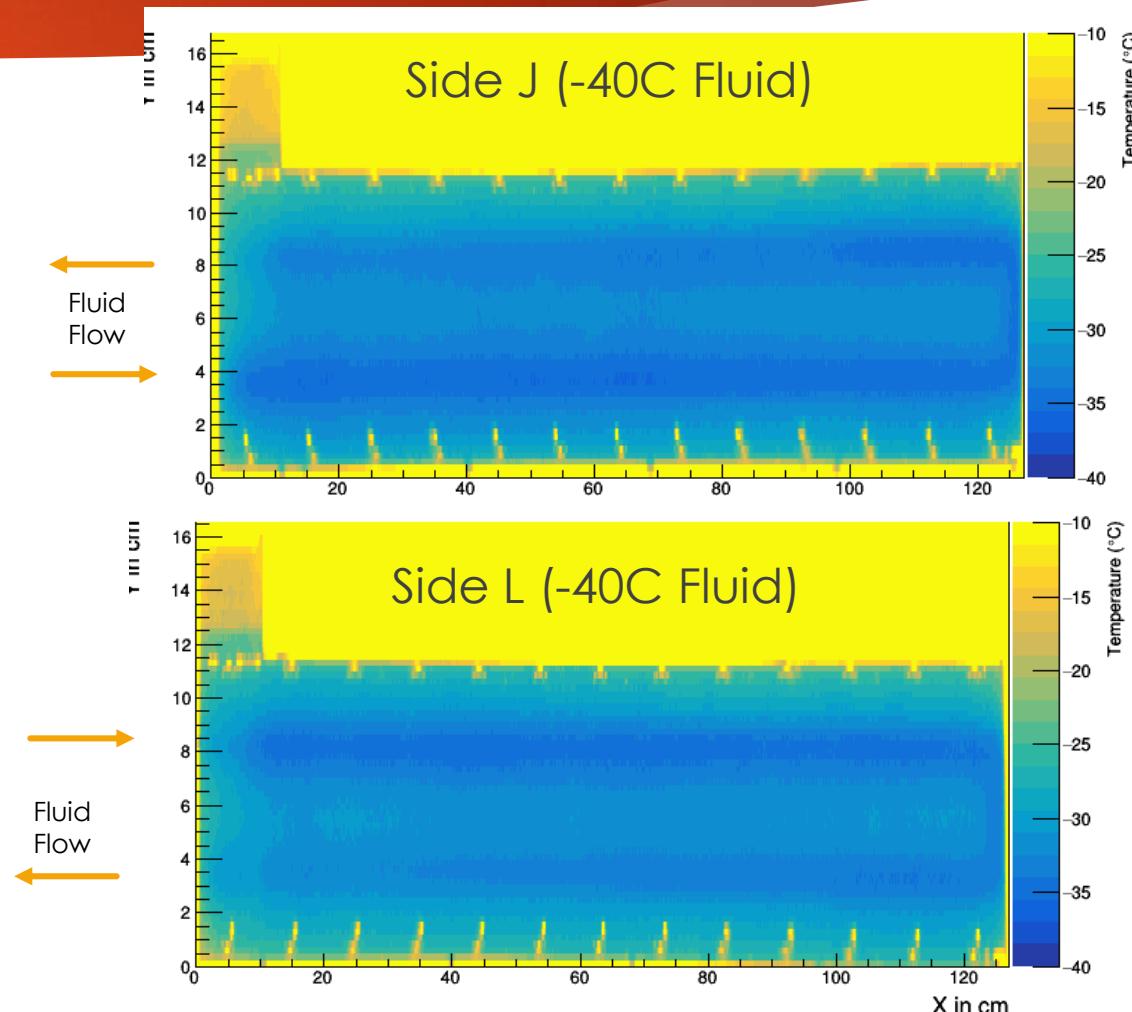
# Stave 7: Thermal Measurements (Thermal images)

- Thermal measurements were taken on both sides of the stave with 50 C fluid flowing into the stave core
- The defect finder found 4 possible defects. Only the side L defects are reproduced in the cold thermal profile
- Linear Fit RMS was found (Stave 6 Results also given for comparison)
  - J Side: 0.13 C (0.12 C)
  - L Side: 0.21 C (0.09 C)

- ▶ Flaws were found by the defect finding algorithm in the hot thermal profiles, but not in the cold profiles. Similar features are still found in the cold profile for side L. This would indicate that there could be a few unimplemented flaws on this stave.
