CAN WE OPTIMISE THE CLEANUP PROCESS FURTHER?

V. Baglin, CERN, Geneva, Switzerland

Abstract

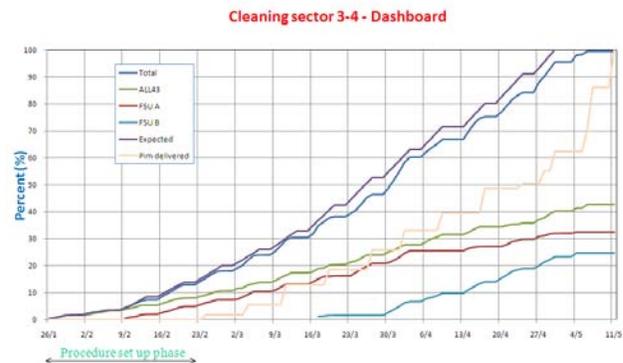
During the cleanup work in the tunnel, a day by day reporting and analysis of the cleanliness was settled. A total of 3 teams employed to clean the beam tube and 1 team for final endoscope analysis were deployed. Figure 3 shows the dashboard of the cleanup process. After the procedure set up phase till the 23rd of February 2009, the work progressed at the requested speed. By the 11th of May, *i.e.* 4 months after the beginning of the cleaning, all the PIM were delivered to TE-MSC for welding.

Figure 3: Dashboard of the cleanup process
