# Experience with FC7 Failures

*J. Troska*

*on behalf of the CMS TCDS team*

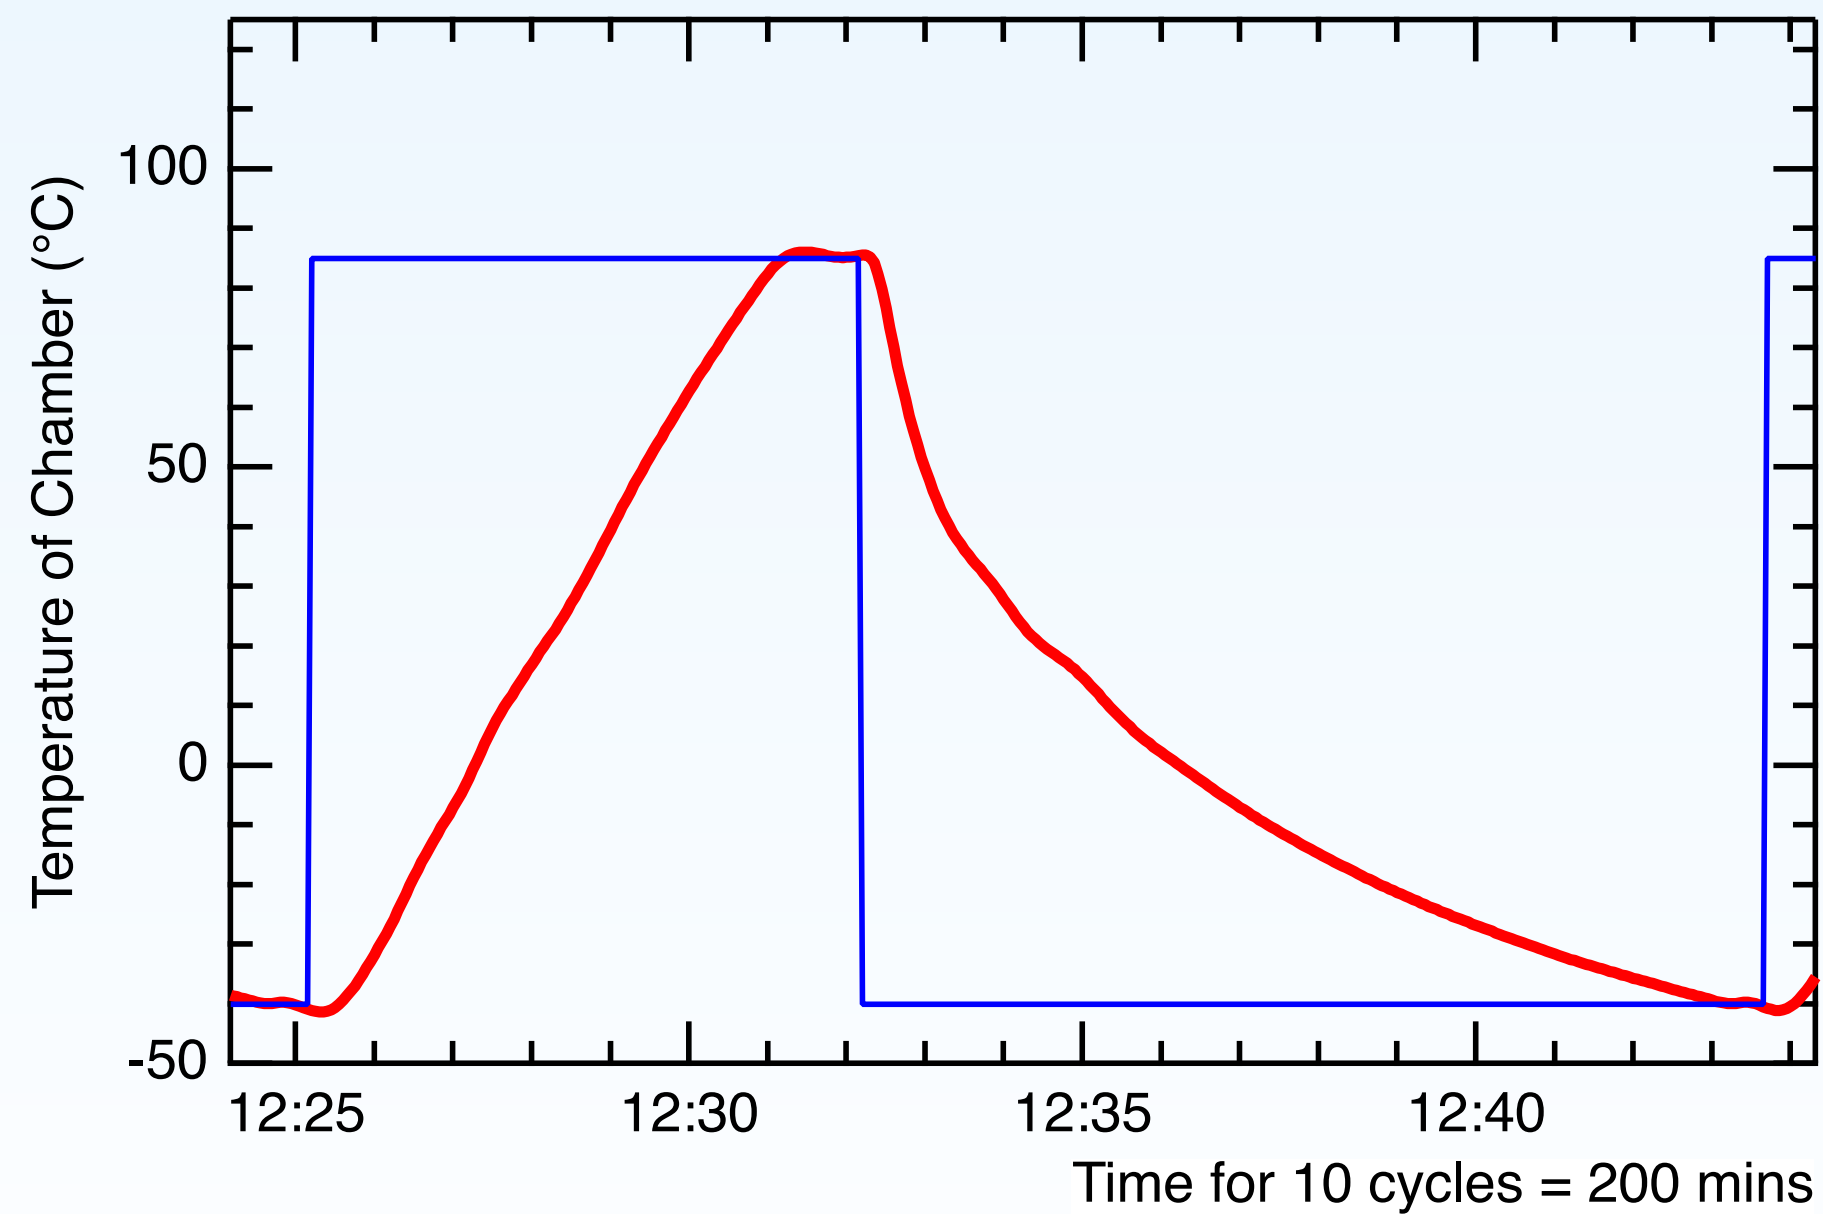
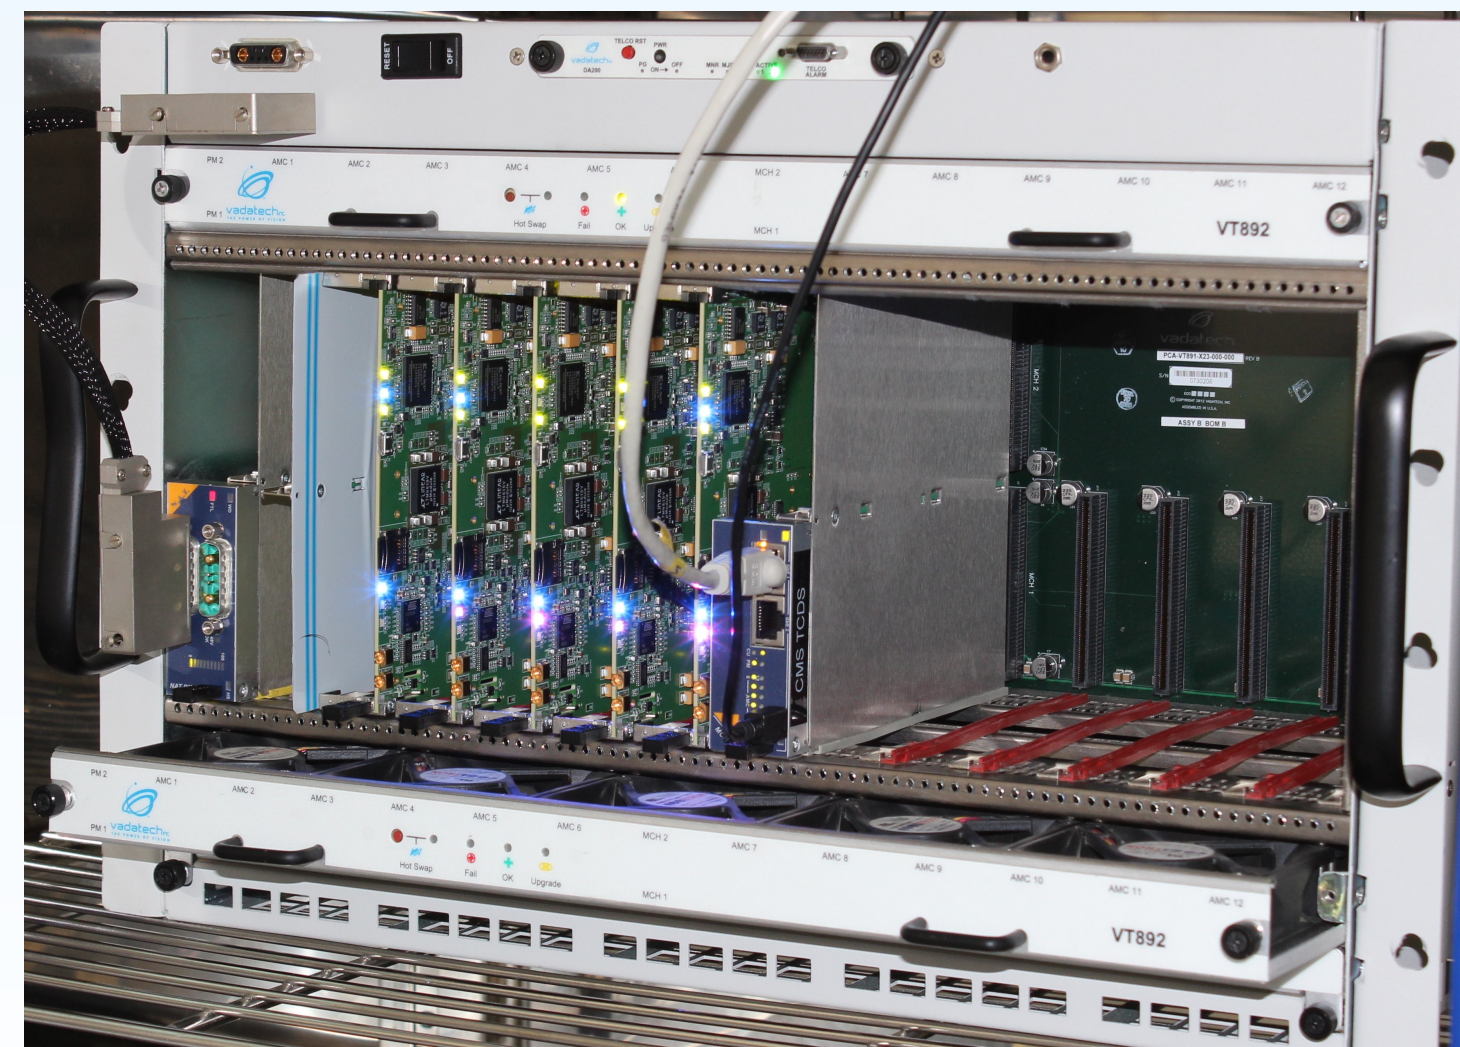
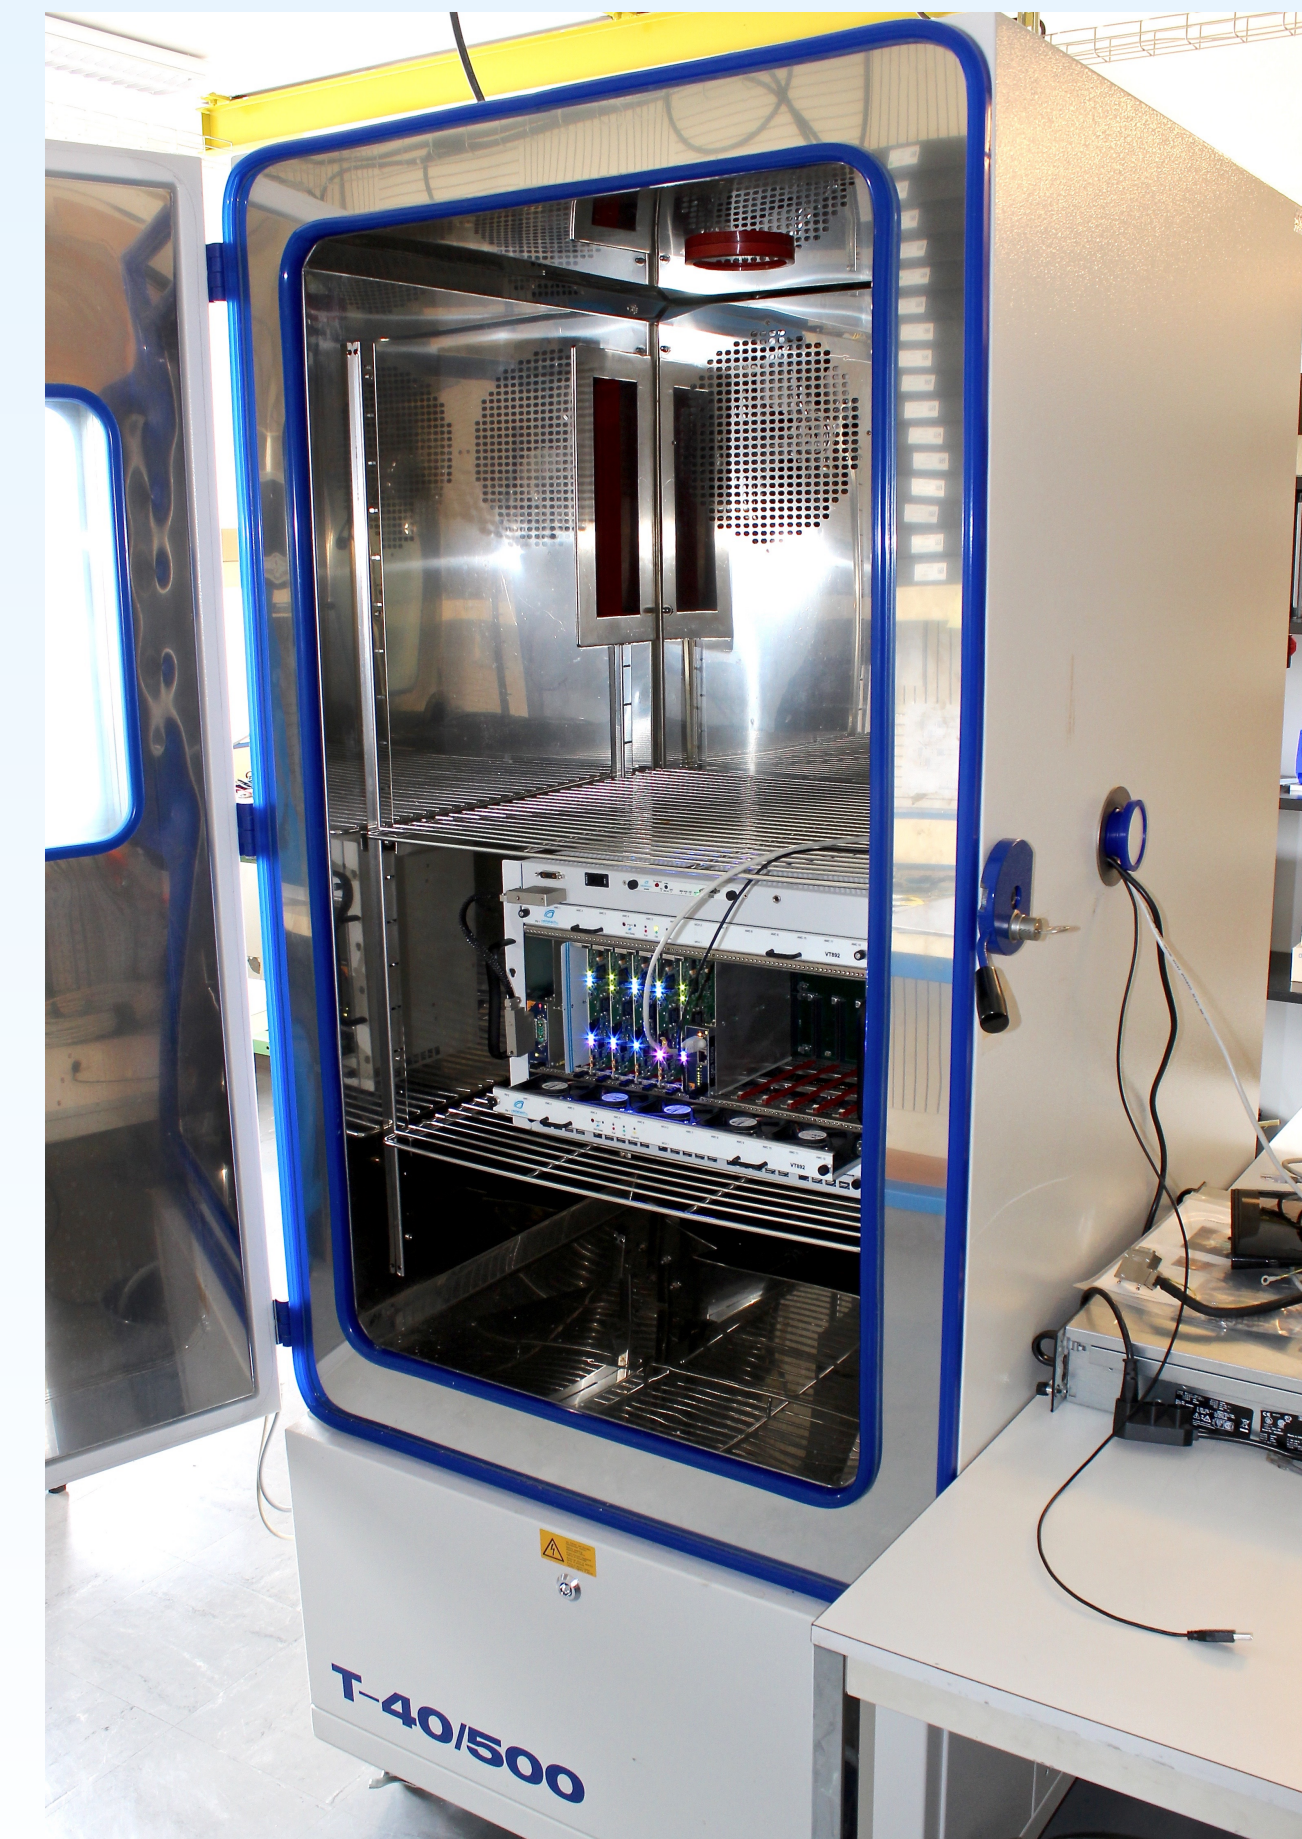
# FC7 R2 Validation

- QA programme carried out on 5 R2 boards and 1 unmodified R1 board:
  - Temperature Cycling: -40 to +85 °C, 500 cycles
    - Measurements at 100, 200, & 500 cycles
  - High-temperature Operating Life (HTOL): ~95 °C, >500 hrs
    - Lifetime acceleration factor of 54-78 with Xilinx recommended activation energy of 0.7 eV

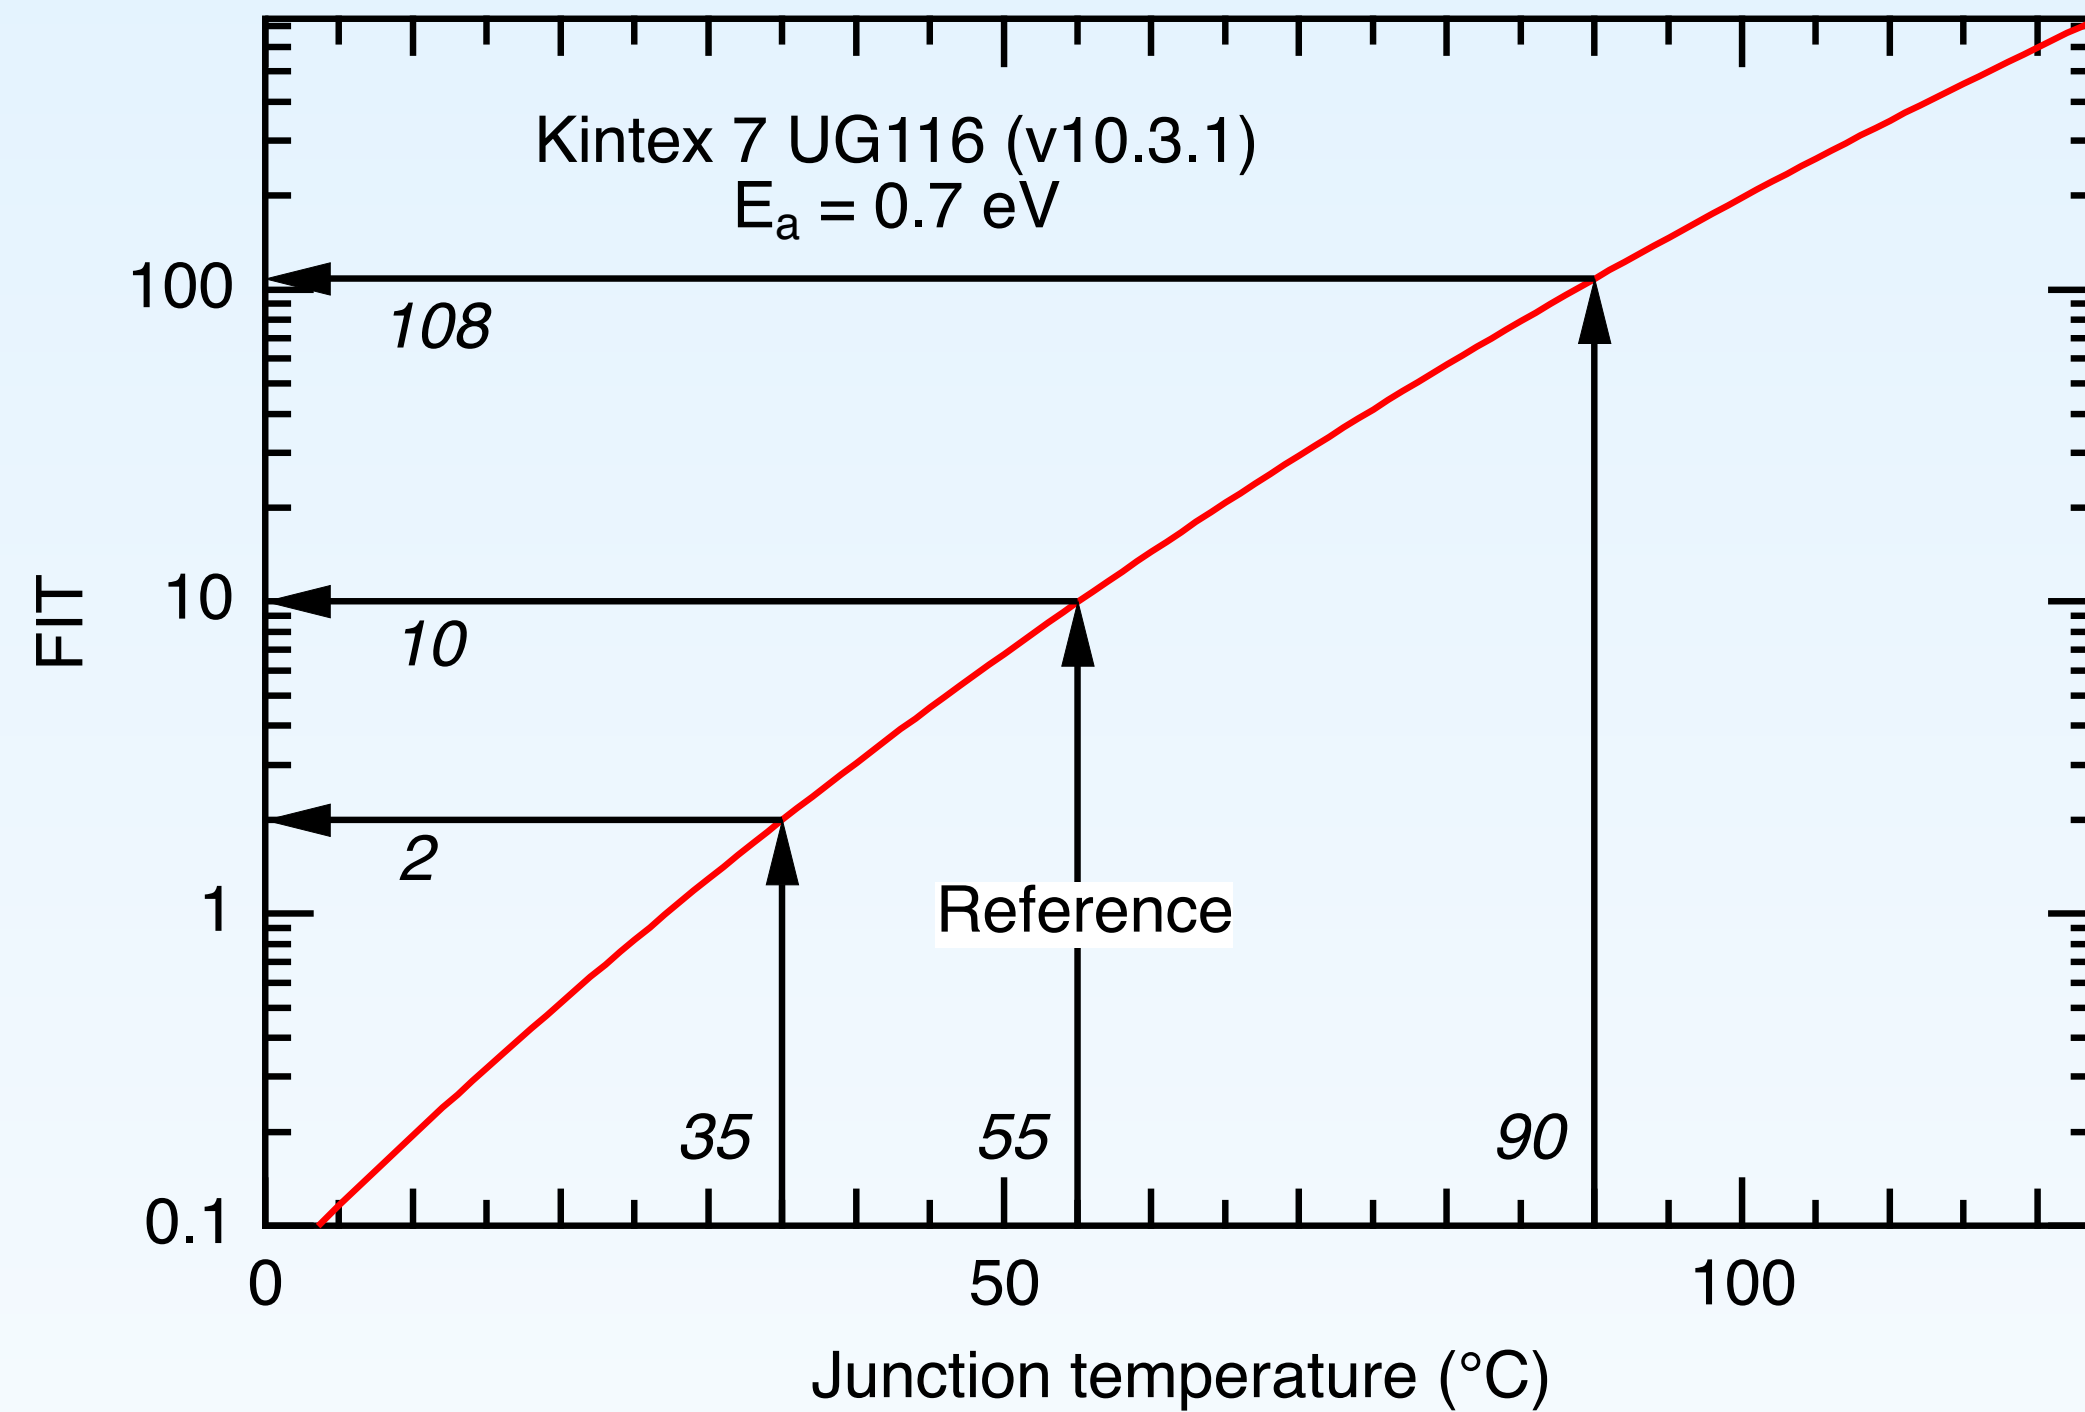
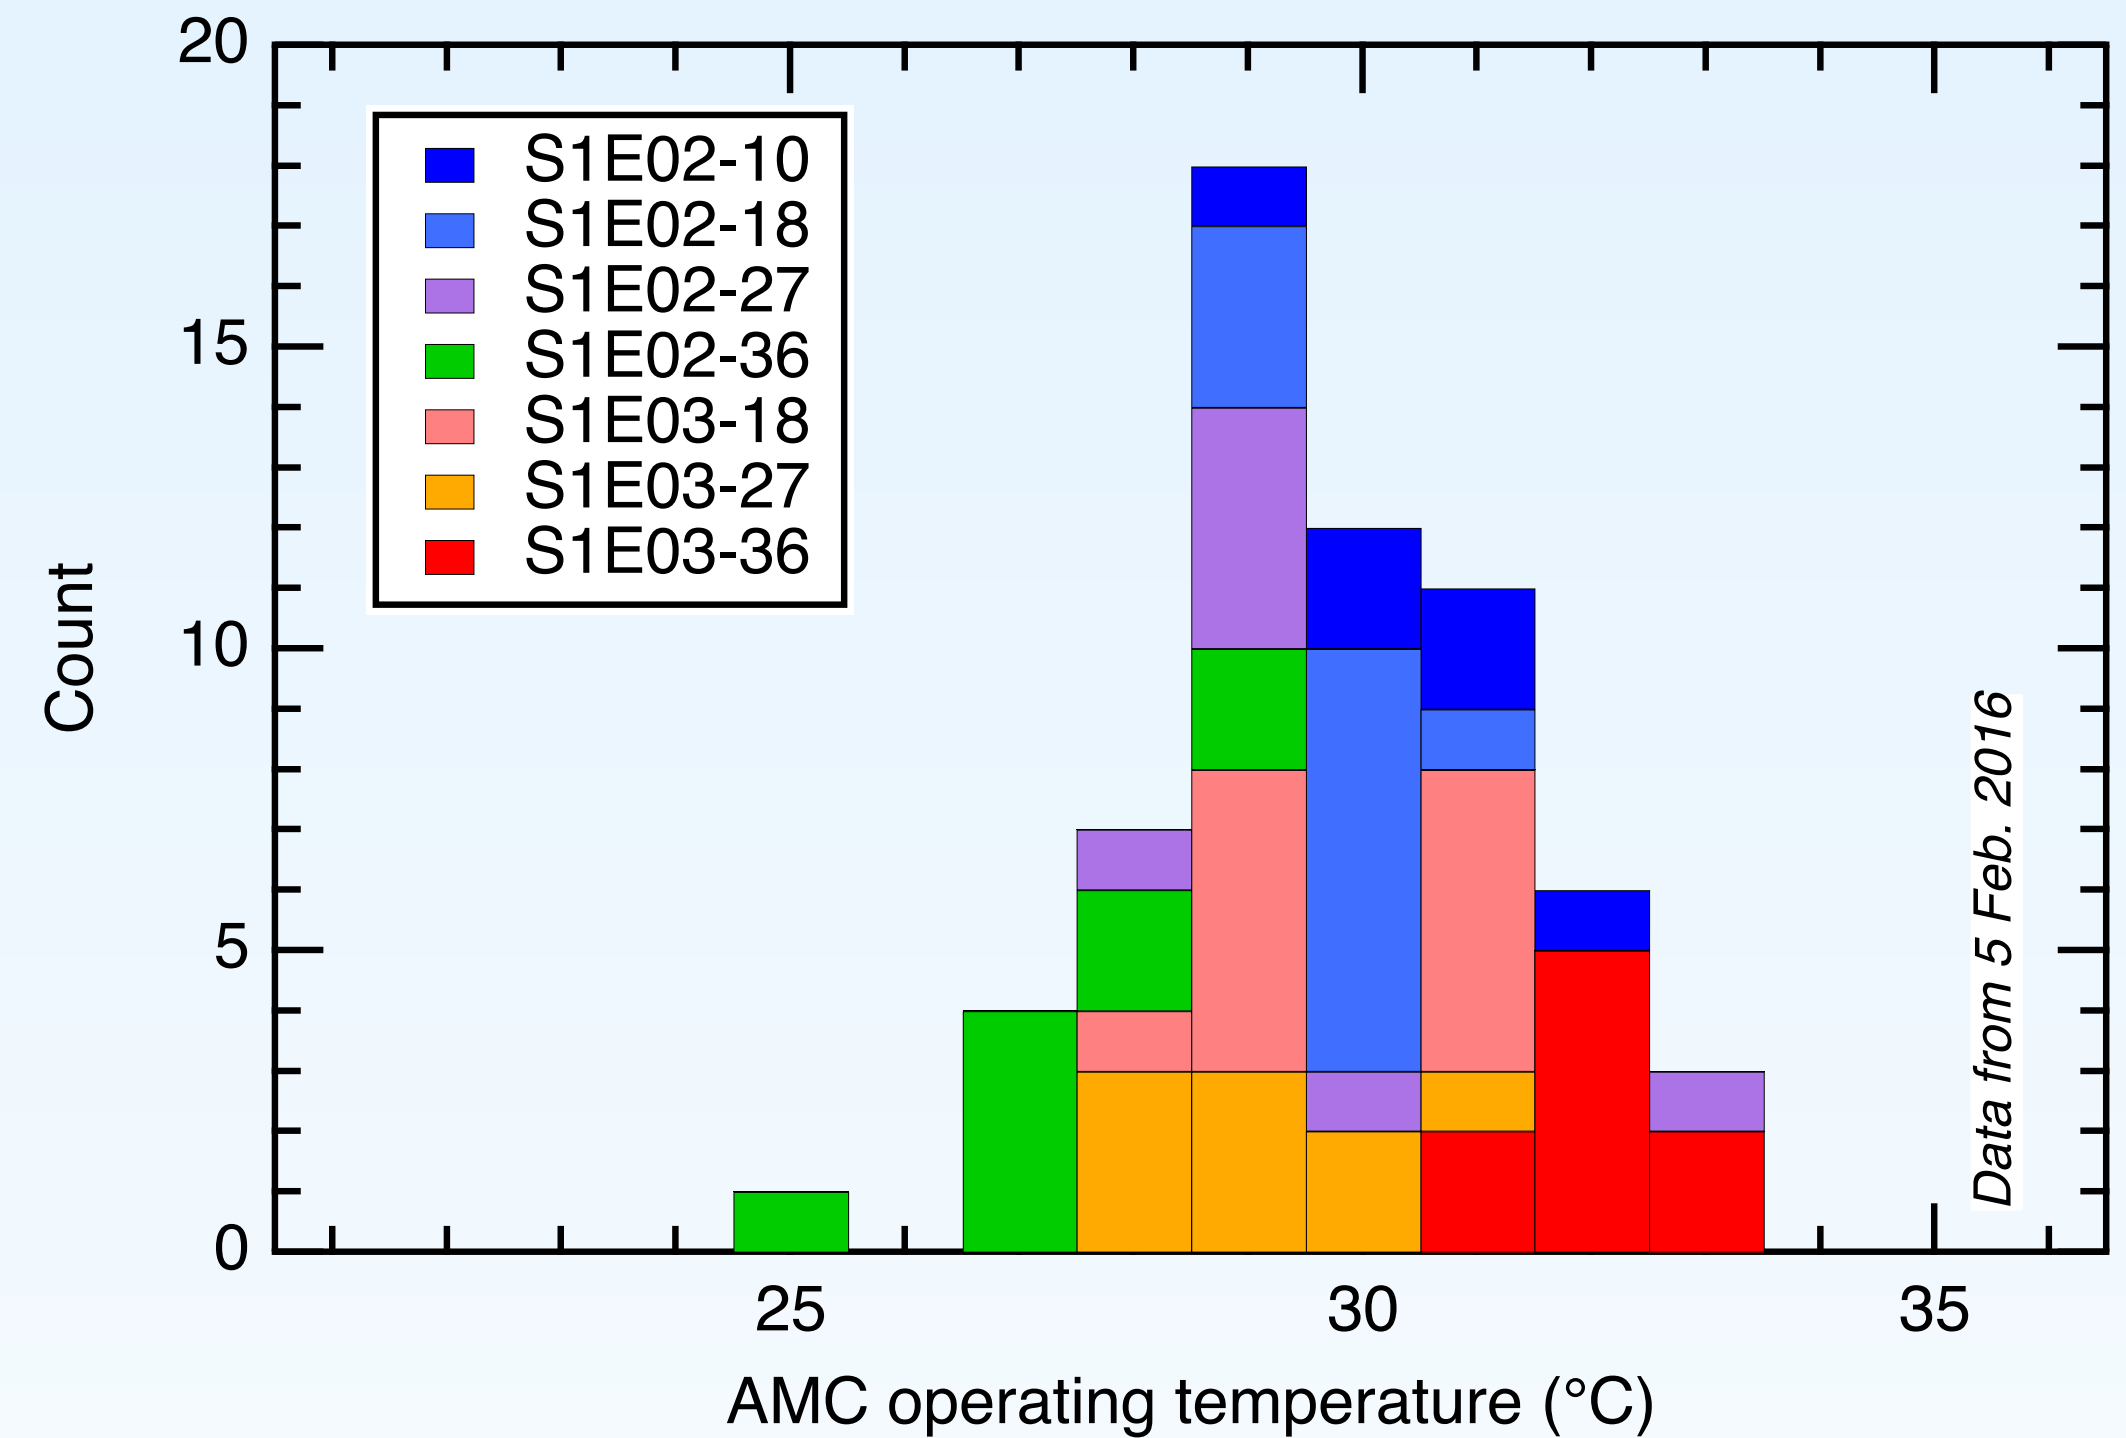
# HTOL Acceleration Factor

- Device temperature measured in-situ in CMS, take 35 °C as conservative maximum value
- Acceleration factor 90 °C w.r.t. to operation is  $\times 54$
