High Power CW RF Sources for Booster and Ring in SSRF

Shenjie Zhao, On behalf of SSRF RF Group

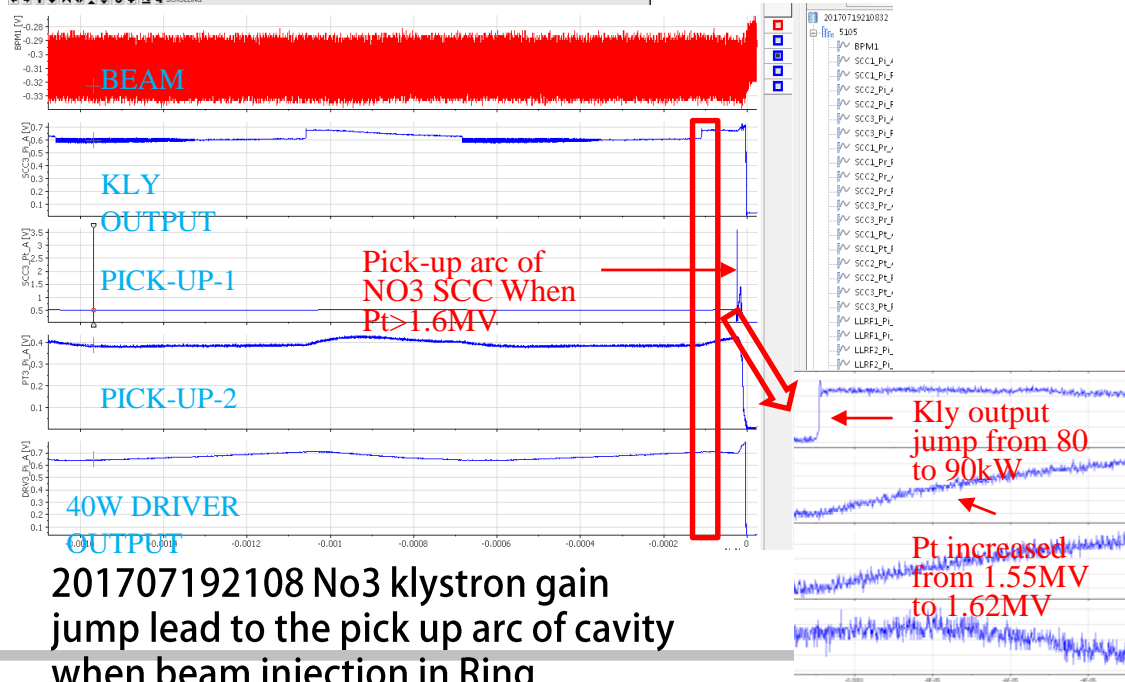
20171013~15 3days high voltage condition on new No3 klystron

201707192108 No3 klystron gain jump lead to the pick up arc of cavity when beam injection in Ring

20171013 new No3 Klystron

- 20161129 80kW to 90kW jump was observed in pulse condition. This jump lead to cavity's pick-up arc at 201707192108 ;
- The check or test of this old klystron in Thales will cost ~50,000 EUR, without not any maintenance guarantee.

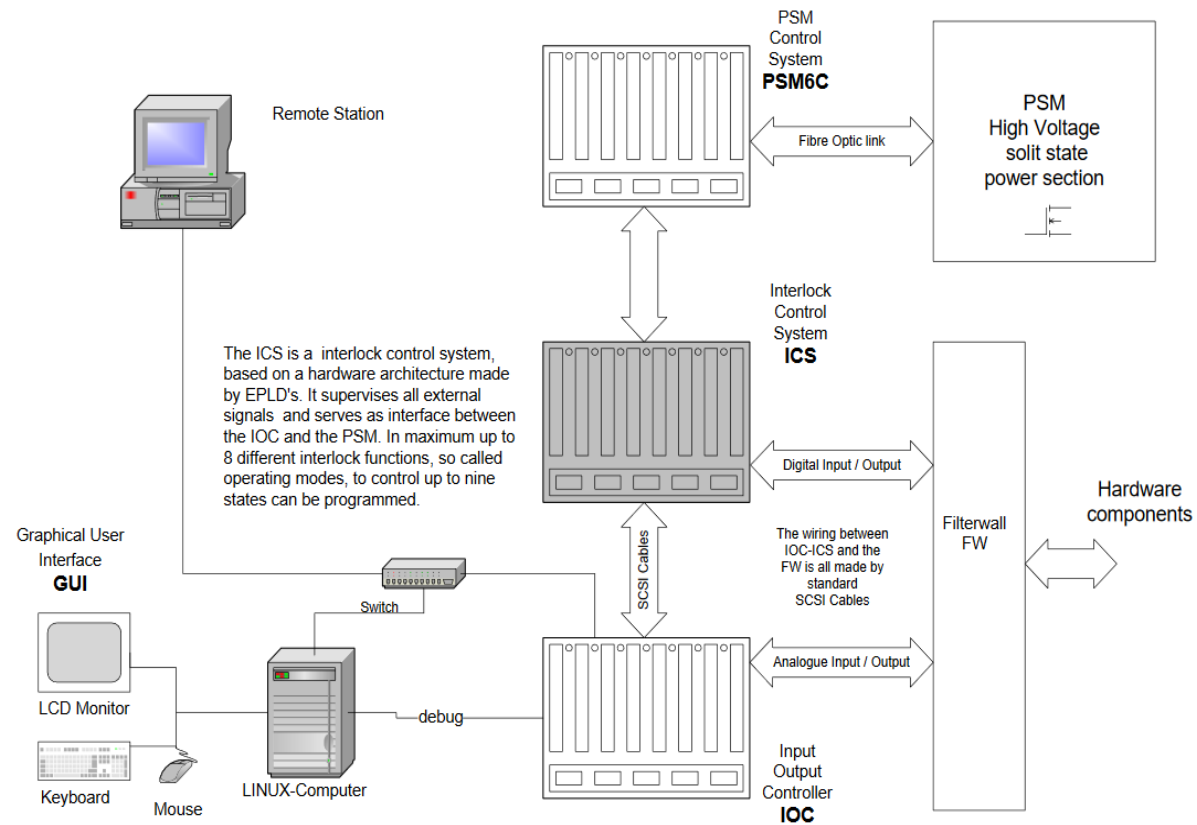
Upgrade of No0 PSU

- The PSU0 was delivered in 2000, and was a very old version;
- Upgrade the control system means Booster and Ring can share the same spare parts;
- The upgraded parts include: PSMC, ICS, IOC, and EPICS.

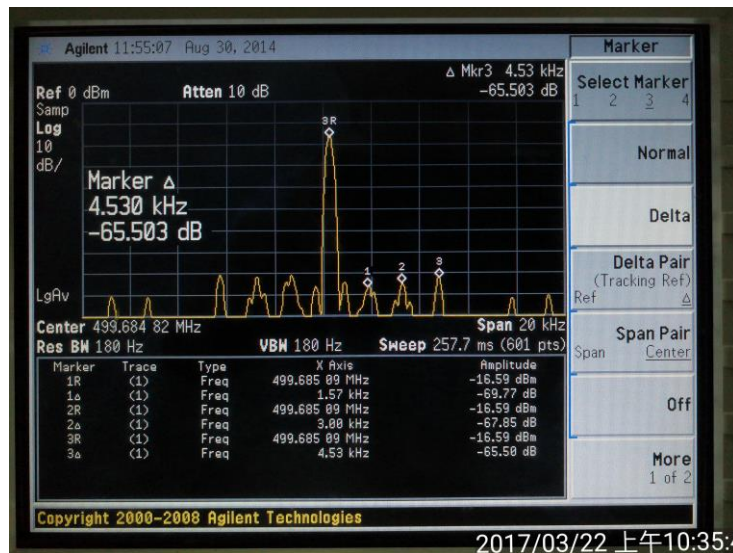
Upgrade of the PSMC of No1~3 PSU

Noise on cavity field without beam

- The low frequency noise was suspected from RF PWM;
- On 2016 Summer, we upgraded the PSMC in ring, which make the PWM frequency adjustable.
- The light noise was verified from PWM of the PSUs.

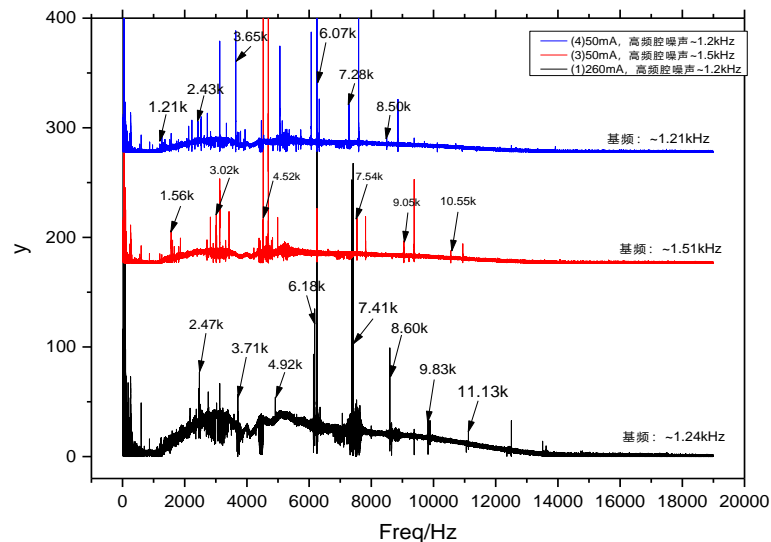
Noise on light spectrum of IR beam line with different RF PWM frequency
