# ***ISOLDE Lines - Survey Results***

***Measurements of  
November/December 2012***

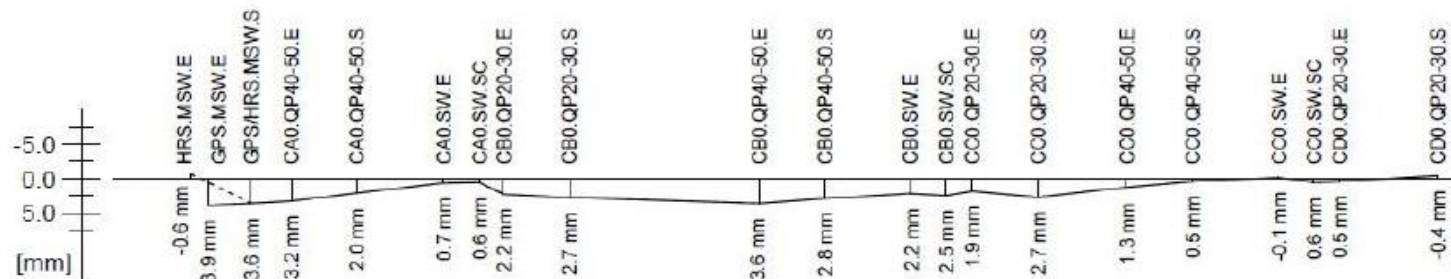
**ISOLDE MAIN LINE:**

Horizontal Offset from the Theoretical Beam Line

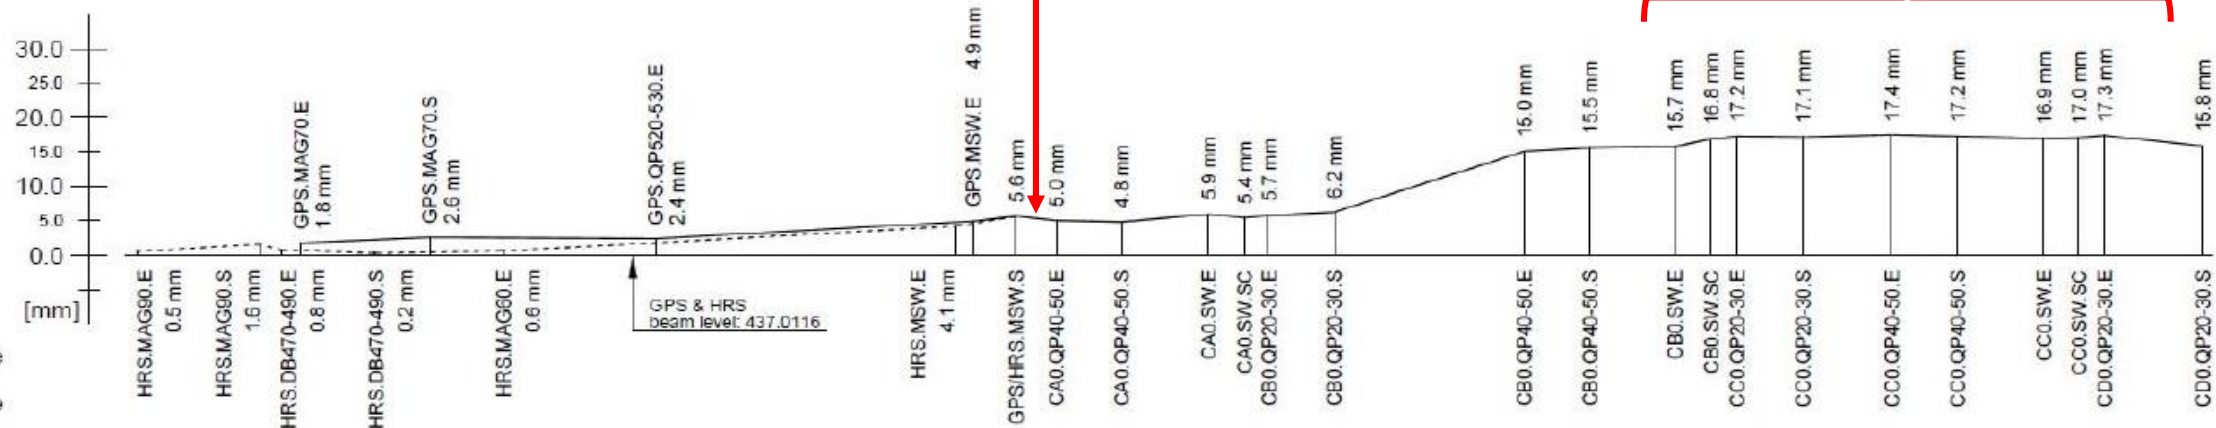
**ISOLDE MAIN LINE:**

Vertical Offset from the Theoretical Beam Line

REX + GLM/GHM  
+ LA beamlines

CRIS, COLLAPS, ISOLTRAP, VITO etc
