TCDLA brazing test – January 2018

Summary

Last test in date with Glidcop that was subjected to:

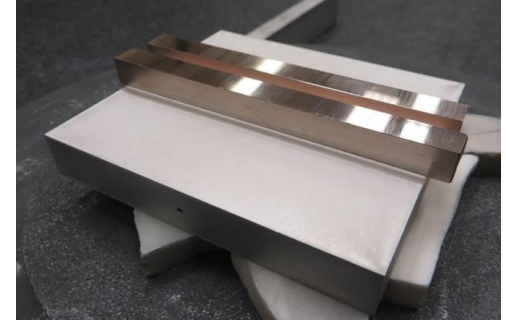
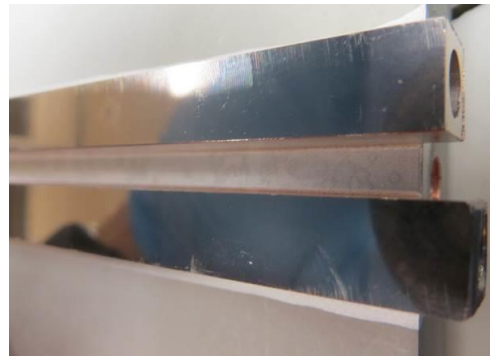
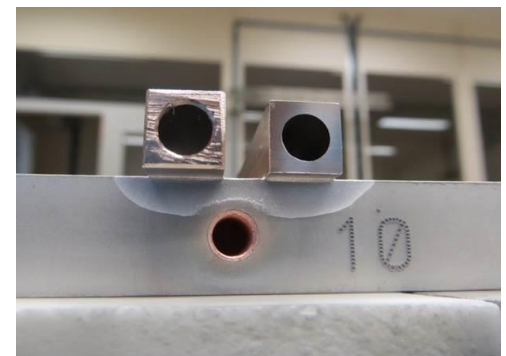
- a. ED30''
- b. Cu
- c. HT 700°C
- d. Ni without brighter, new bath
- e. HT Brazing thermal cycle
- f. Brazing

→UT is very good (see scan on next slide)

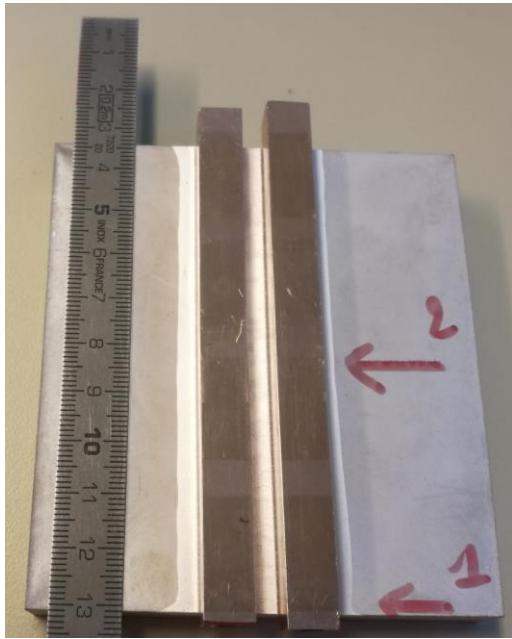
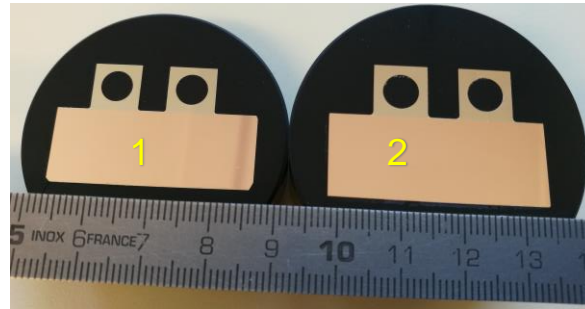
Metallographic cuts

Two transverse cross sections

- 1 close to the edge
- 2 at centre

- Cut 1: good brazing interface free from imperfections (rare micro-pores). Micro-porosities are noticed just below the Ni layer,
- Cut 2: good brazing interface free from imperfections (rare micro-pores). Micro-porosities are noticed just below the Ni layer,
- Thicker Ni layer close to the edge of the piece.
