## Quality Control of the dismounting of MBHDP102 First results – De-collaring process

11T Dipole Task Force Meeting # - CERN – 21/02/2018

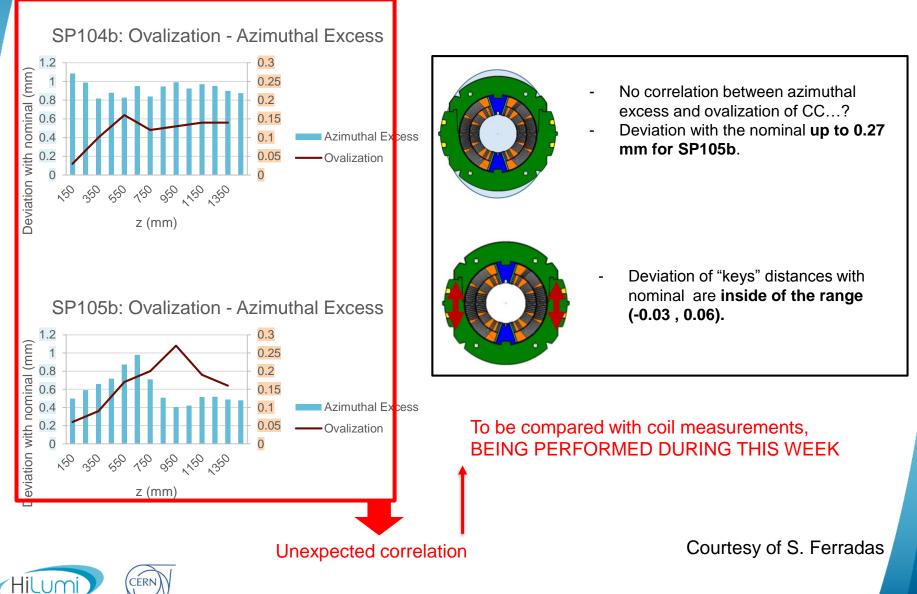
### **Geometrical measurements CC**

- Magnetic measurements apparently ok.
- Electrical: insulation and discharge are ok. Some VT out of service.
- Geometrical: analysis and coil measurements ongoing.
