MQYYM Coil 7 issue

February 21st 2018

H. Felice, D. Simon, M. Segreti, J.M. Rifflet

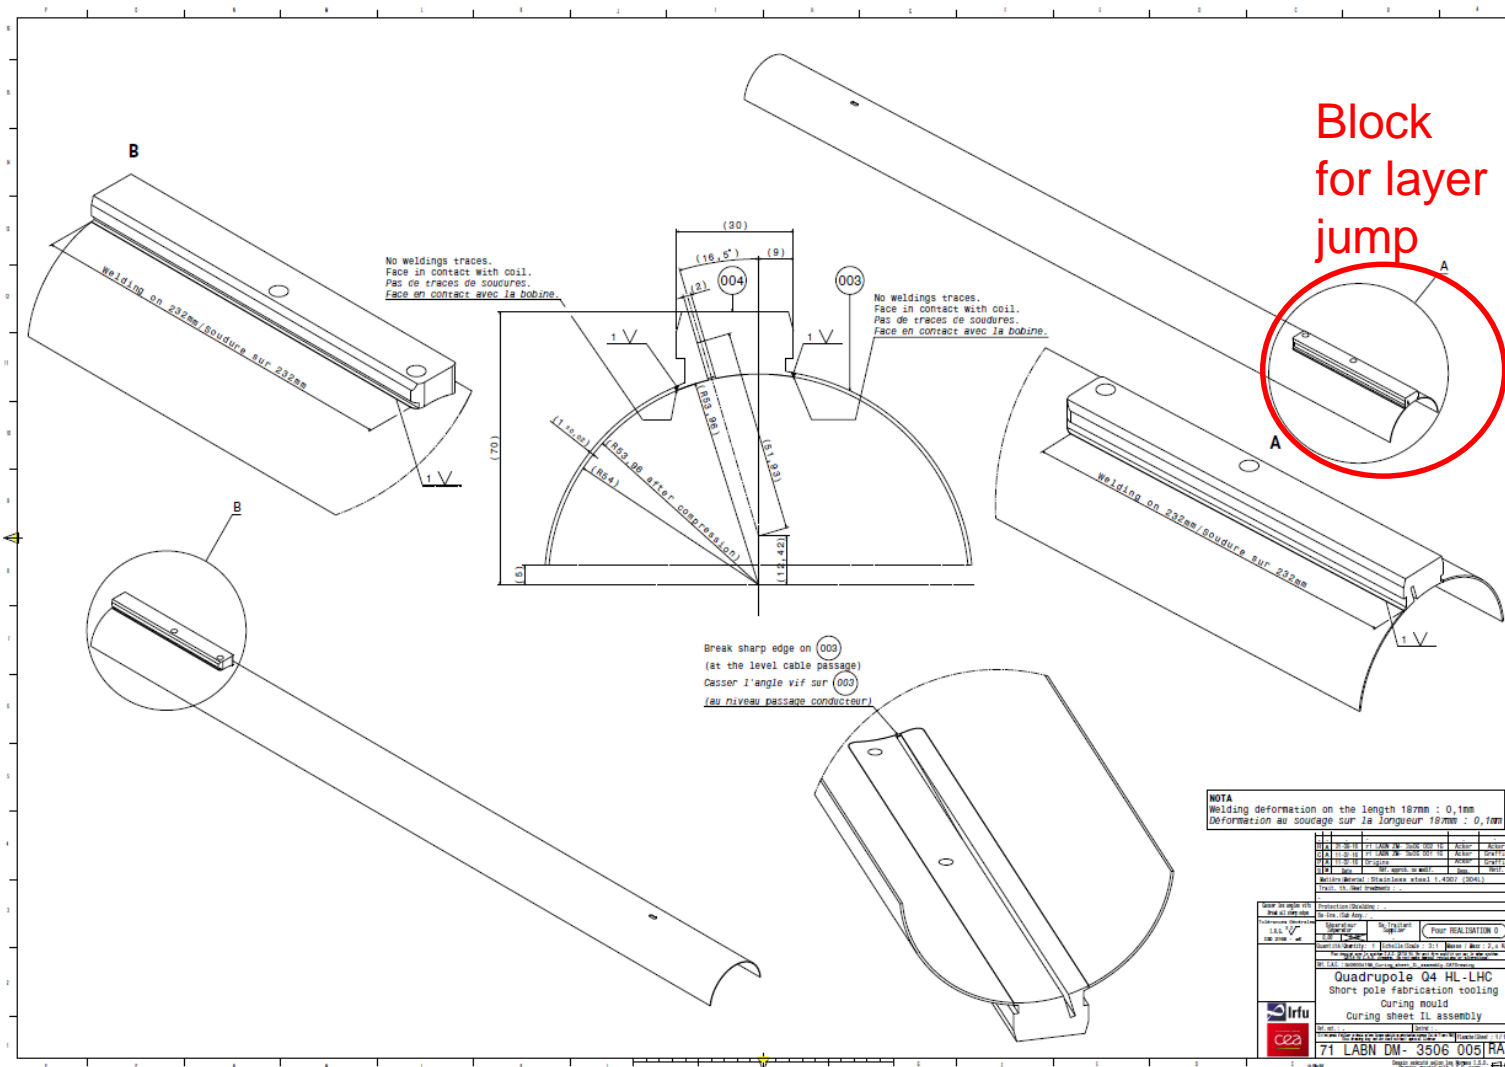
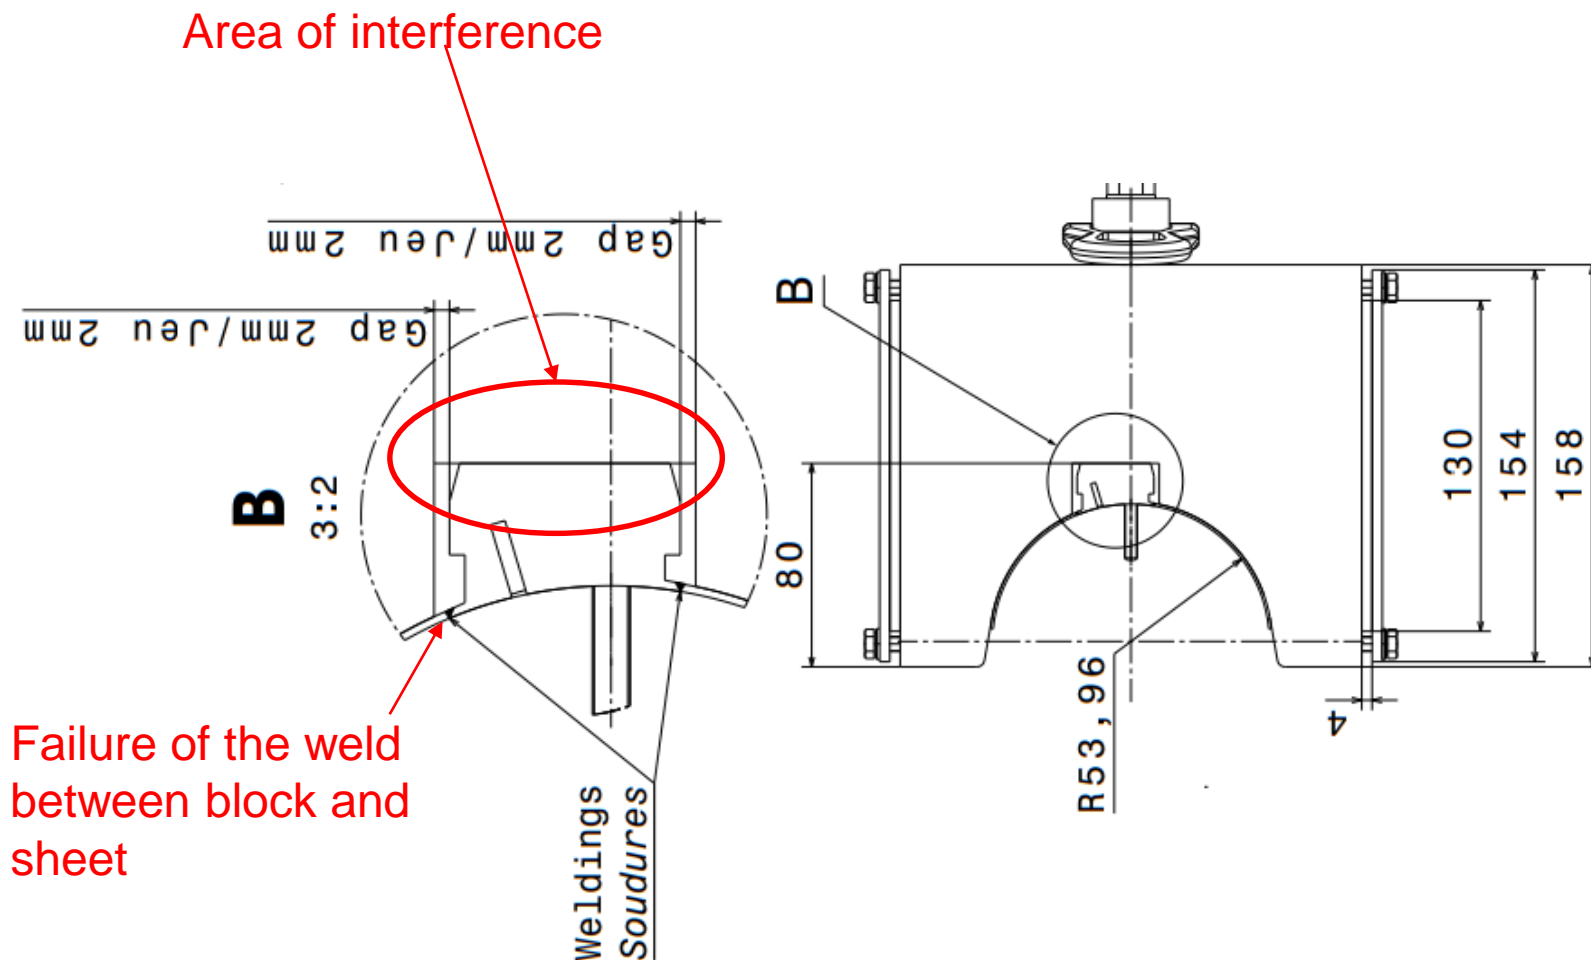
CURING SHEET DETAILS

The layer jump guide moved inward by $\sim 0,3$ mm
The layer jump guide has an interference with the mould ranging from **0,22 mm to 0,26 mm** => **imprint in parts / failure**

=> The curing sheet has been repaired. Interference has been removed

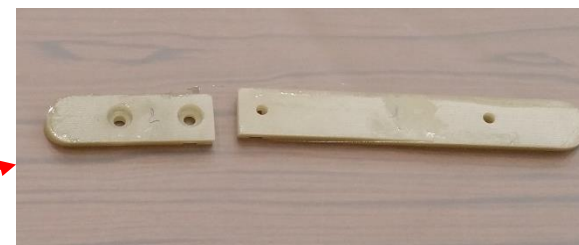
⇒ Make the first **2 end spacers** in Blue Stone epoxy to make the curing test

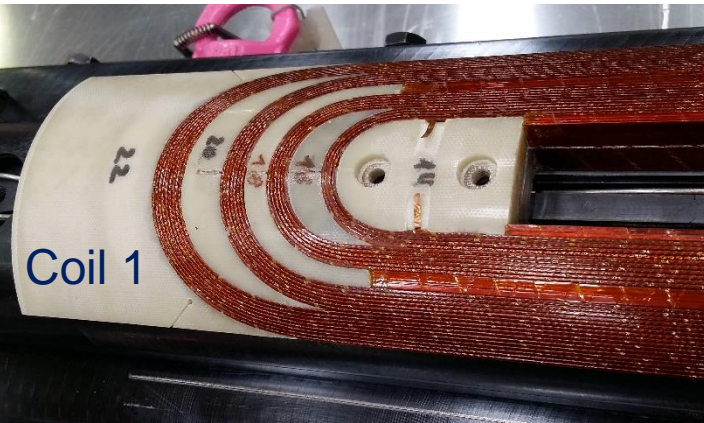
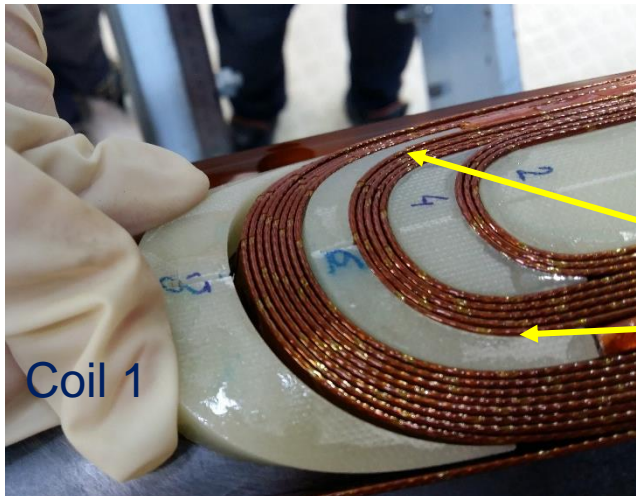
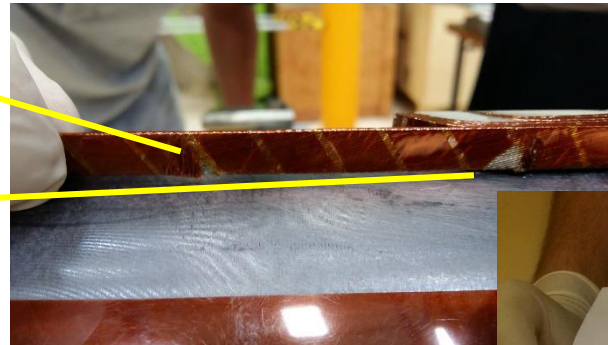
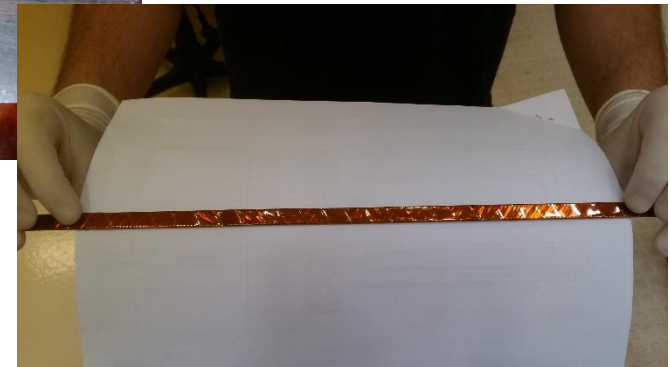
- Vtaps:
 - narrower CuSn_6 flags and SnAg solder
 - Grooves added in the end part
- **Slit** in some of the spacers, filled with G10 pieces before polymerization
- Finalization of procedures for insulation of angular wedges

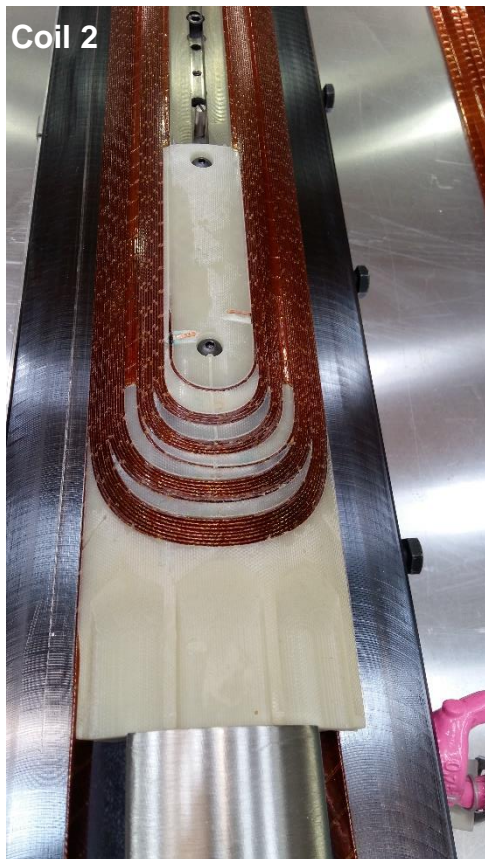
- No major issue during coil fabrication of coil 2 and 3
- Concern on vtap flags: grooves are not deep enough => some compression of the taps

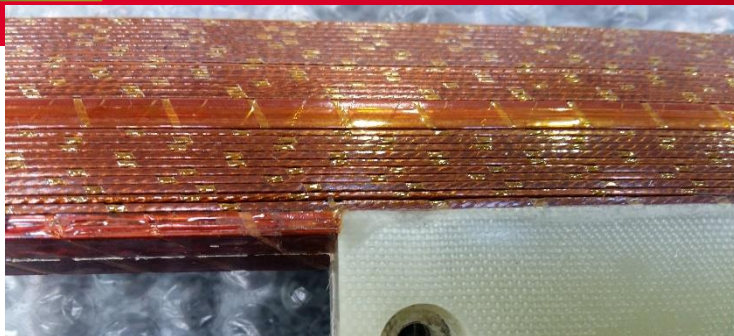
- Vtaps/endpart groove problem solved
- But :
 - Unglued turn on the outer layer => adhesive missing?
Unexpected cleaning?
 - Gap in the last but one turn in the RE IL
 - Repair: Filling the area with resin is considered but of concern
 - **Change of process:** Release of the end pusher after press top plate positioning and before mandrel release
