I PS EAST HALL MAGNETS

II SPS NORTH EXP. AREA MAGNETS

PS+SPS days 24-1-2007 W.Kalbreier, D.Smekens, T.Zickler AT-MEL, CERN, 1211 Geneva 23

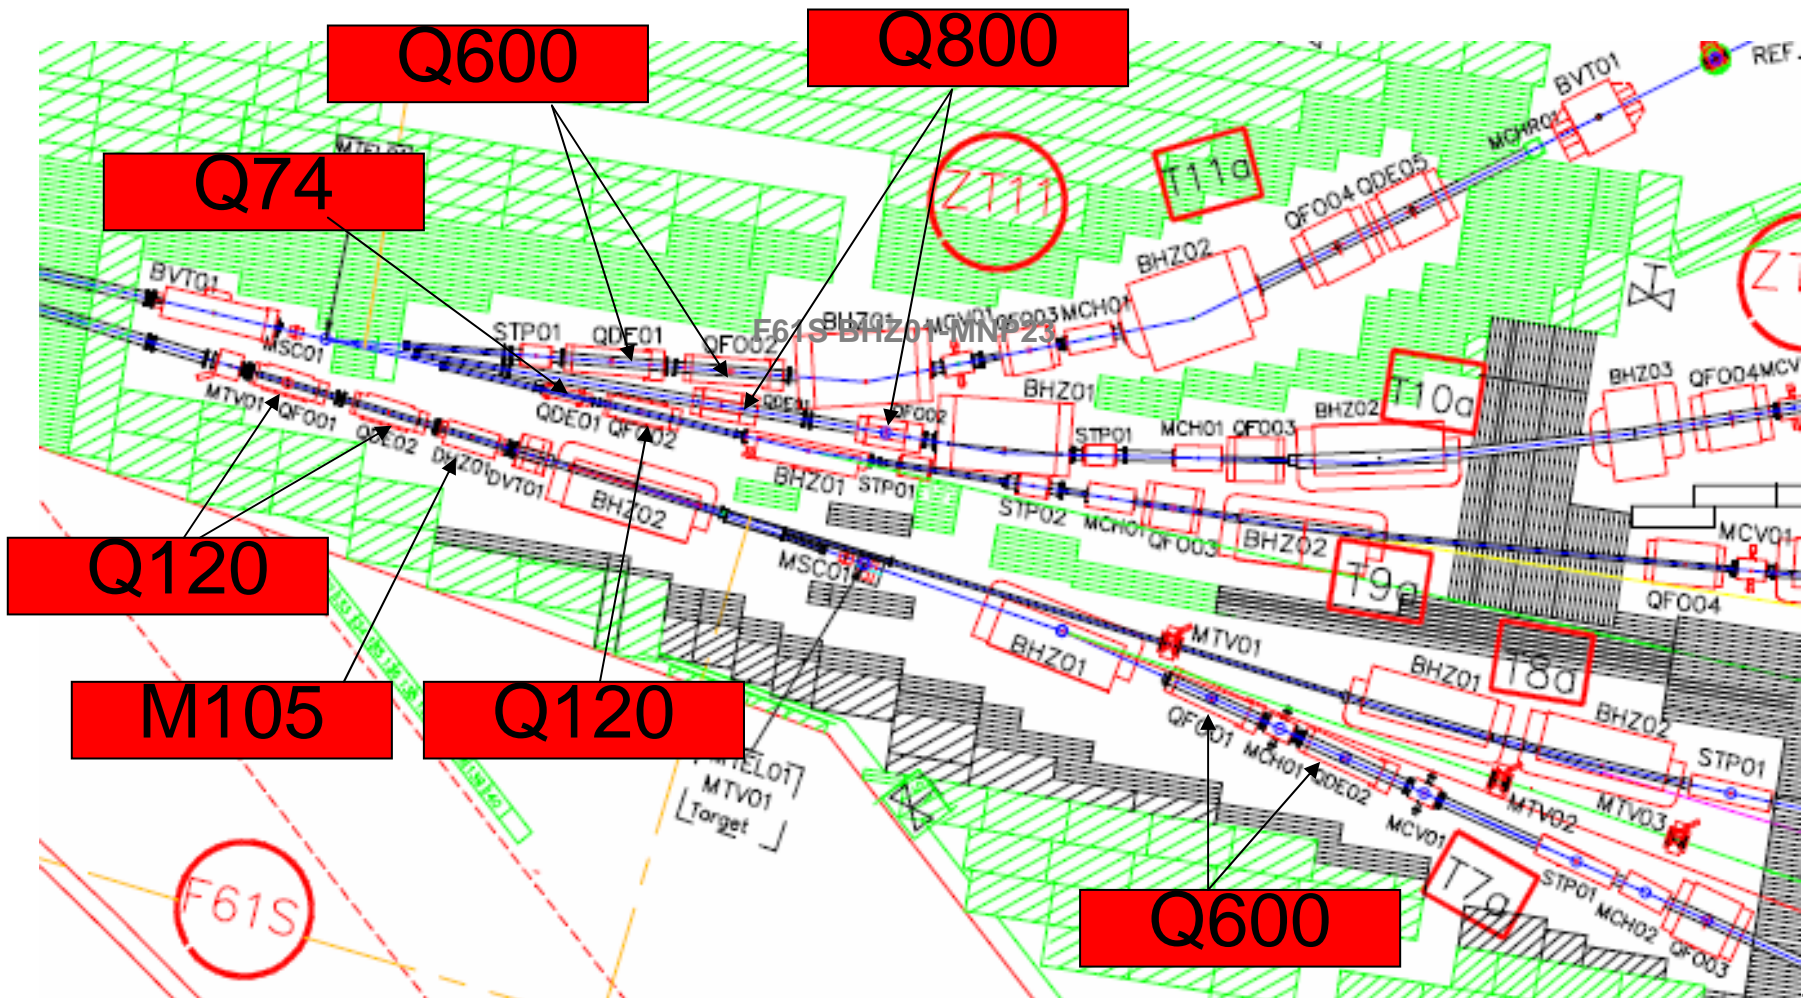
As MNP23 problems have been presented in several ATC sessions in 2006 I skip it here + leave it for questions.

→ February 2007: install C-shaped MCB magnet to replace MNP23 for 2007 operation.

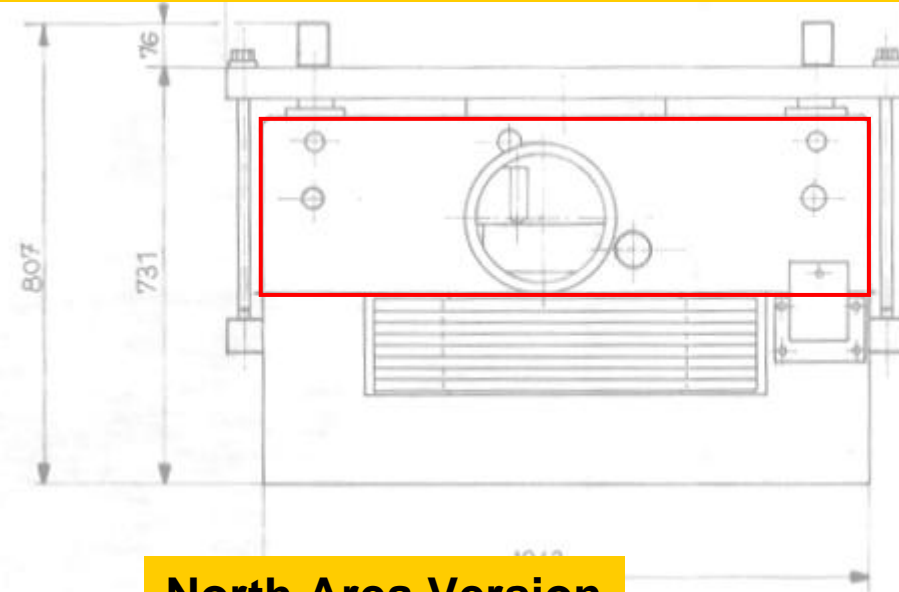
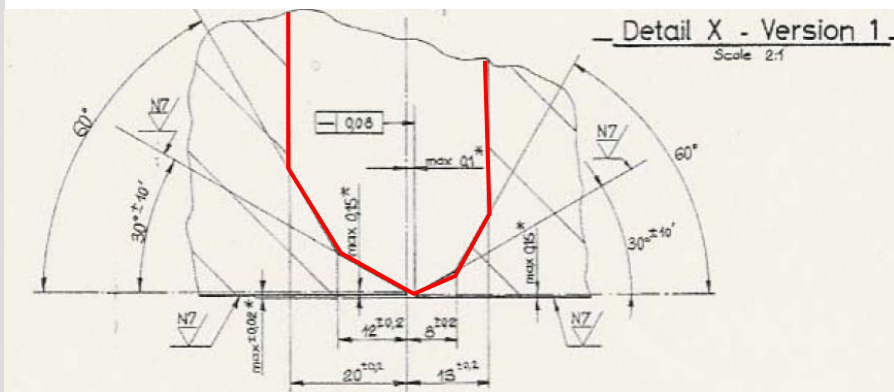
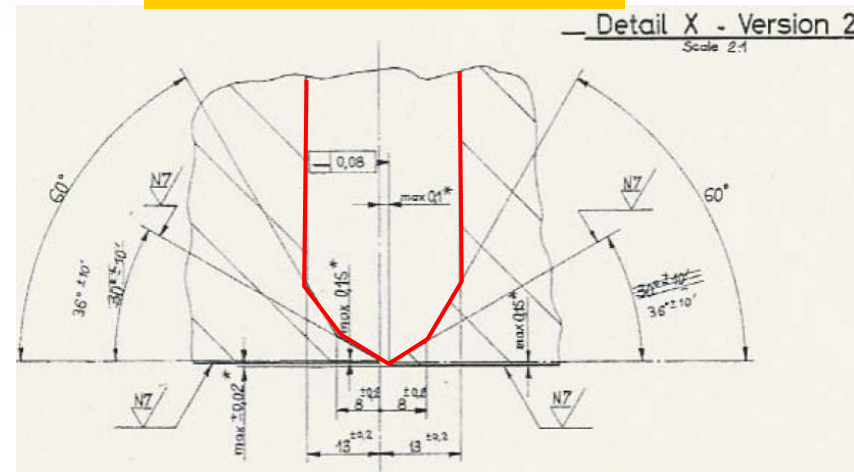
North Area Version

- ➔ Vacuum leaks. Due to corrosion of the stainless steel in contact with the PVC material used for the covers (made in the 70's).
- ➔ Not repairable in situ. Leaky Magnets have to be replaced

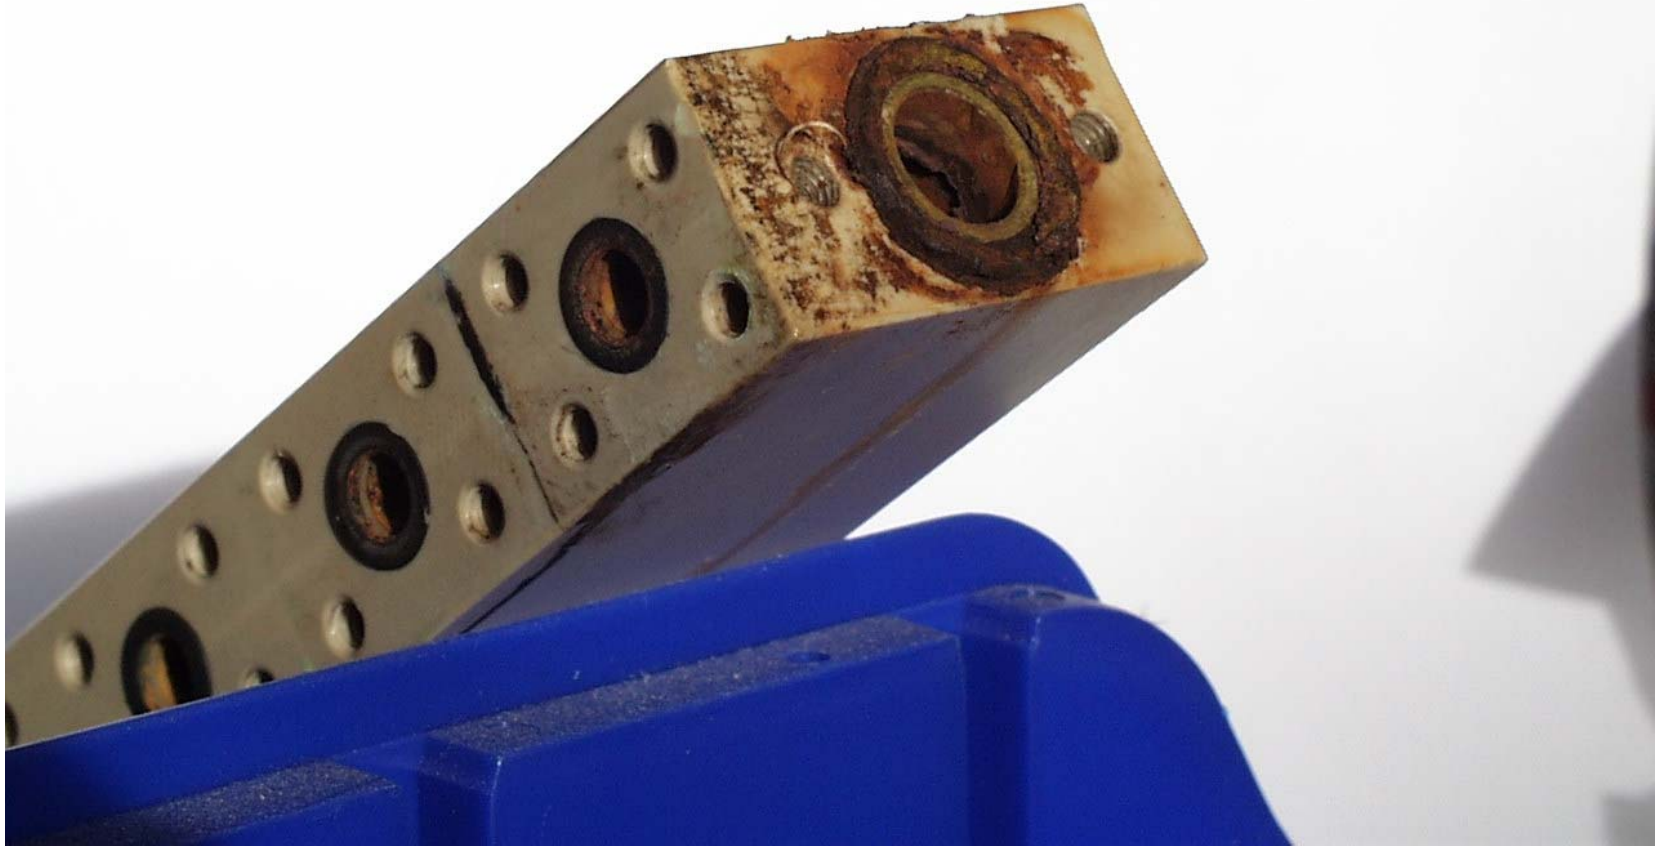
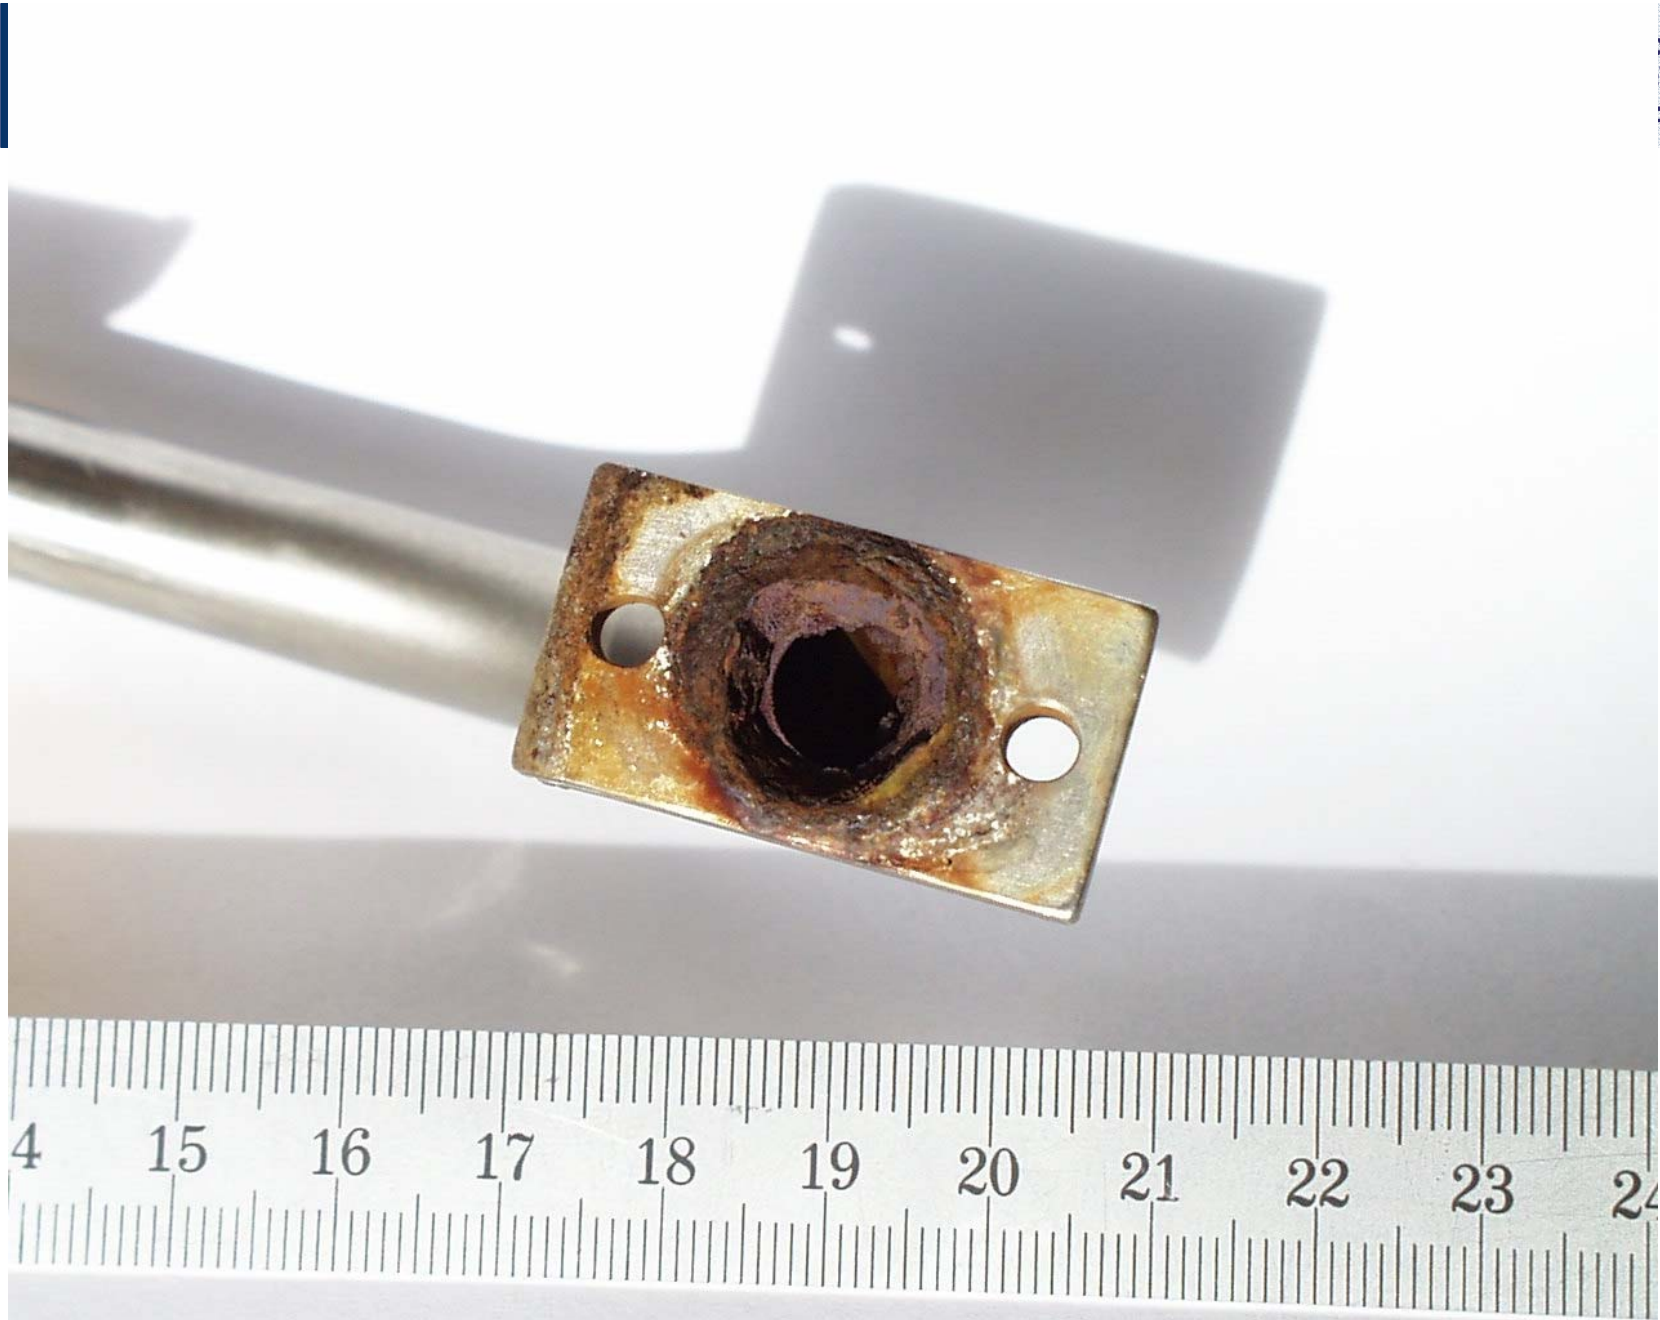
- ➔ An analysis by V. da Silva AT/MEL/MI in 2005 showed that corrosion problems were due to insufficient quality of the demineralized water:
 - too high conductivity (up to 15 microS/cm, nominal 0.5 microS/cm),
 - resin cartridges not regularly exchanged and problems of monitoring the conductivity.
 - As a consequence of the low water quality the inner walls of the cooling channel were corroded resulting in a deposit of $\text{CuO} + \text{Cu}_2\text{O}$ blocking the water circulation of the coils .
- ➔ In close collaboration with TS/CV we purchased + installed new devices to monitor the water quality online (operational since 3-2006).

- ➔ 2005: Fabrication of 5 new coil sets (3rd generation) to be mounted in the existing yokes at SEF/FR. The coils had improved cooling features (cooling per half-turn instead per full-turn) in order to reduce the very high water speed and the maximum coil temperature.
- ➔ March 2006: Installation of MNP23 with 1st new coil set from SEF.
- ➔ April 2006: a short circuit required the replacement of the MNP23 just before beam operation.
- ➔ July 2006: an electrical breakdown in the 2nd coil set required the replacement of the magnet.
- ➔ October 2006: an electrical breakdown in the 3rd coil set ended its operation after 4 weeks only.

- ➔ As the origin of the breakdown was fully unclear, it had been decided to use the 4th coil set in order to launch a study including simulations and measurements under true operating conditions (except beam).
- ➔ A study started in November 2006 by M. Zerlauth AB-CO & J. Kozak AT-MTM, D. Bodart AT-MEL & A. Beuret AB-PO using the 4th coil set. .
- ➔ The preliminary results after about 4 weeks were as follows:
 - no convincing fault explanation yet
 - the max over-voltage spikes from the power converter are only about 50% above the nominal max of 400 V.
 - several kV are required for causing the severe damage observed!

- ➔ Mid-February 2007: The study will continue when cooling water is again available until the origin is found.
- ➔ Results will be used for an improved fabrication of the 5th new coil set followed by long-term testing before an eventual re-installation in 2008.
- ➔ February 2007: install C-shaped MCB magnet to replace MNP23 for 2007 operation.

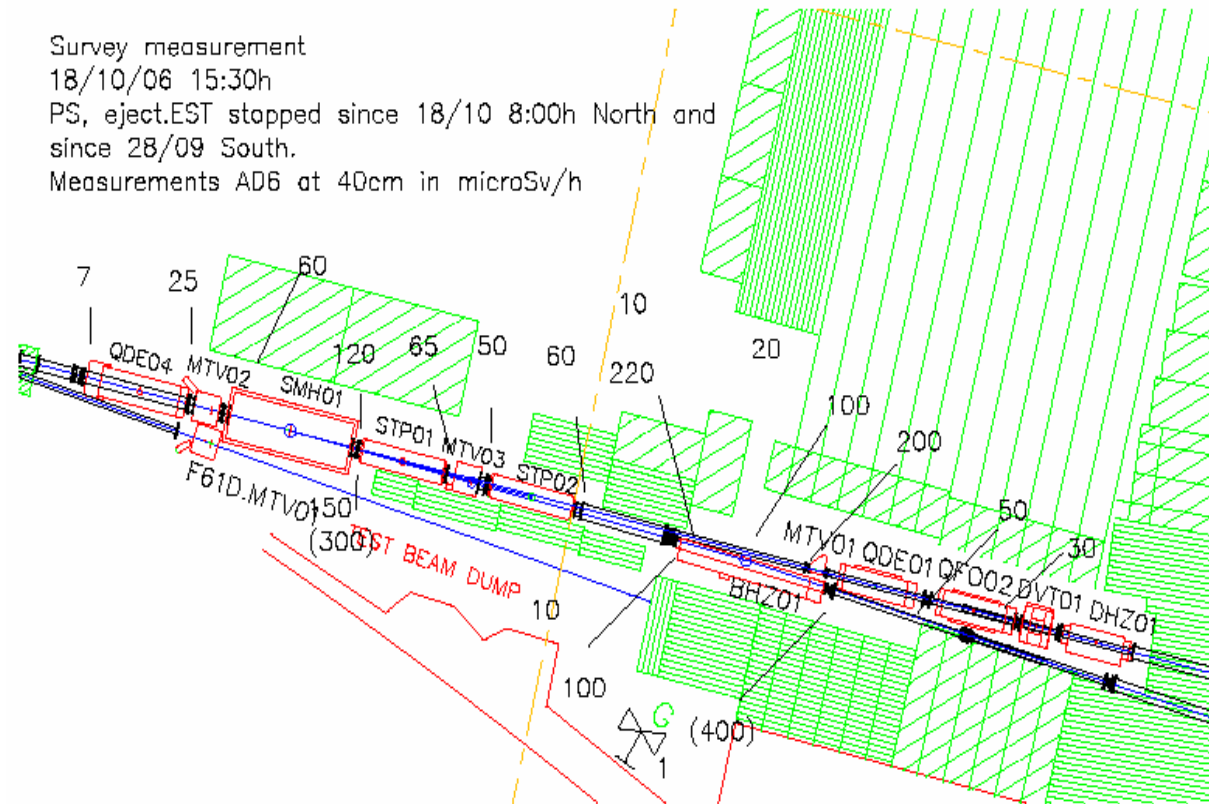
Survey measurement
 18/10/06 15:30h
 PS, eject.EST stopped since 18/10 8:00h North and
 since 28/09 South.
 Measurements AD6 at 40cm in microSv/h

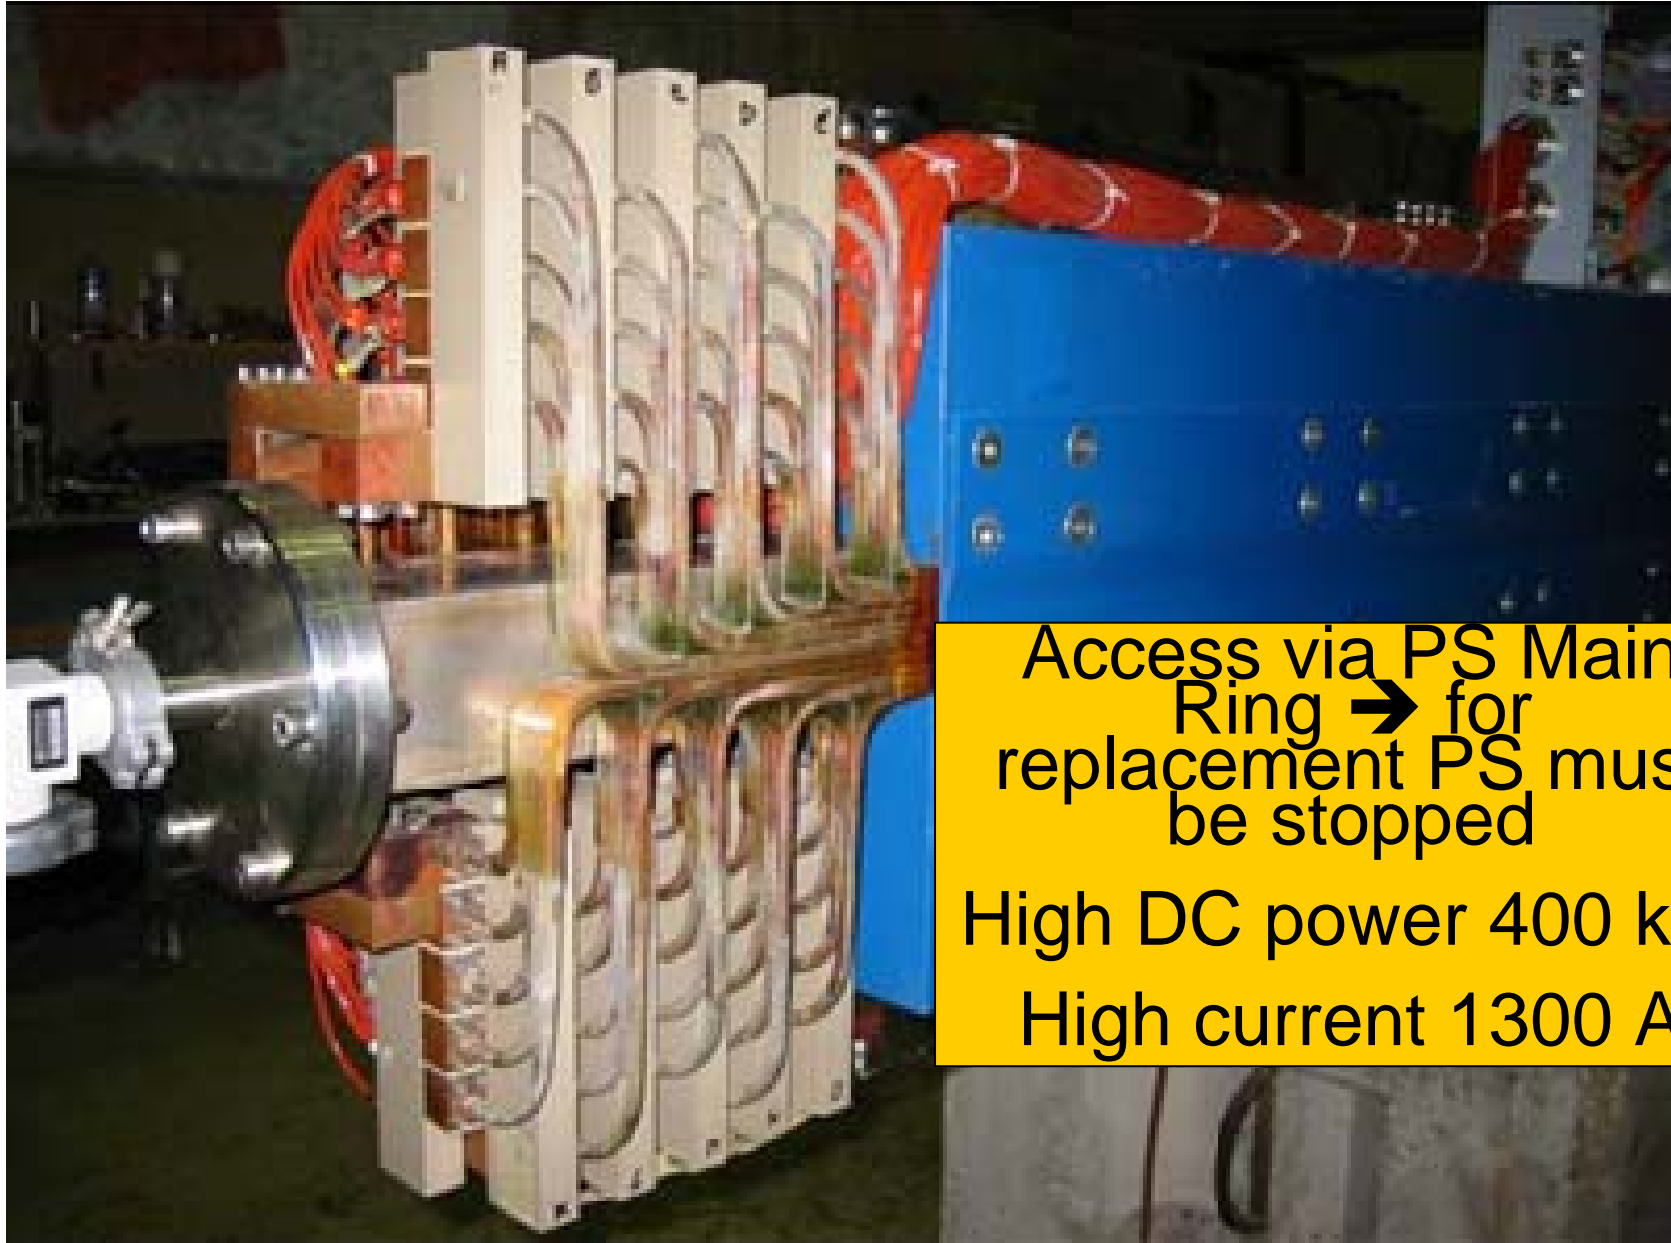
→ Beam line layout for F61 + F61S+N + line T10:

- Insufficient space for interventions
- In high dose level zones insufficient transversal space
 - one can only move along the lines and
 - thus it takes too long to escape rapidly from the radiation field.

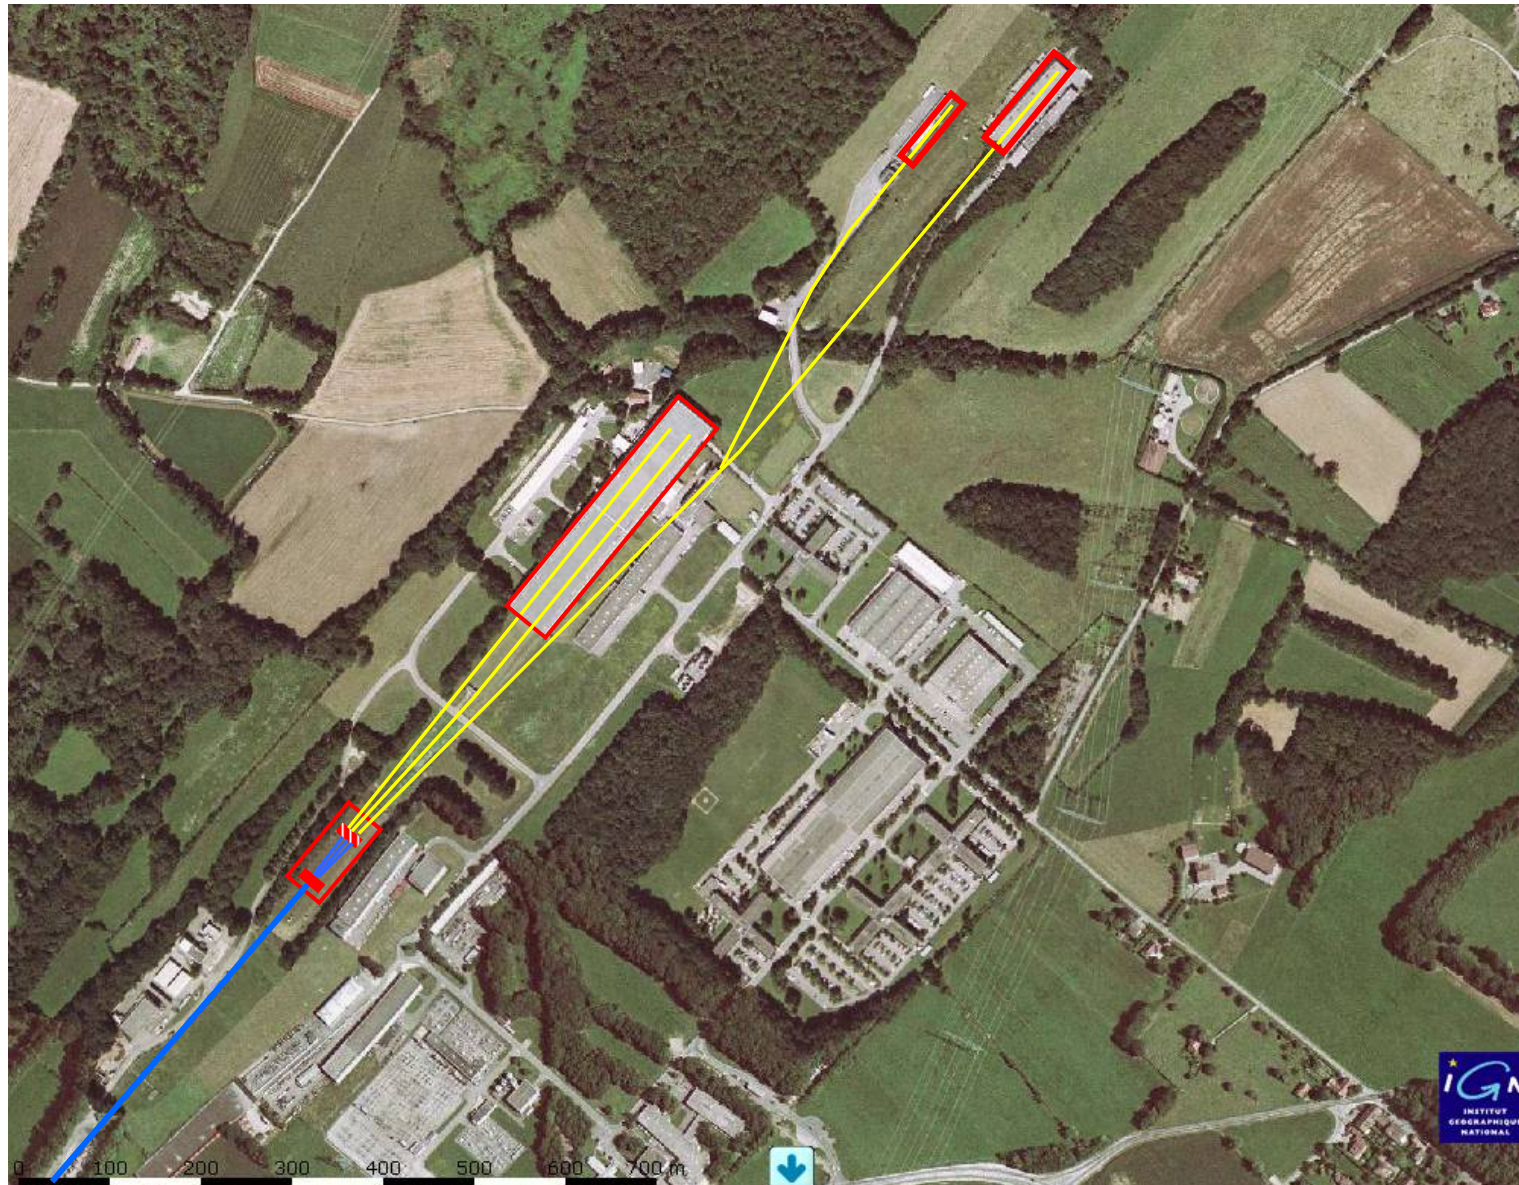
→ 2 recent breakdowns on MSN manifolds (1 during 2005 shutdown, 1 during 2006 run)
