## I PS EAST HALL MAGNETS

## II SPS NORTH EXP. AREA MAGNETS

ATC-ABOC days 24-1-2007 PS+SPS EA magnets W.Kalbreier, D.Smekens, T.Zickler AT-MEL

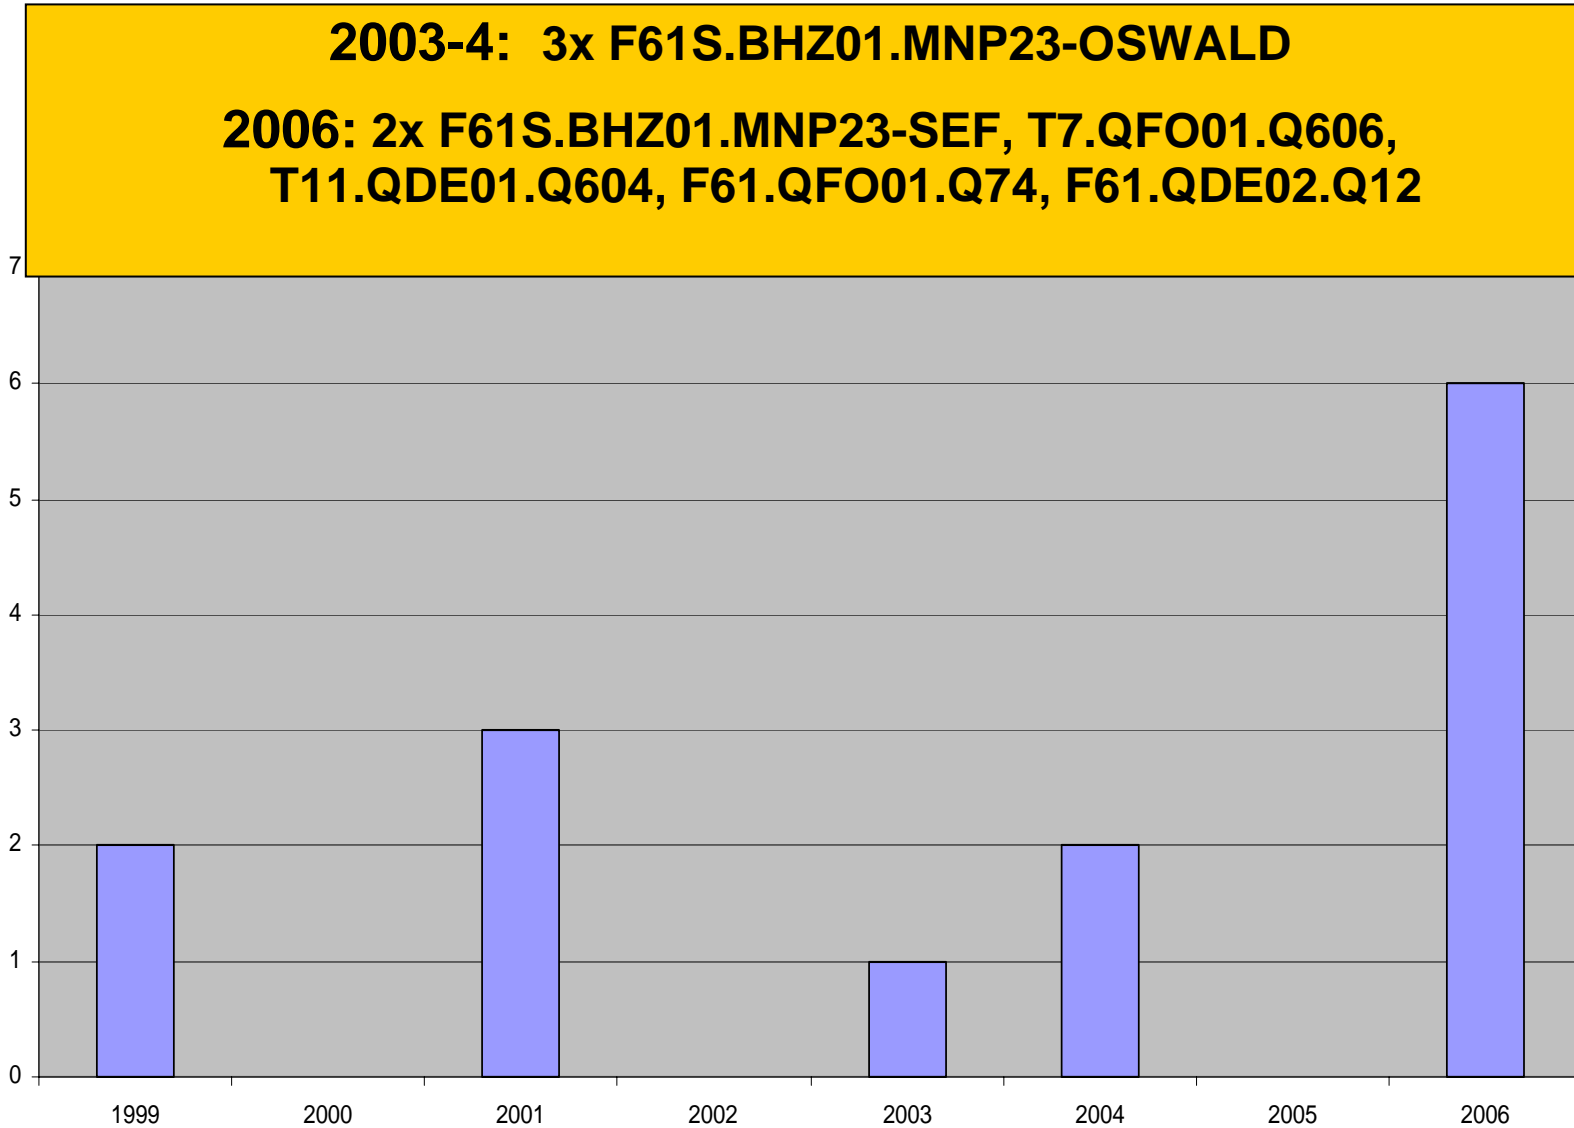
Access via PS Main Ring → for any magnet replacement PS must be stopped

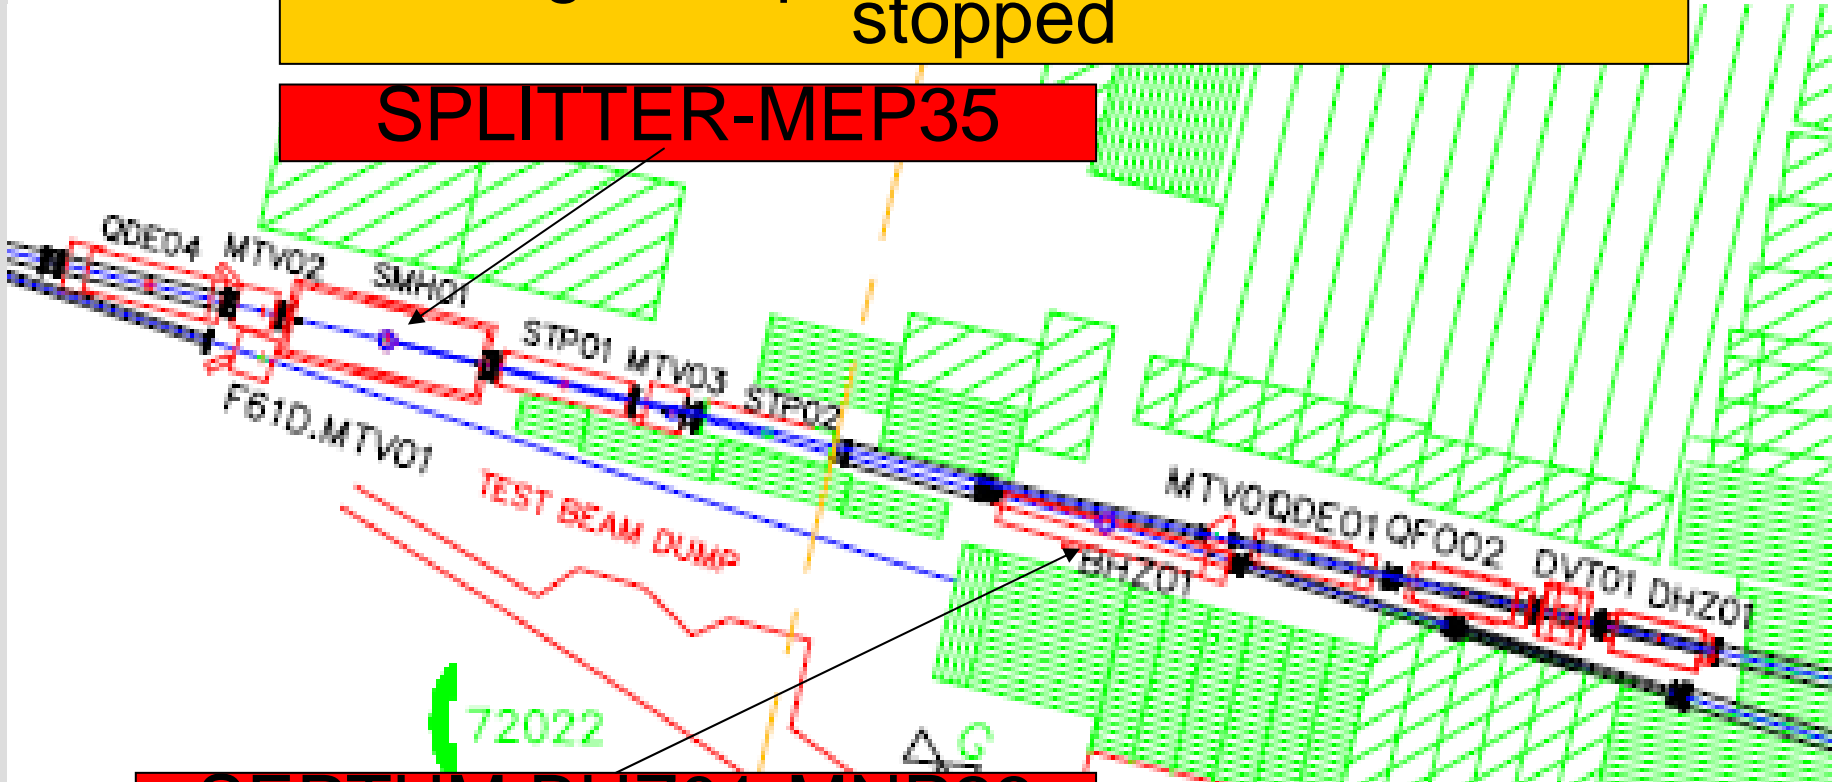
**SEPTUM BHZ01-MNP23**

**After installation → Access via PS Main Ring**  
**→ for replacement PS must be stopped**

- High DC power 400 kW
- High current 1300 A

# F61S. BHZ01.MNP23 10-2006 breakdown 3<sup>rd</sup> coil SEF

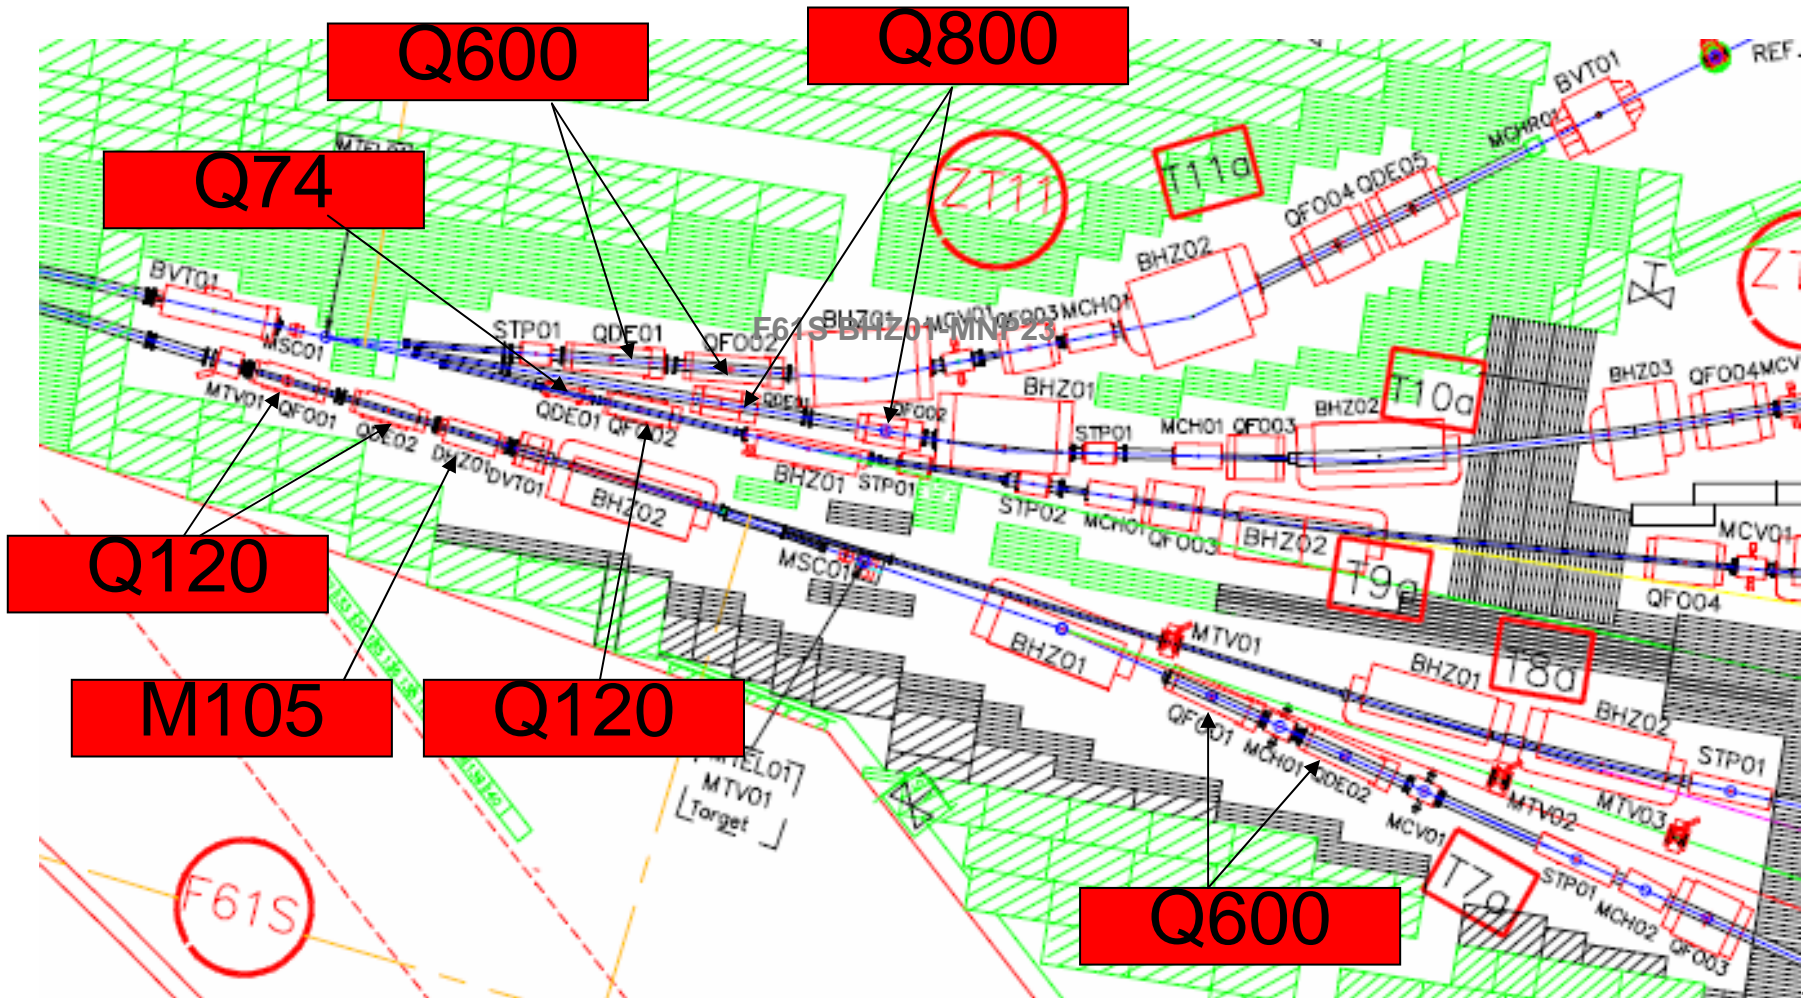
# East hall primary zone: Access possible during PS operation

Extremely densely packed + covered with concrete shielding roof → for any magnet replacement an opening + closing takes 2 weeks + cool-down + magnet exchange period

**As MNP23 problems have been presented in several ATC sessions in 2006 I skip it here + leave it for questions.**

**→ February 2007: install C-shaped MCB magnet to replace MNP23 for 2007 operation.**

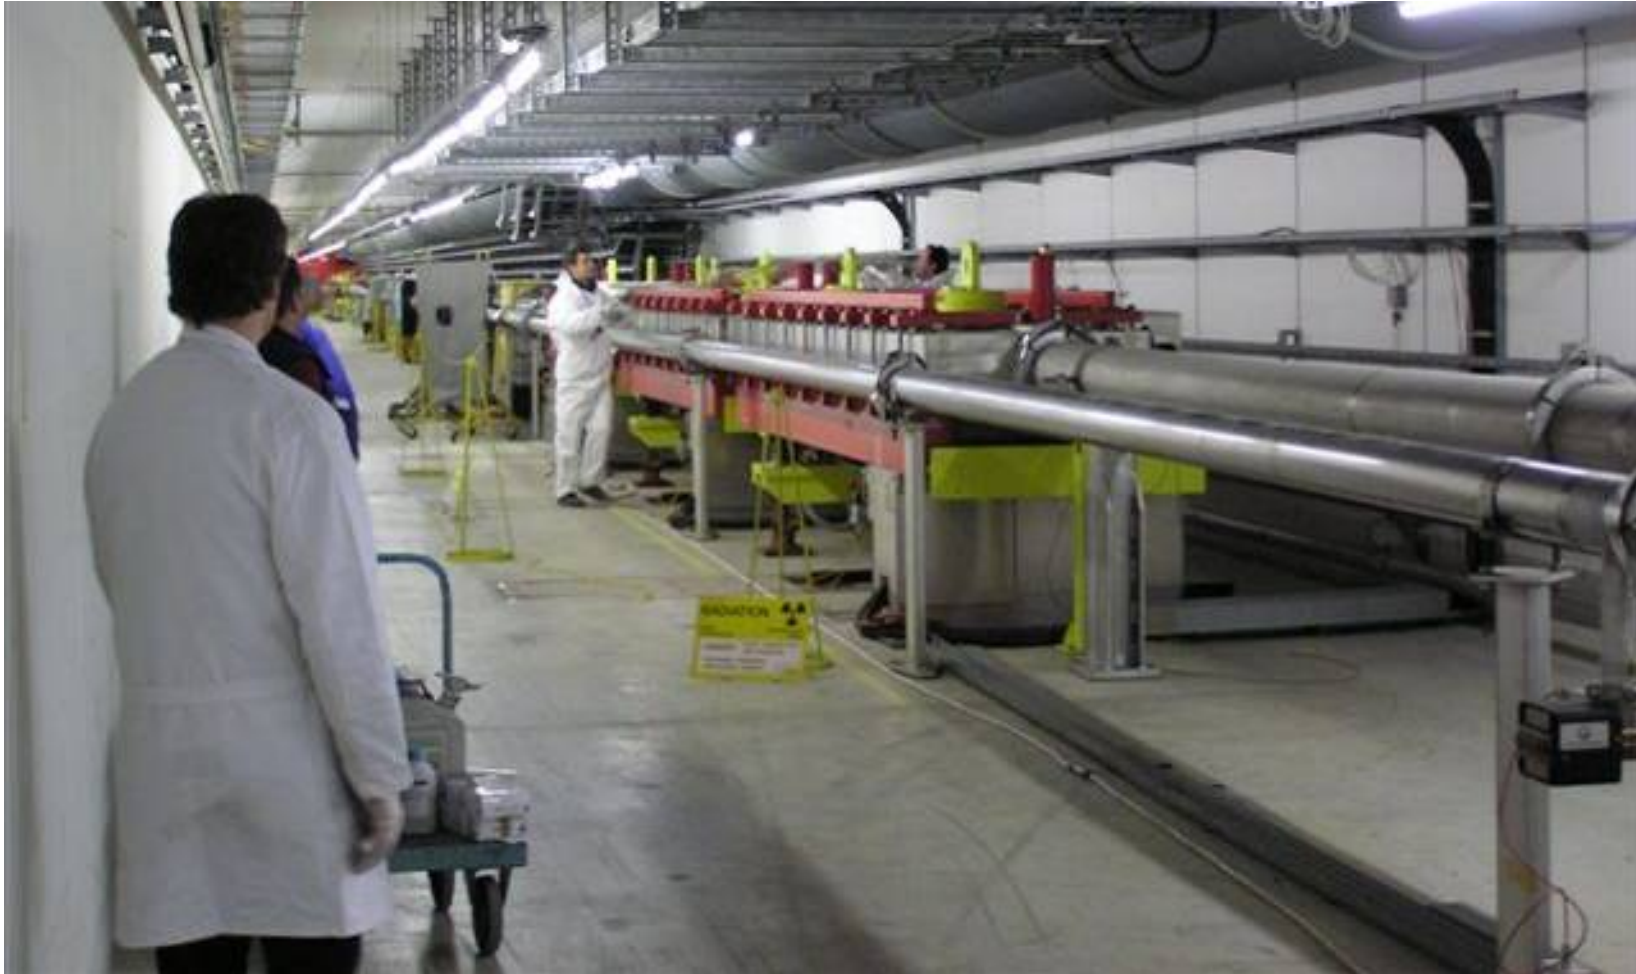
- ➔ **MSSB Splitter Magnet Situation**
  - 1 spare magnet for North Area
  - Corrosion problem on all 6 North Area MSSB magnets
- ➔ **Risk of several failures in a row**
- ➔ **Availability of 3 West Area MSSB magnets (different septum profile)**
  - Conversion WEA MSSB into NEA MSSB seems possible

- ➔ Vacuum leaks. Due to corrosion of the stainless steel in contact with the PVC material used for the covers (made in the 70's).
- ➔ Not repairable in situ. Leaky Magnets have to be replaced

**Replacement of 1 complete upper yoke+vacuum tank: ~115kCHF**

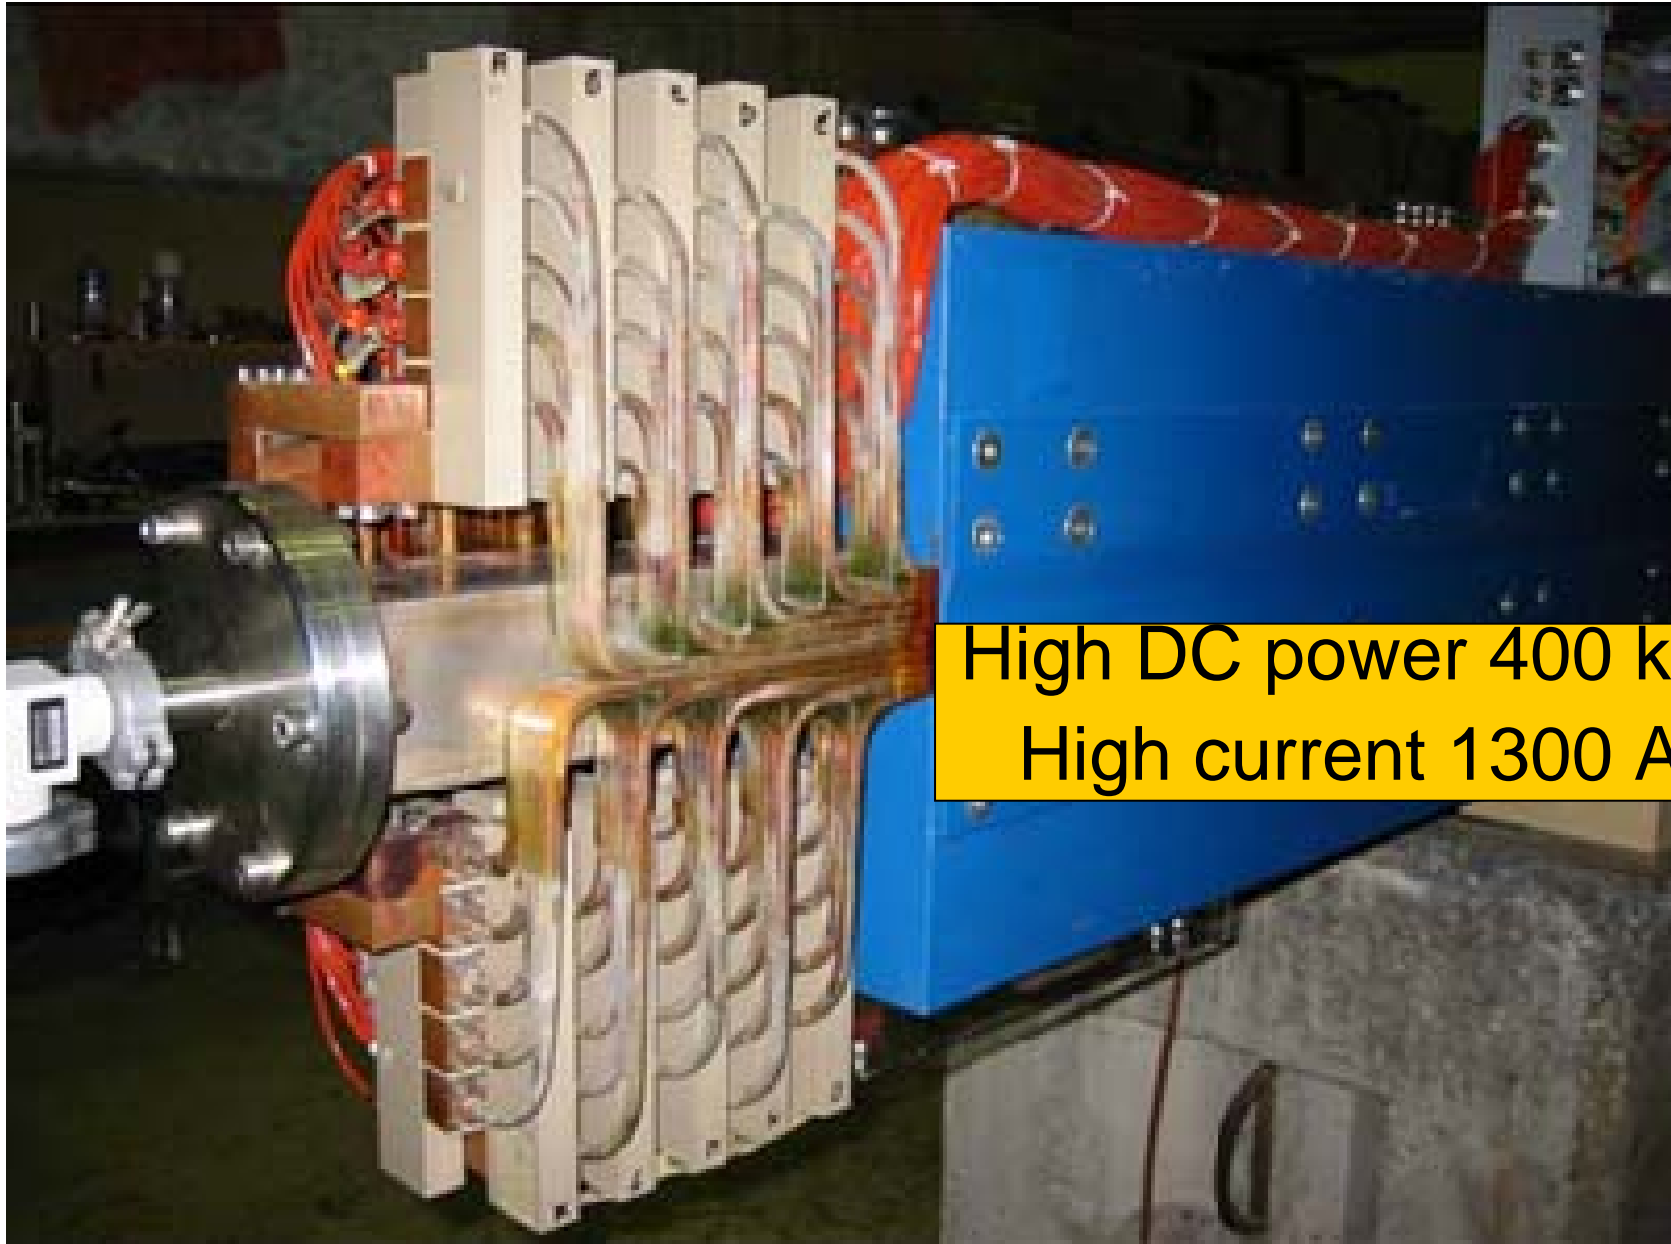
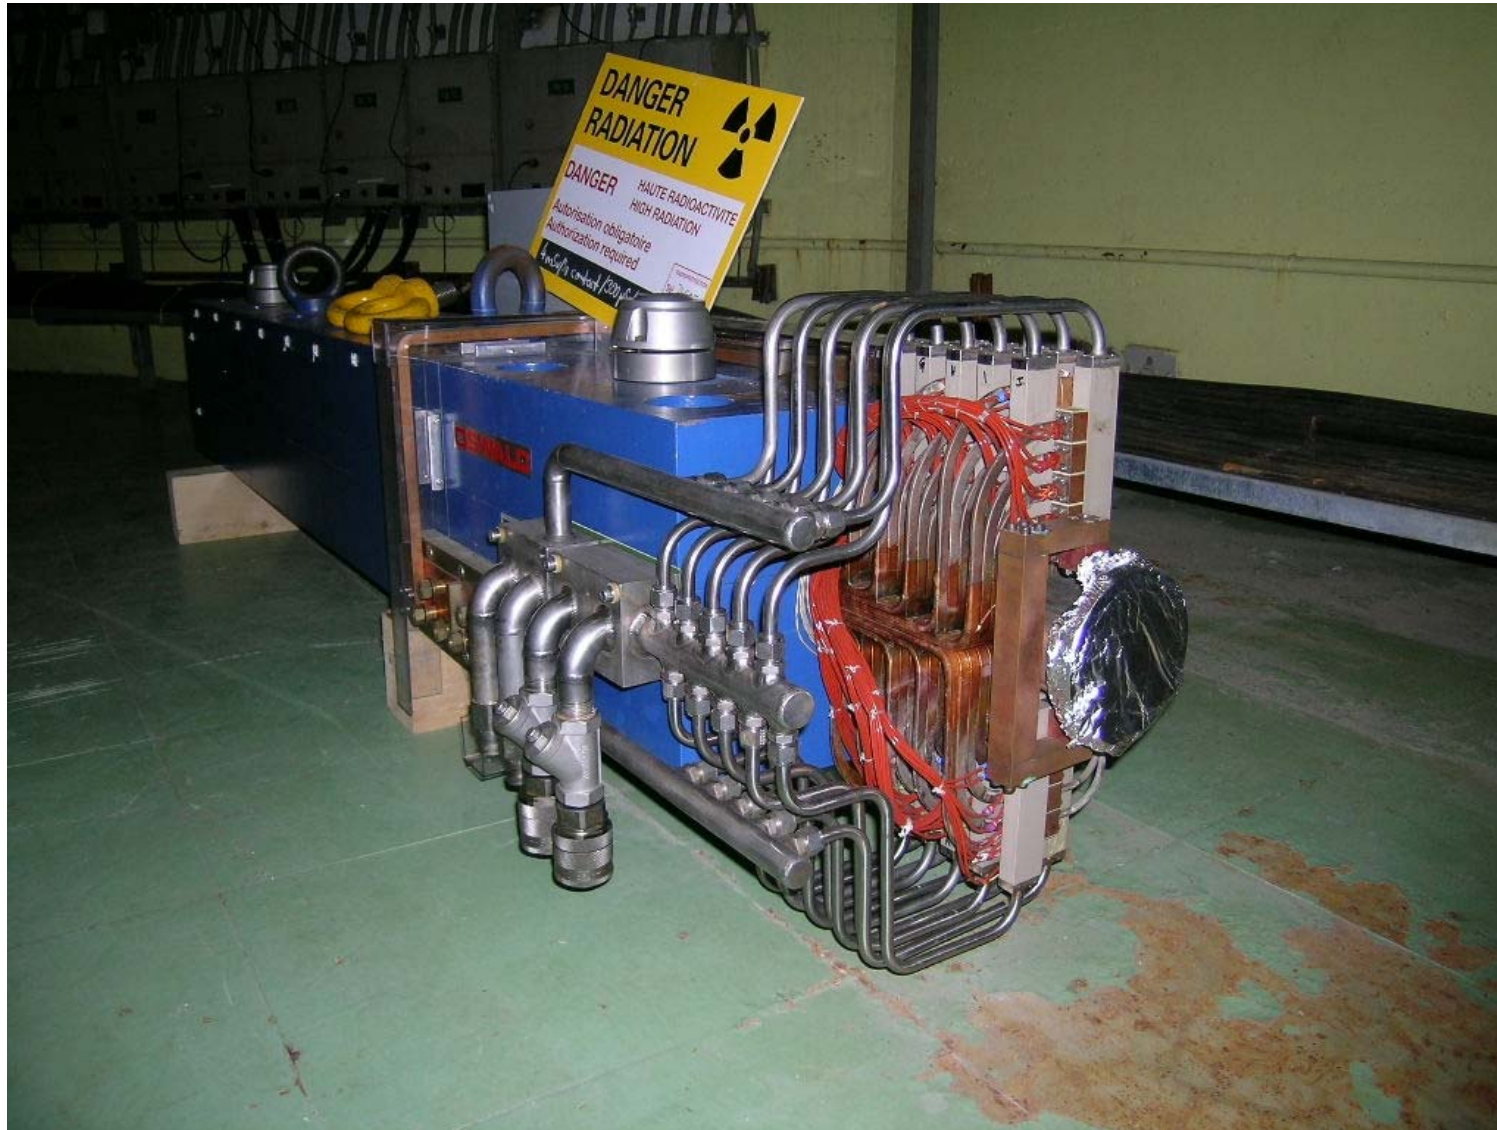
→ Damaged unit in F61S was replaced the 1<sup>st</sup> unit of the new septum in March 2002 & operated until November 2003 (→ water leak + cooling channels blocked due to corrosion).

High DC power 400 kW  
High current 1300 A

- July 2004: high leakage current + cooling channels blocked by a deposit stemming from corrosion. → required the replacement of the 2<sup>nd</sup> unit operating since March 2004.
- November 2004: same problems with the 3<sup>rd</sup> unit operating since September 2004.

- An analysis by V. da Silva AT/MEL/MI in 2005 showed that corrosion problems were due to insufficient quality of the demineralized water:
- too high conductivity (up to 15 microS/cm, nominal 0.5 microS/cm),
  - resin cartridges not regularly exchanged and problems of monitoring the conductivity.
  - As a consequence of the low water quality the inner walls of the cooling channel were corroded resulting in a deposit of  $\text{CuO} + \text{Cu}_2\text{O}$  blocking the water circulation of the coils .
- In close collaboration with TS/CV we purchased + installed new devices to monitor the water quality online (operational since 3-2006).
