The SPS Beam Dump

Jan Uythoven (AB/BT)

SPS Beam Dumping System

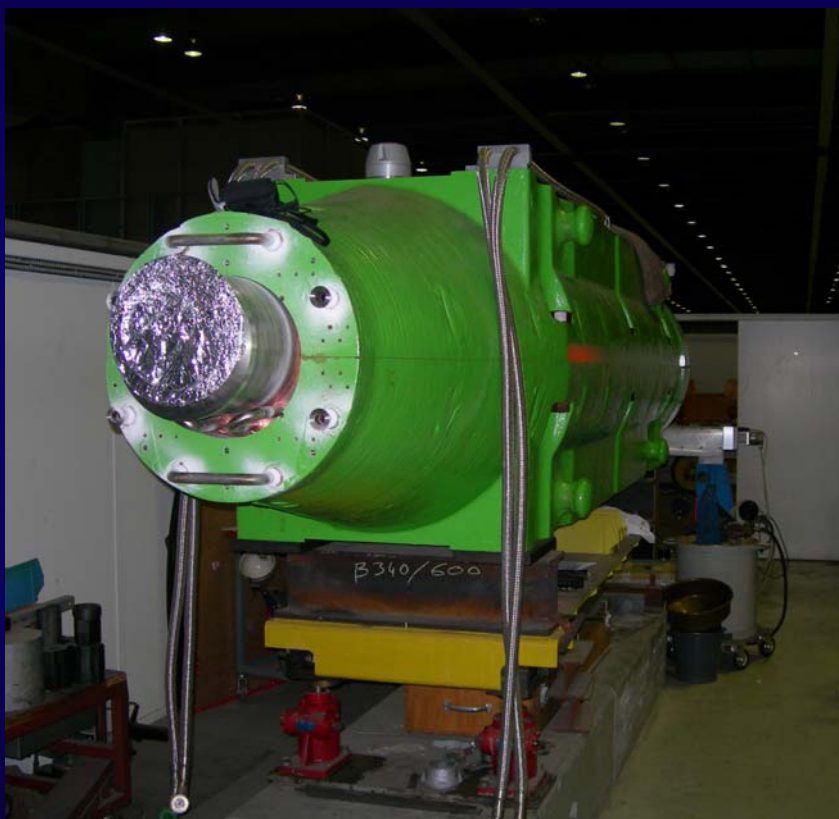
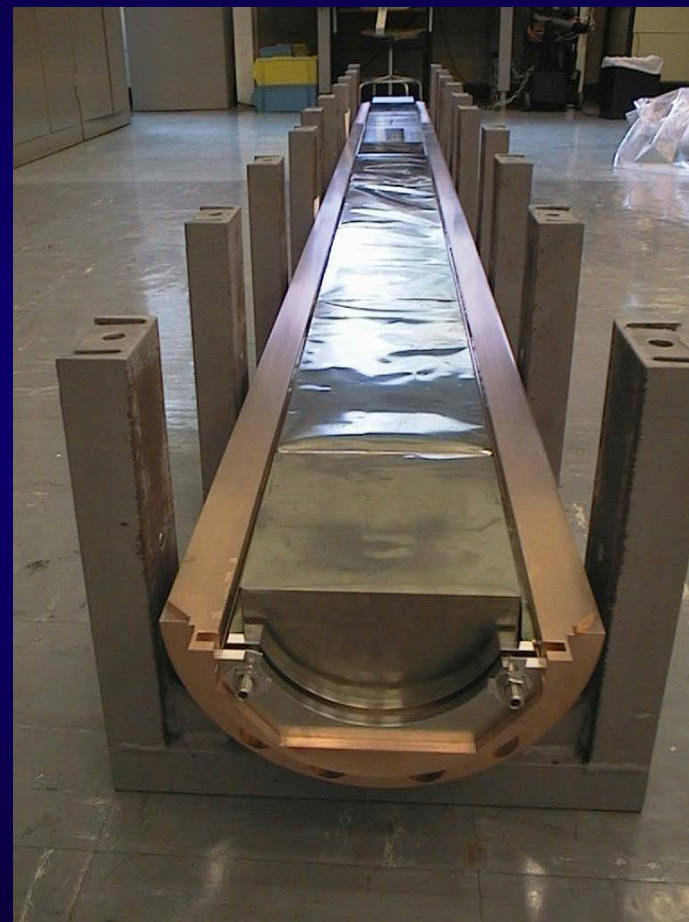
- ◆ ~ 10 years ago TIDV magnet with water cooled Al / CU core
 - ◆ No degassing because different surface material and core well cooled
 - ◆ Small cracks in water cooling system spoiling the vacuum
- ◆ Replaced by first TIDVG with graphite core and Ti foil
 - ◆ Ti foil on top of core to prevent graphite particles to 'float' towards the MKP just next to it
 - ◆ Carefully conditioned with the beam after installation
 - ◆ Couple of weeks dedicated work in parallel with machine set-up
 - ◆ Foil damaged (hit in case of asynchronous dump), leading to 'soft aperture restriction'
- ◆ Replaced 2006 run with TIDVG without foil
 - ◆ 'Bake-out' in situ with warm water under pressure (150 °C)
 - ◆ Vacuum problems during 2006 run ->
- ◆ Spare (=third) TIDVG soon at workshop in March to remove Ti foil + ??
