Analysis of Booster and Storage Ring RF System Reliability at the Advanced Photon Source

Doug Horan – Advanced Photon Source RF Group
2010 – Sixth CW and High Average Power RF Workshop
ALBA, Barcelona, Spain

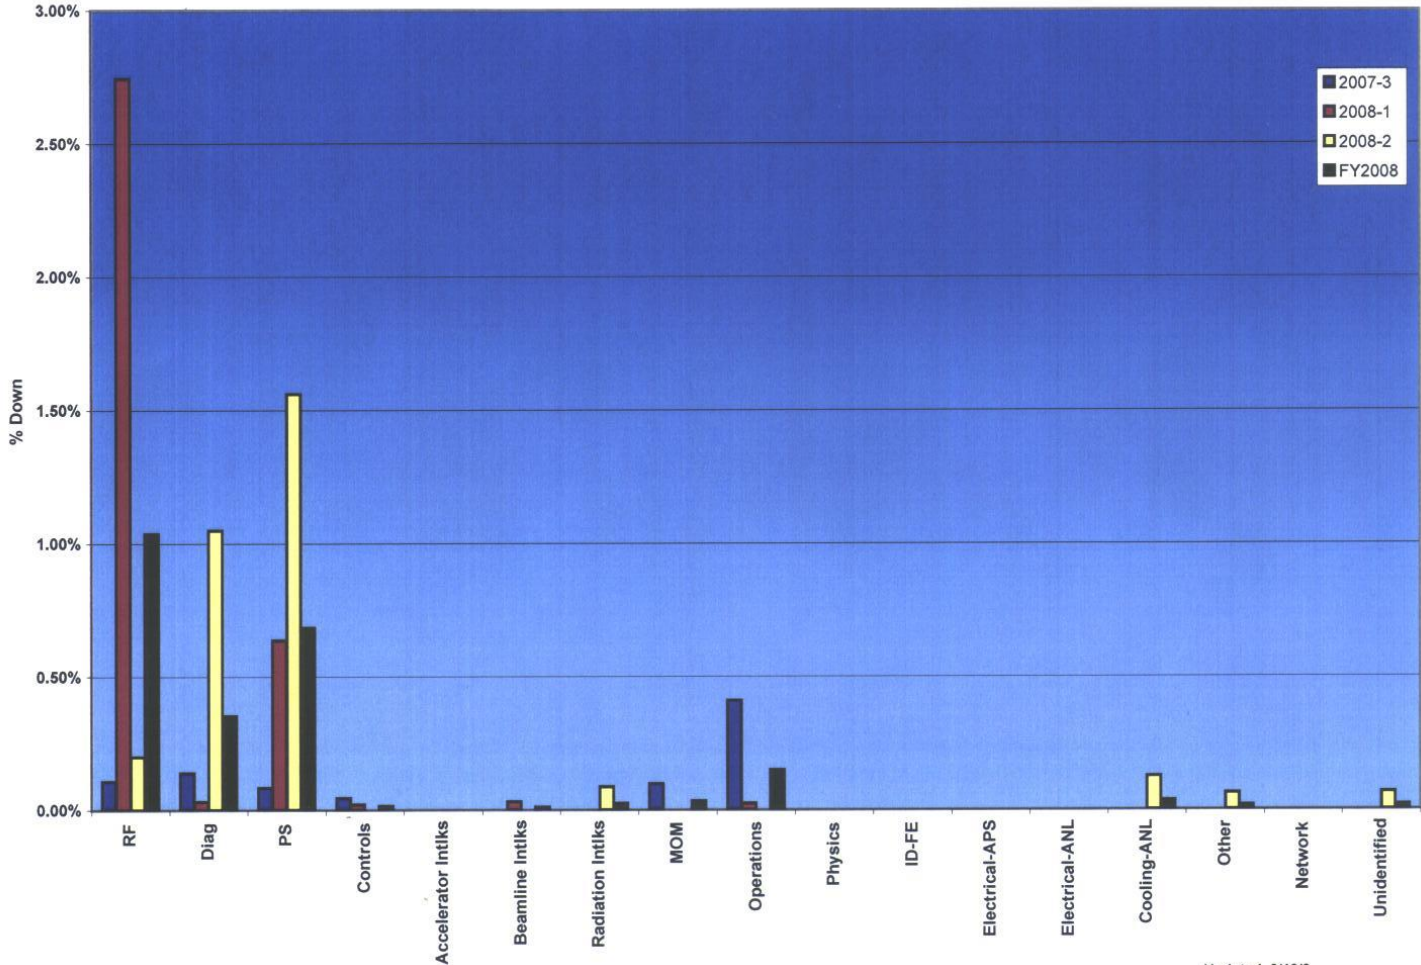
- Overall APS reliability was 97.6% with 91.4 hours mean time to beam loss
- Overall RF downtime was 1.04% with 319.9 hours mean time to beam loss
- 2.75% rf downtime in 2008 was due to booster coupler failure

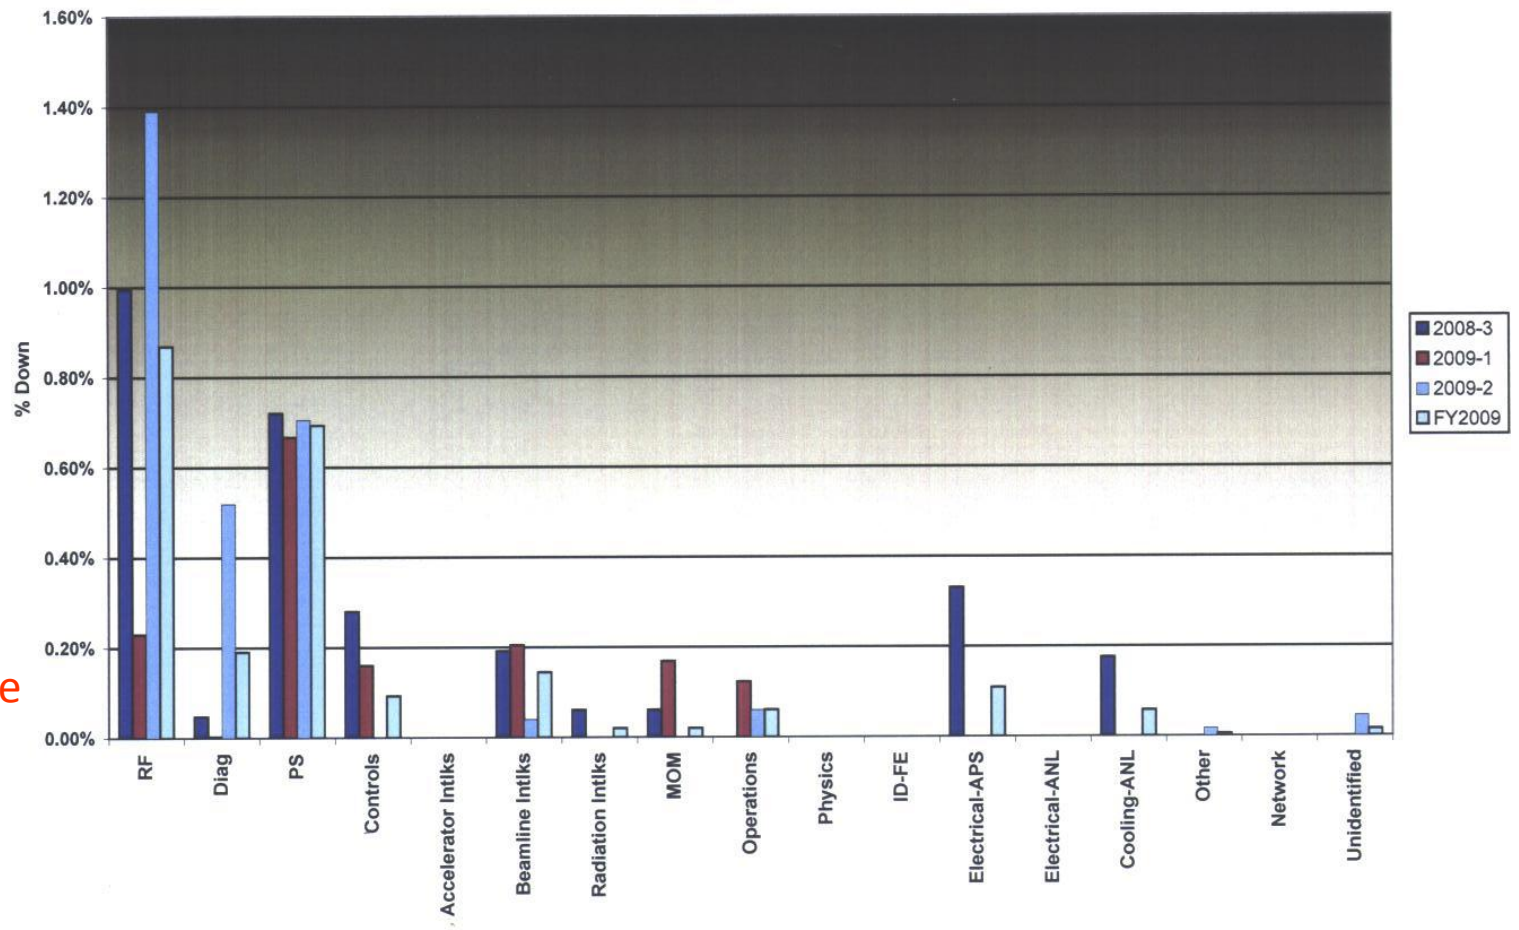
- Overall APS reliability was 97.7% with 77.5 hours mean time to beam loss

- Overall RF downtime was .87% with 271.3 hours mean time to beam loss

- High rf downtime in 2009-2 due primarily to HVPS failures

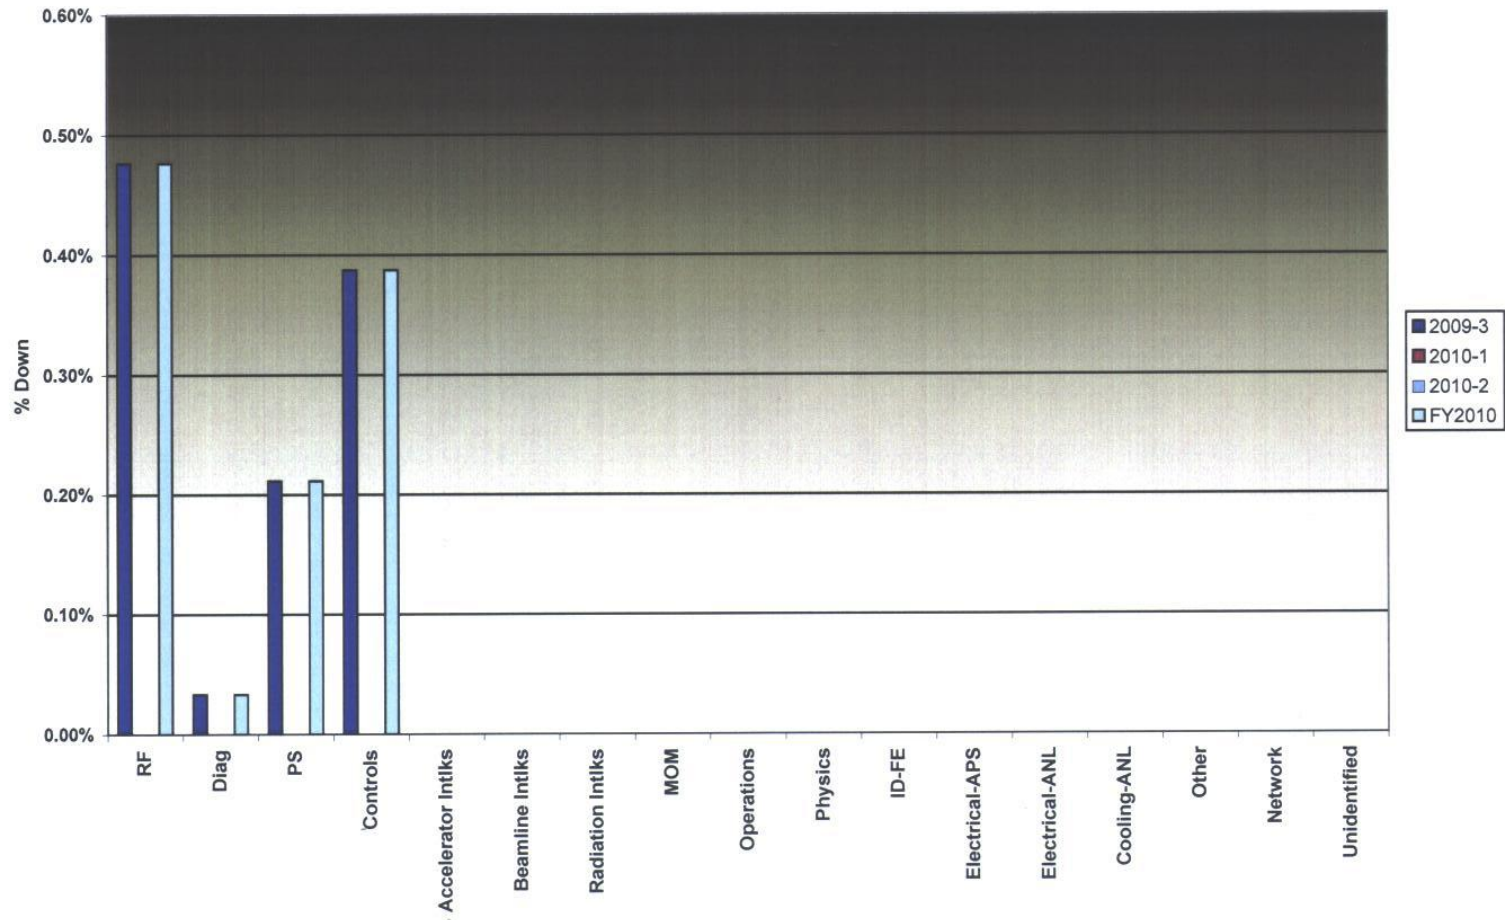
...Overall APS reliability is 98.9% with 139.6 hours mean time to beam loss

...RF downtime is 0.48% with 383.9 hours mean time to beam loss

- **Biggest problem in present run: klystron arc detector tripsnot real?**

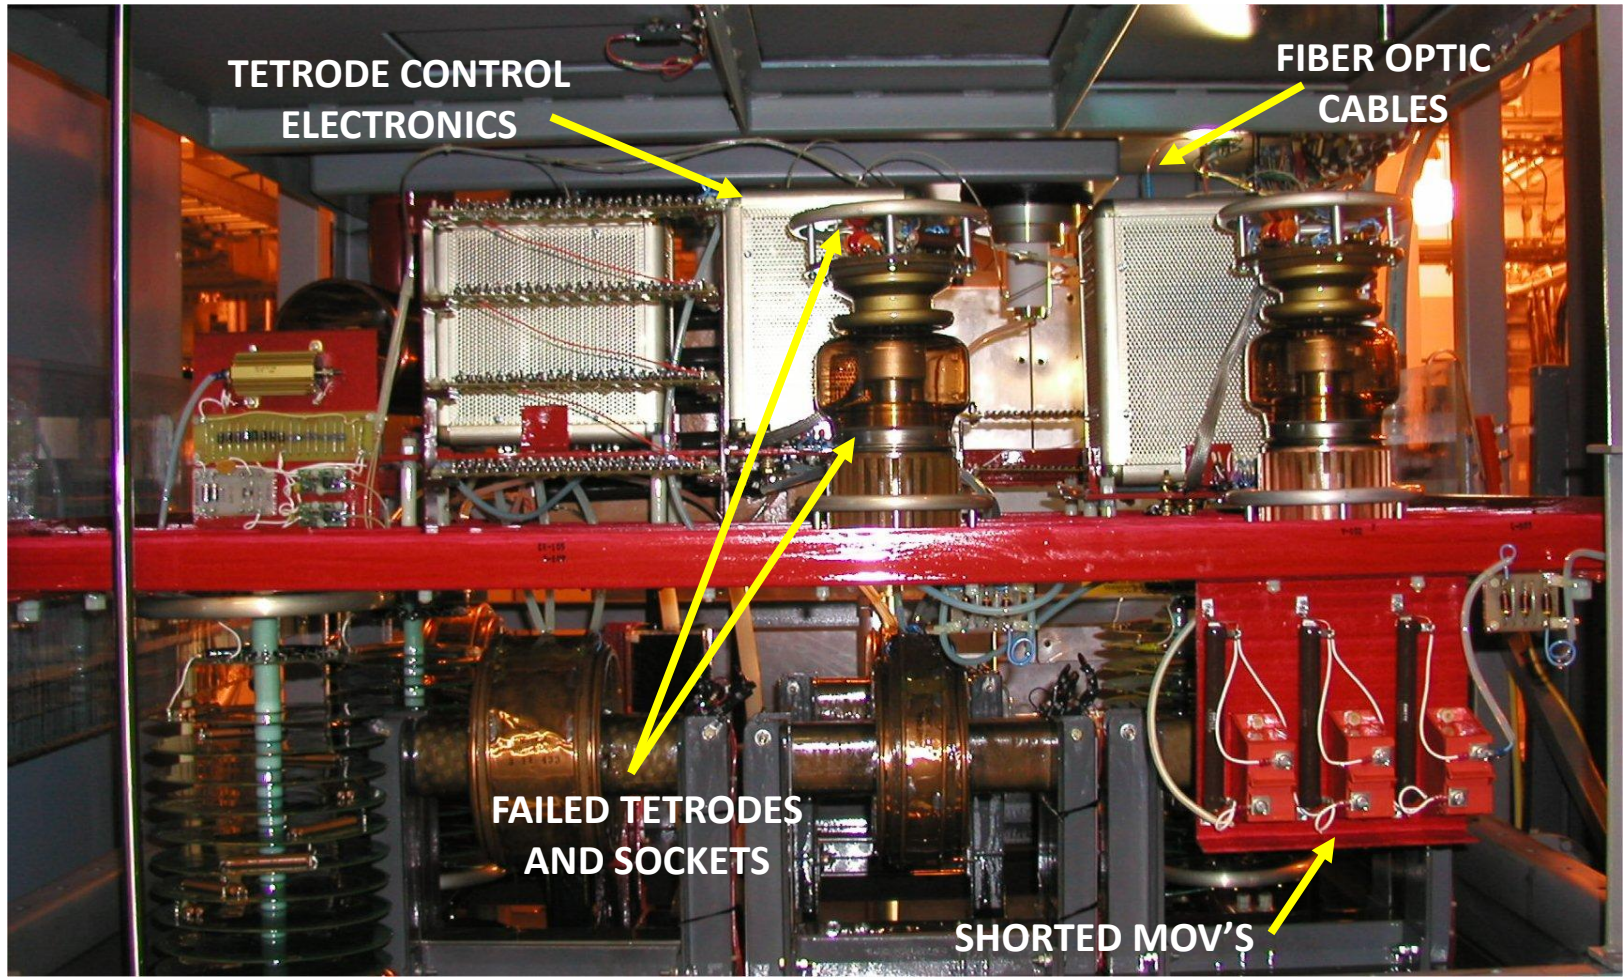
Mod-Anode Regulator Failures

- Many component failures resulting in significant downtime:

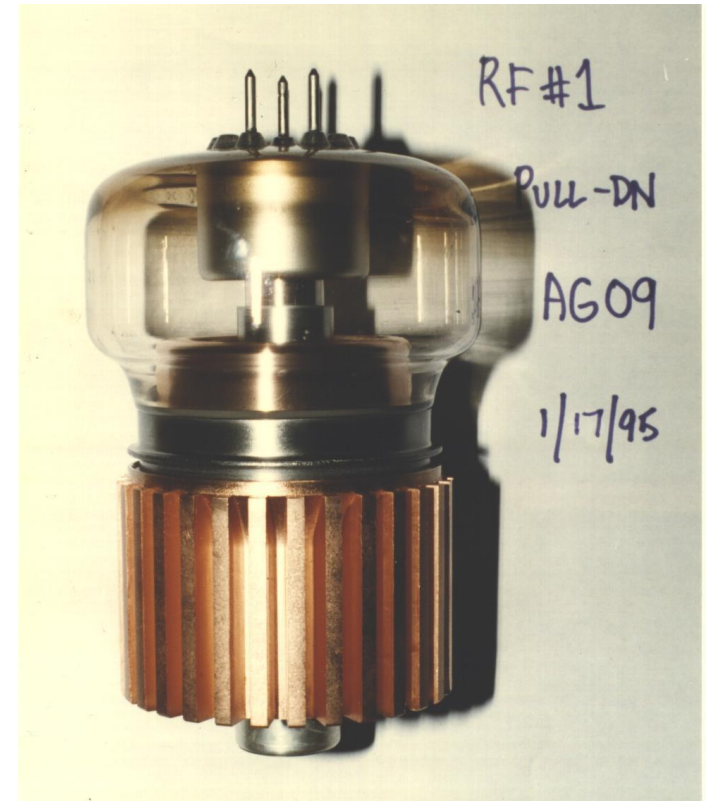
- Two Thales TH5188 tetrodes are used as an active voltage divider in mod-anode regulator
- Production of TH5188 ceased approximately five years ago – *we made bulk purchase for spares*
- *Approximately 5 verified failures in the last ten years*

Solution: A tetrode test set was constructed to evaluate and test new and used tetrodes and other mod-anode electronics modules under high-voltage operation conditions

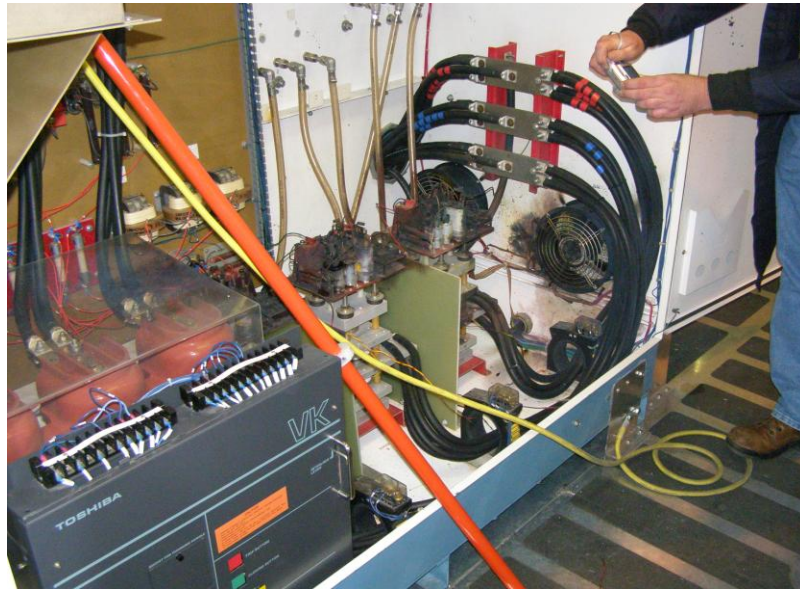
Cathode Voltage Regulator - SCR Cabinet Failures

- Three catastrophic events have occurred: 1996, 2003, 2007
- Root cause in 1996 and 2007 events was traced to failure of SCR snubber capacitors

Solution: Replace original capacitors, and re-configure wiring between SCR stacks to reduce possibility of phase-to-phase shorts when components fail

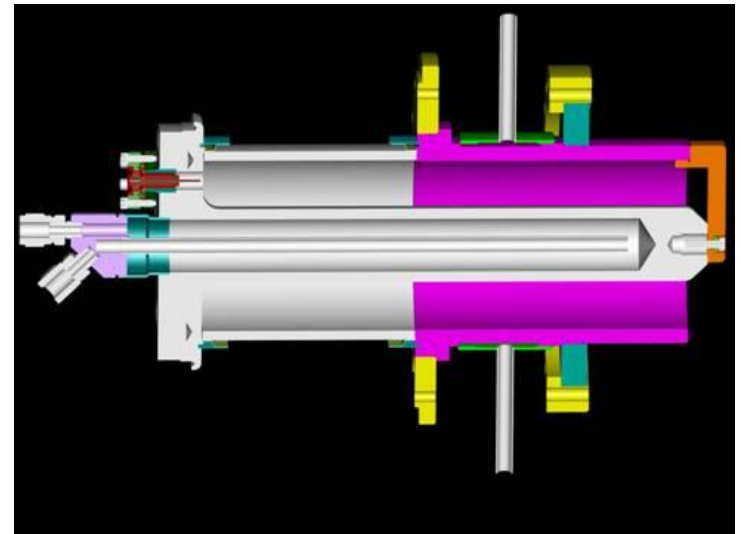
FAILED BOOSTER C1 COUPLER

- **Four coupler failures in the last two years:**
 - 3/22/08 – Booster C1 -- sudden pinhole leak in ceramic
 - 4/25/08 – S40/C2 – intermittent vacuum trips
 - 6/04/08 – S40/C2 – new coupler destroyed by overpower accident during beam studies
 - 6/17/09 – S40/C2 – sudden pinhole leak in ceramic
- **Operating data before failure and post-mortem analysis did not find a definite cause for ceramic pinhole leaks**
