Link Monitor Error Analysis Update

Alexander Schmah
University of
Heidelberg
16.07.2018

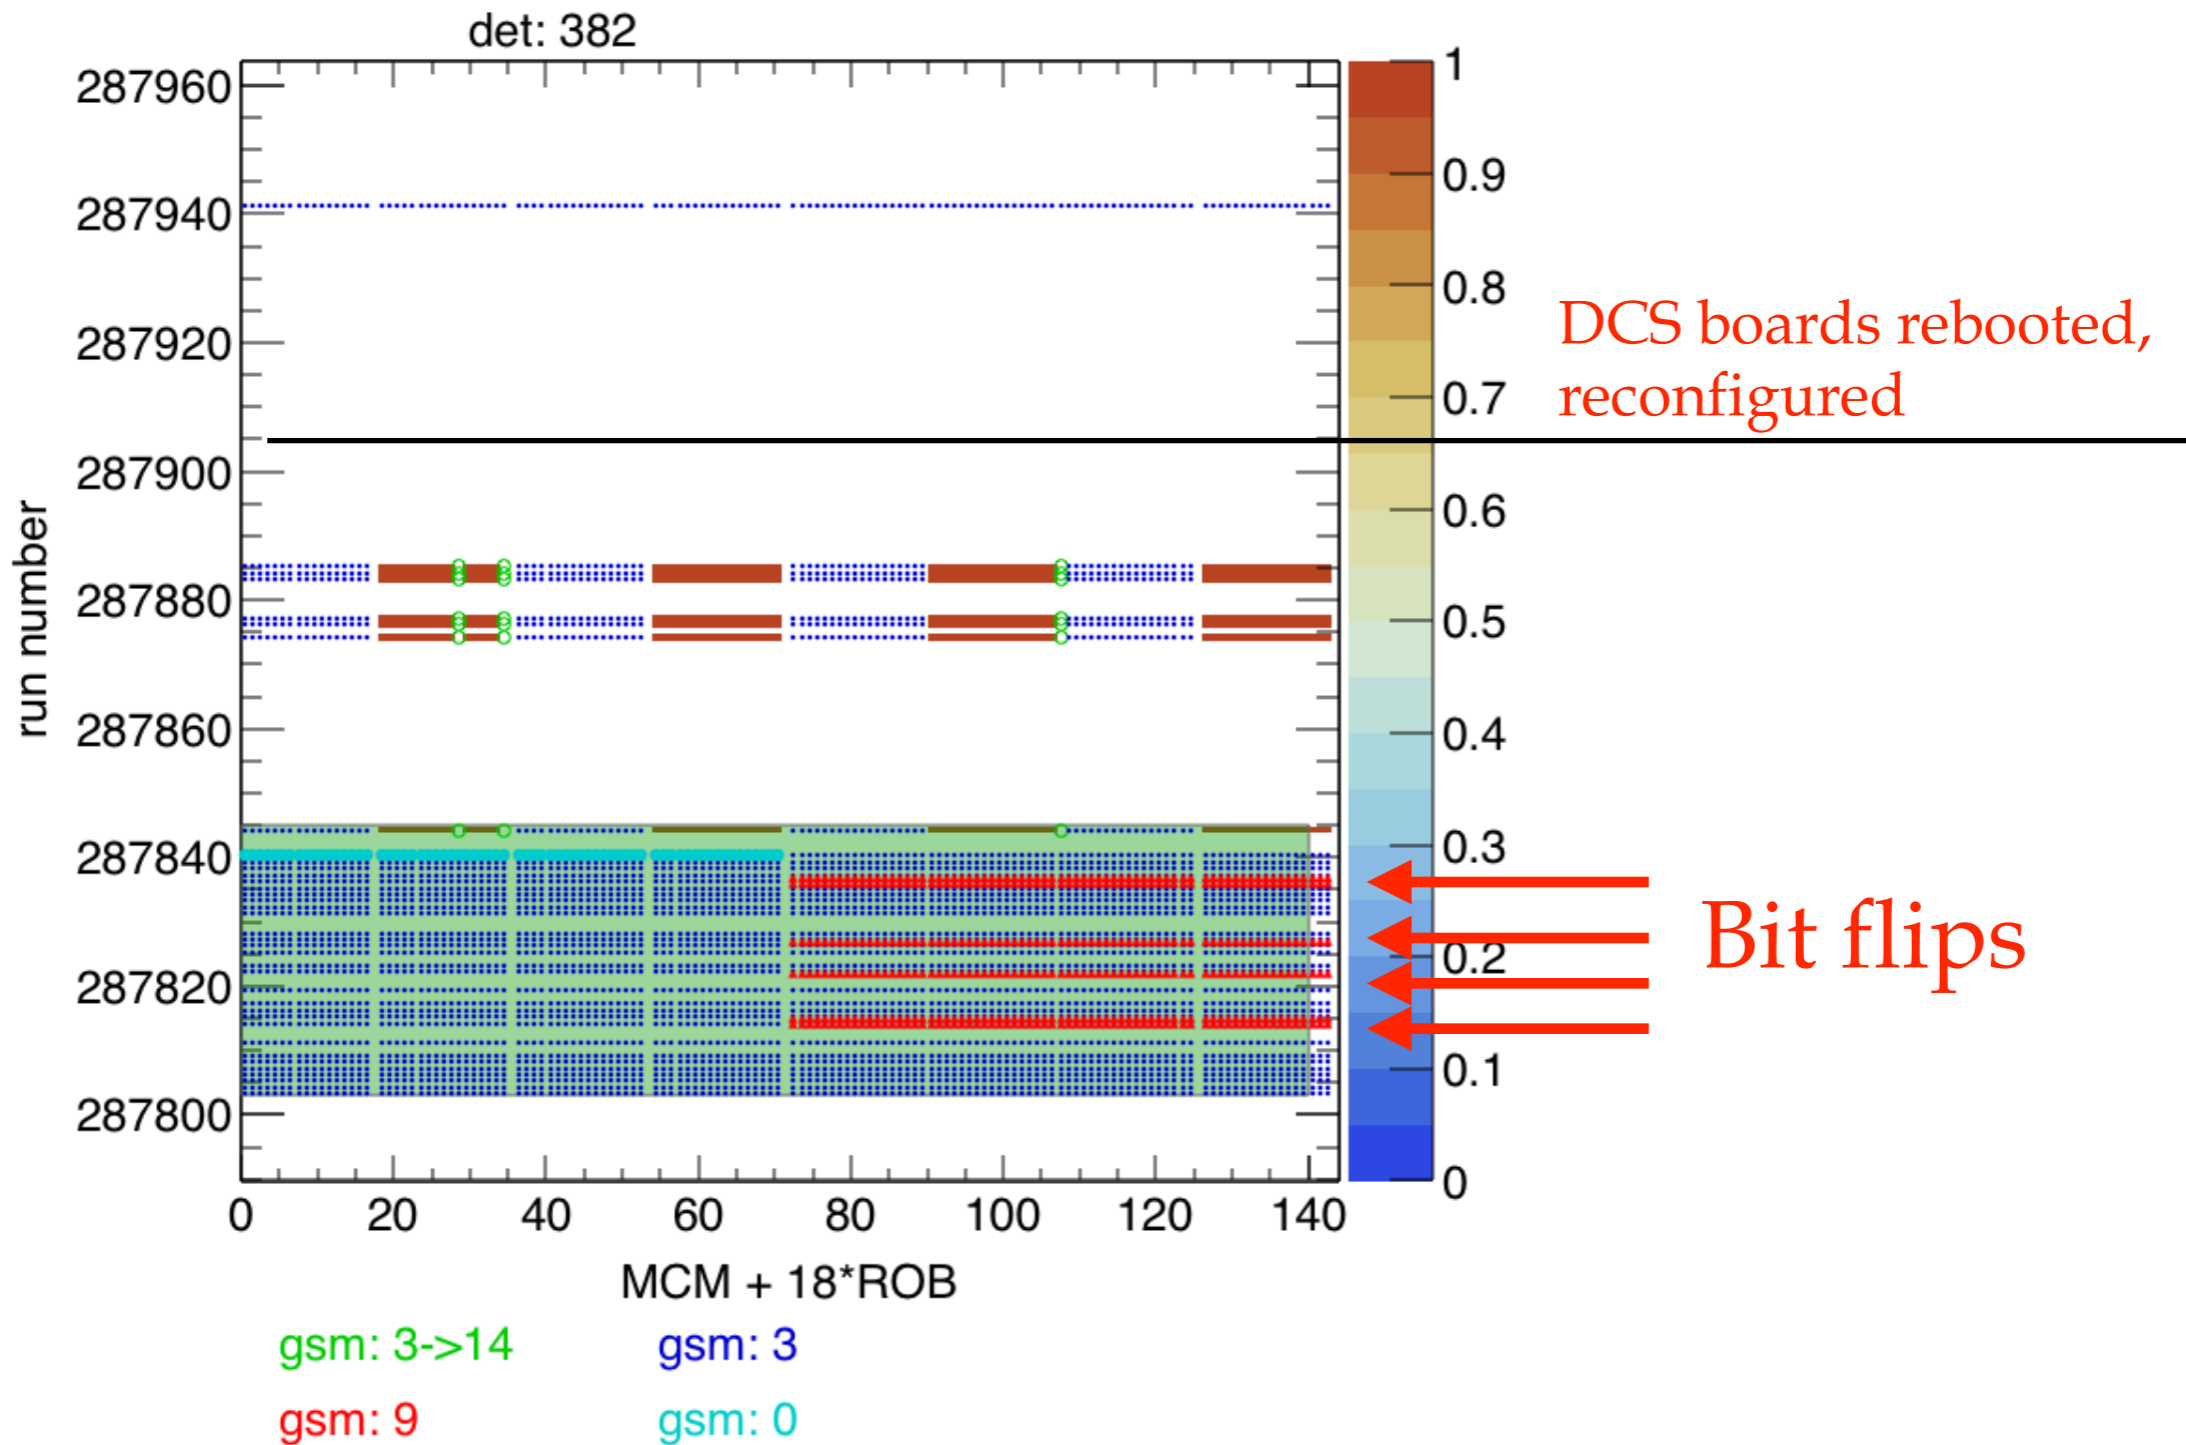
GSM States: TRD det. 382

- This detector shows a really weird error. The event and trigger counters are all fine, then they are both off by exactly one bit (bit 17, not shown here). At this time they are still in mode 3 (wait pre trigger).
- At some point the first 4 ROB switch to gsm state 0 (**low power**), then one MCM within those 4 ROB is causing a problem, gsm state 14 (**tracklet send**), the half chamber then switches to gsm state 9 (**full readout**).
- Later the two counter are again in perfect agreement with ALL other MCMs.
- The 4 ROB are from different half chambers. It is not at all easy to understand how this could happen. Sebastian and I discussed it with Venelin. There might be some possibilities but its not conclusive yet.

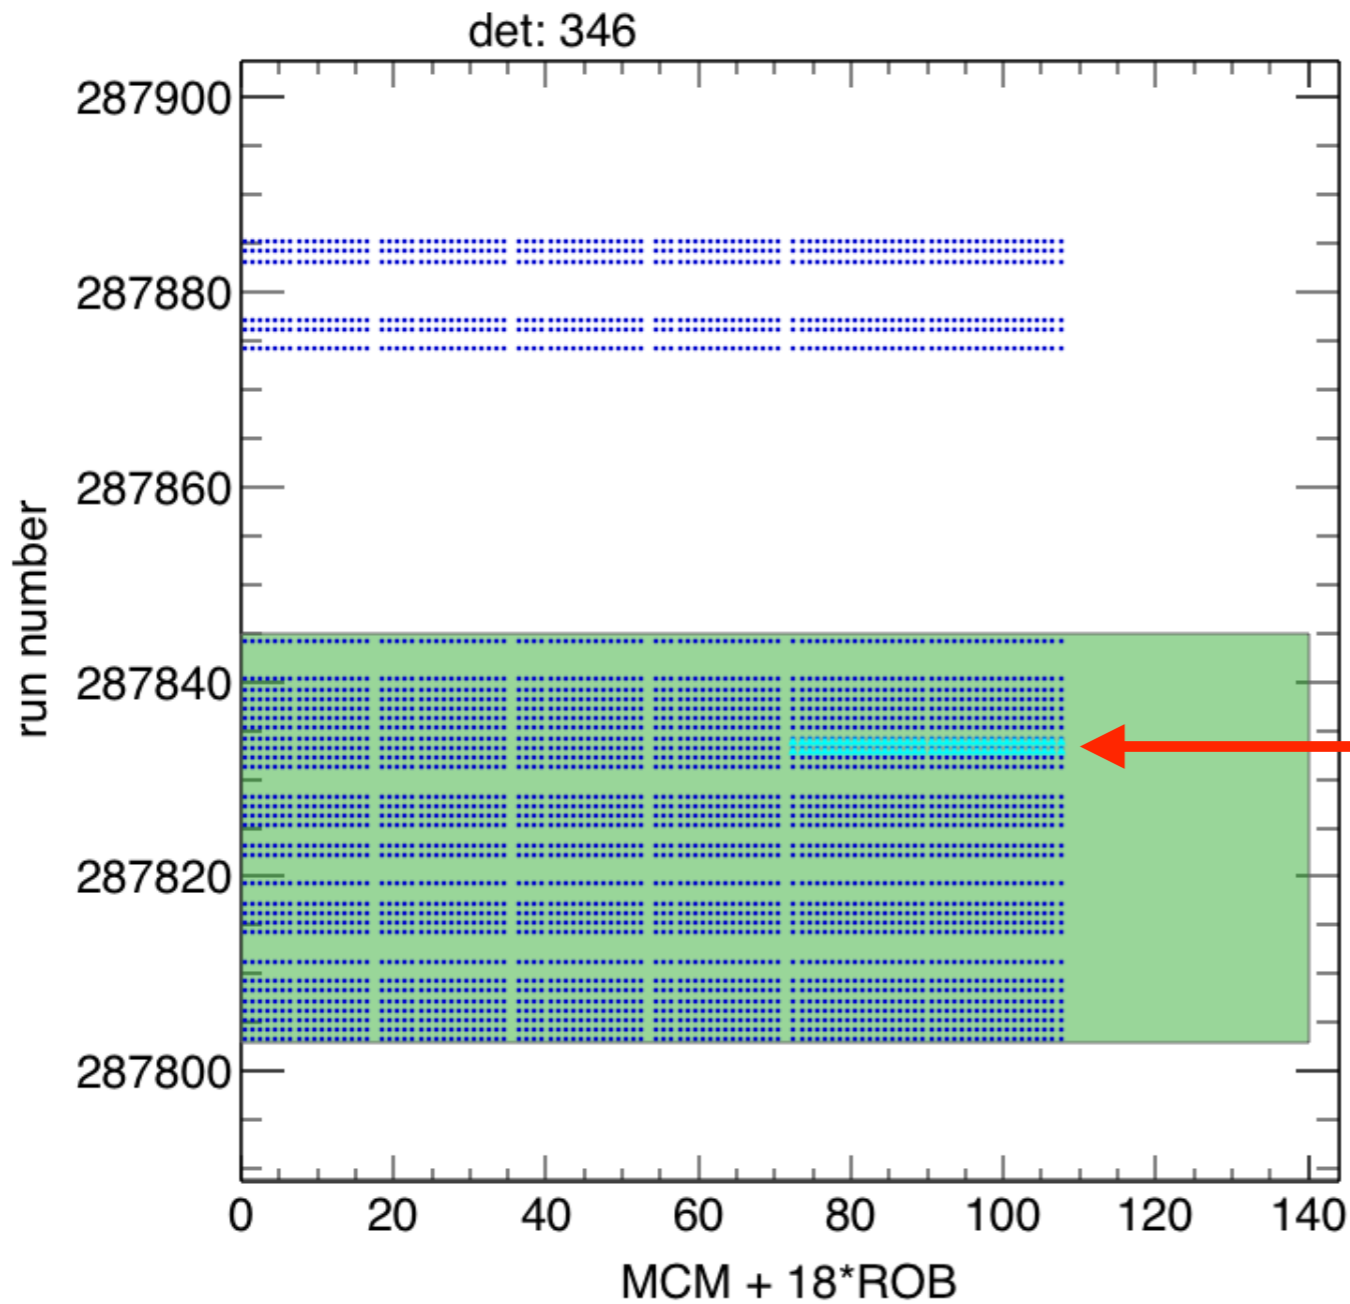
GSM States: TRD det. 346

Bit flips

gsm: 3->14

gsm: 3

gsm: 9

gsm: 0
