RF performance and operational issues

The LHC RF team
reported by A. Butterworth

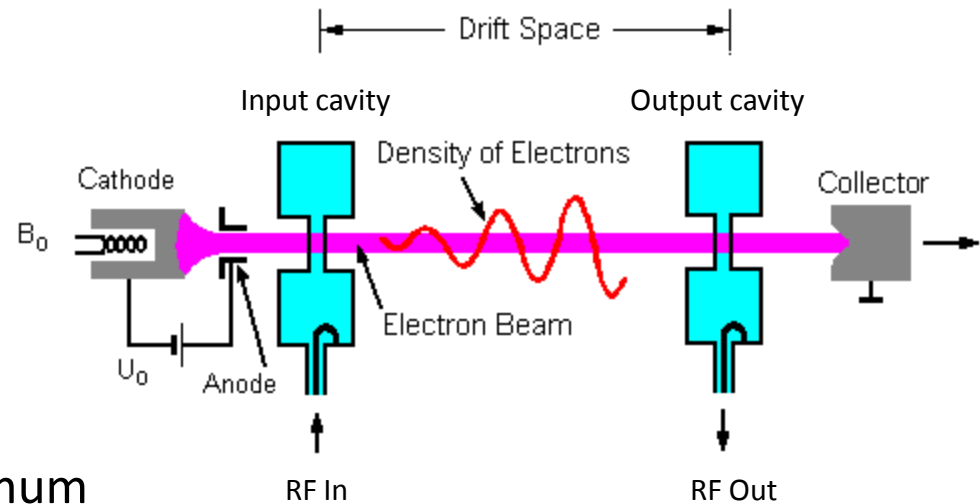
$$P_{\text{collector}} = P_{\text{DC}} - P_{\text{RFout}}$$

→ $P_{\text{collector}}$ close to rated maximum

- Mitigation: reduce collector power:
 - fewer cavities with higher voltage per cavity
 - higher RF power per klystron → reduced collector power (below 450 kW)
 - 4 cavities @ 2 MV, many RF trips
 - cavities had de-conditioned during 2 weeks of running at injection level
 - eventually +/- reliable with 5 cavities @ 1.6 MV
- Other measures:
 - Automatically switch power system to READY when RF OFF
 - reduced current, $P_{\text{collector}} \approx 100\text{kW}$

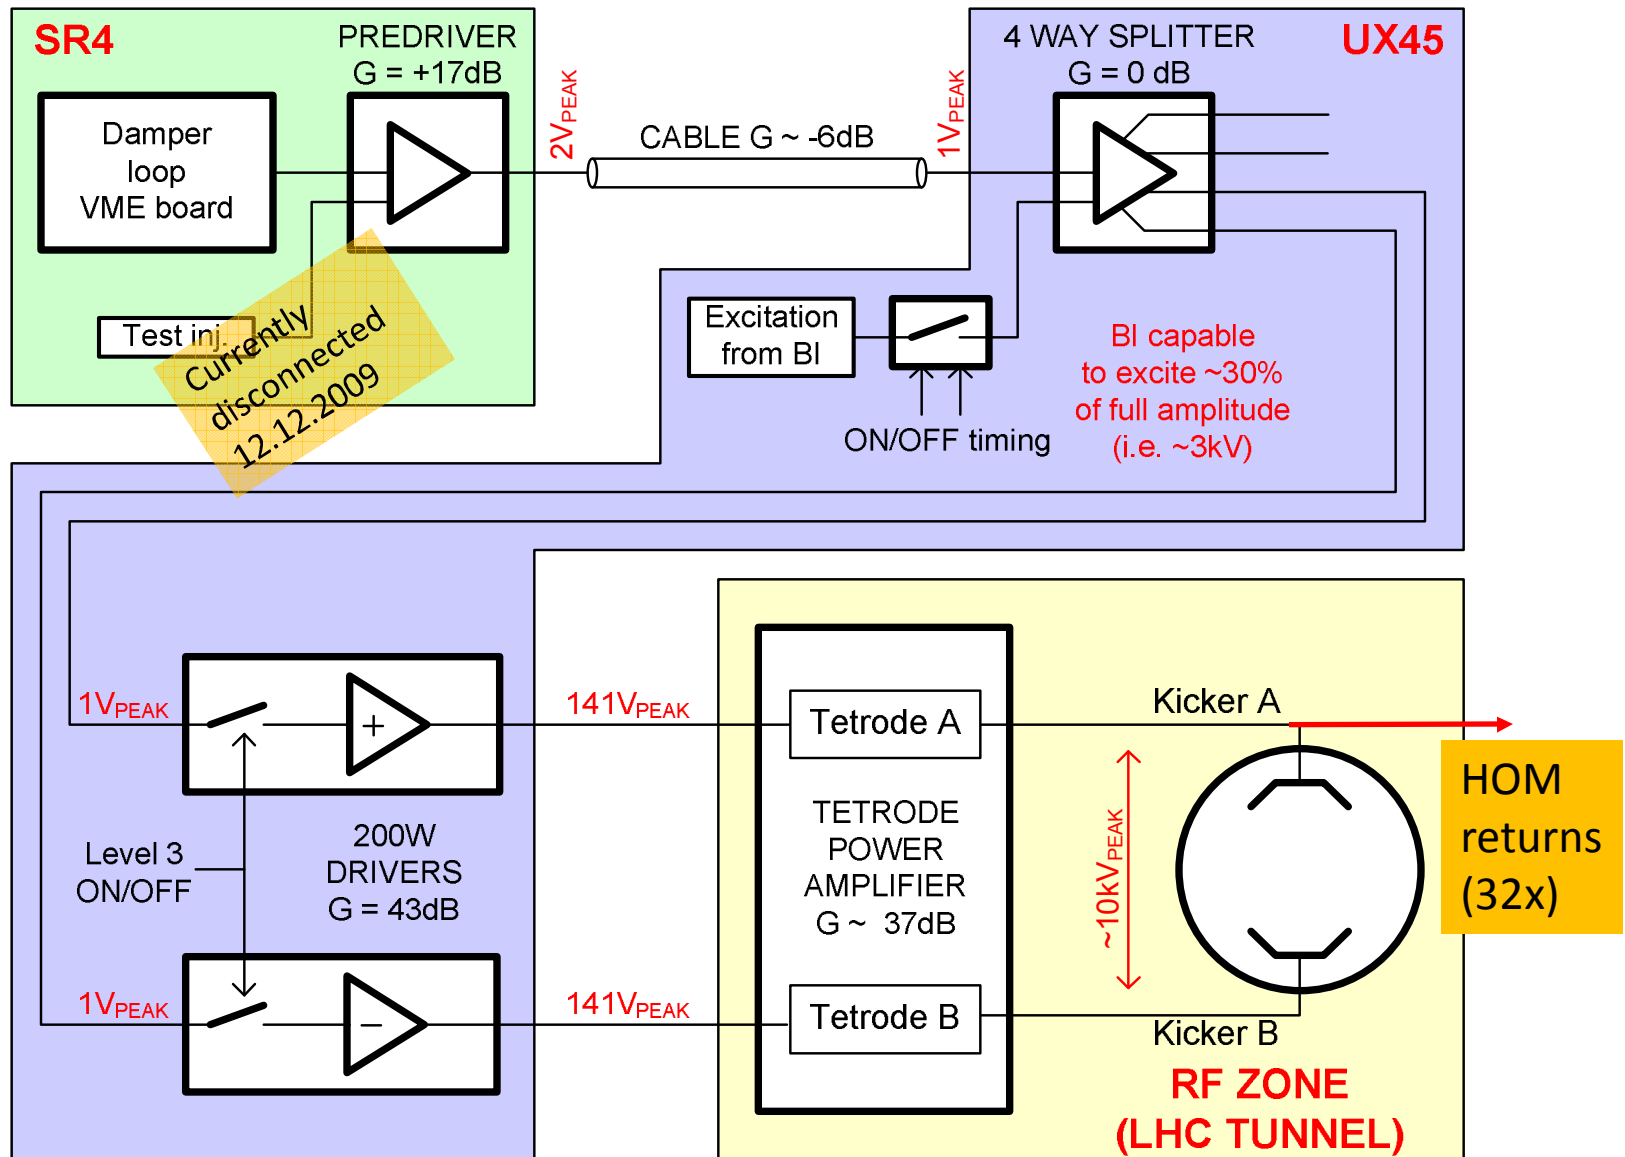
Simplified synoptic of ADT (transverse damper) 8x per beam

Reflection from cable in vertical part (in the pit) is high, periodic perturbation in frequency domain at approximately 200 MHz and 400 MHz (unfortunately)

Two cables being replaced during the technical stop
