Cu/Cu Repeater CHARM Radiation test Presentation

Radwg meeting
26 Nov. 2018

Julien Palluel BE/CO/IN
Eva Gousiou BE/CO/HT

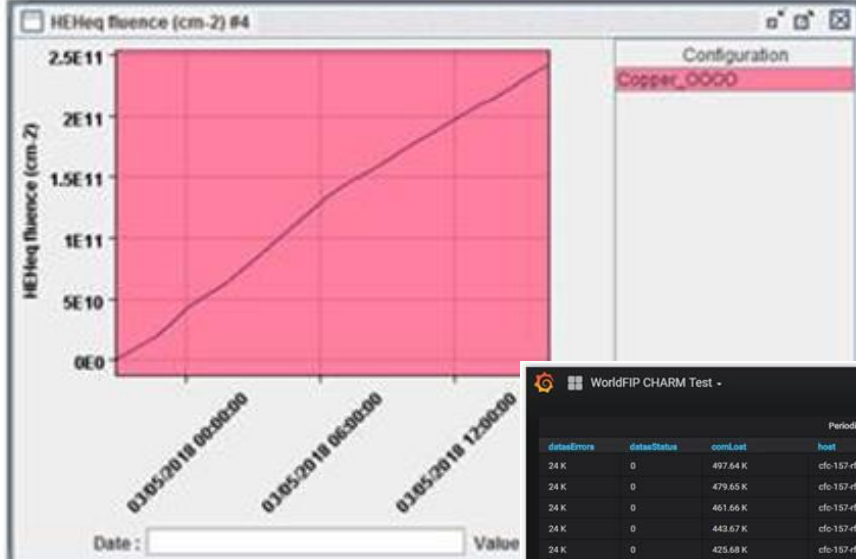
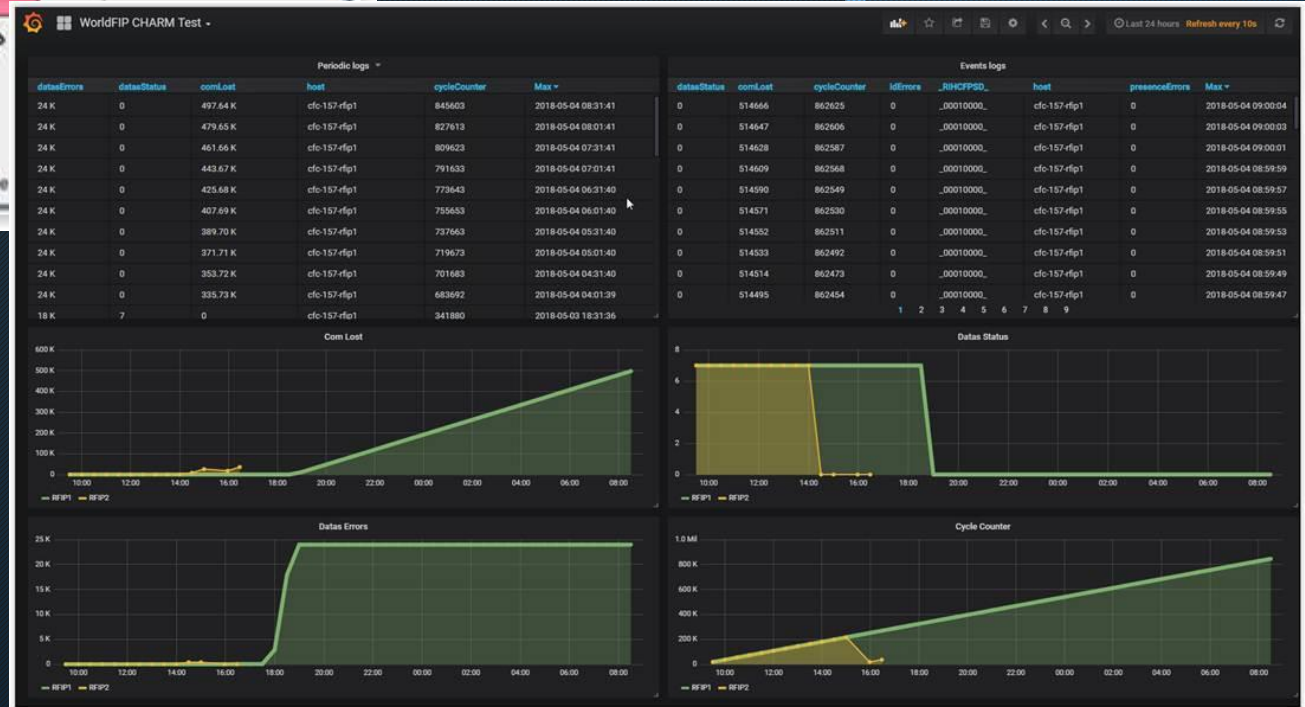
RUN 1: Rep02 & Rep04

Both DUTs quickly died at 60Gy.

- We confirmed that IRFR9220 TID was very low 60 Gy
- We confirmed that Si3443 is a good replacement for IRFR9220
- We found that BC817 TID was 250 Gy and needs to be replaced

2 components need to be replaced : IRFR9220 and BC817
